Zeitschrift: IABSE reports = Rapports AIPC = IVBH Berichte
Band: 73/1/73/2 (1995)

Rubrik: Session C3: General repair of buildings

General Repair of Buildings

Extending the Lifespan of the Architectural Heritage

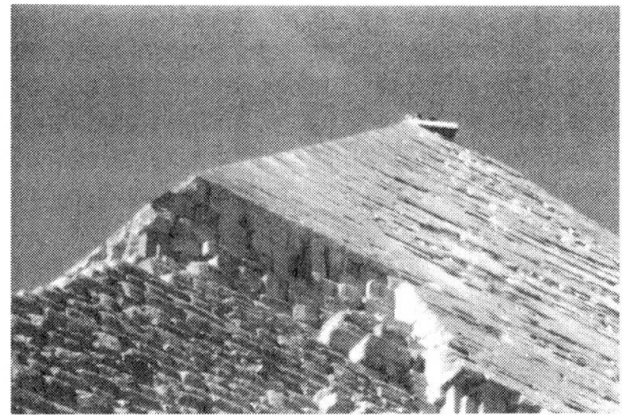
Fig. 2: Shifting of a block on the top of Chephren's Pyramid

On 17 November 1994, a scientific mission made an ascent of Chephren's Pyramid (Figure 1) to evaluate the role of temperature and wind in the decay of the stone and to assess the stability of some blocks that have been shifted by earthquakes in the past (Figure 2). On the one hand the survey contributed new and important elements for deeper understanding of the construction of the pyramid and, on the other, showed that, apart from the problem of weathering, no radical structural interventions were necessary, it being sufficient to add some supports in the same limestone to ensure the stability of blocks at risk.

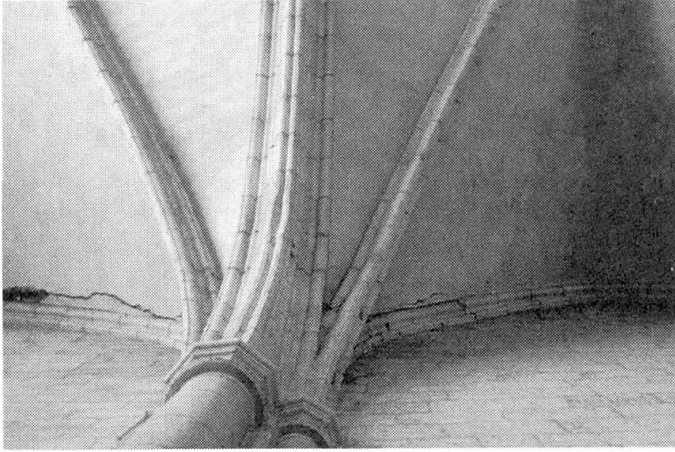
In the cathedral of Vitoria in Spain the main columns have been affected by significant levels of curvature and deformations: at mid-column level, these measure about 30 cm (Figure 3) and the deformations have detached some of the vaults (Figure 4).

Fig. 4: Disconnections between the vaults and walls

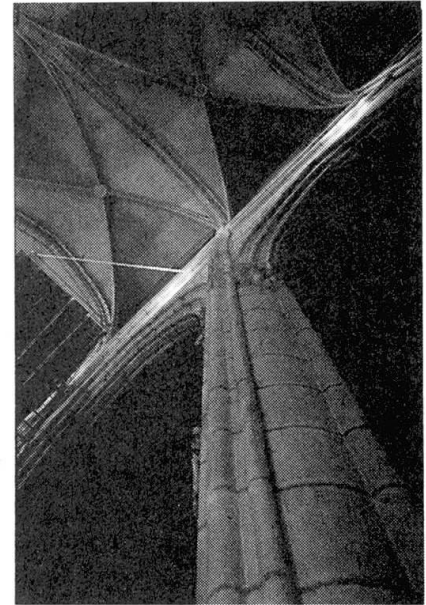
Fig. 3: Deformations on the columns of Vitoria Cathedral

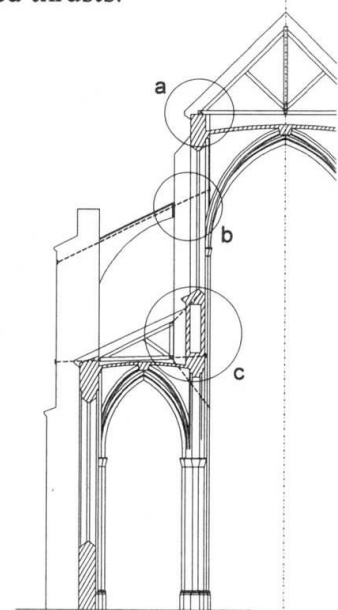
Fig. 8: Projected reinforcement measures

- the tops of the pier extensions (a) will be longitudinally and transversely connected by trusses inserted in the garret to improve collaboration between the two sides of the nave and between the bays;
- the thrust assured by the flying buttresses in zone (b) may have been reduced by visco-elastic deformations: this will first be verified and if it is necessary to adjust the thrust by the use of flat jacks, a bidirectional counteraction will be assured by post-tensioned bars;
- finally, to stiffen the areas of the triforium and above the aisle vault springing (c), and make them more shear resistant, a truss will be inserted in the aisle garrets, which will be fixed to the buttresses and to the pier extensions.

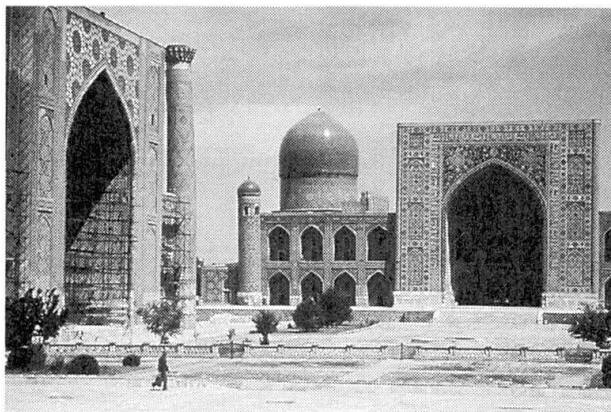
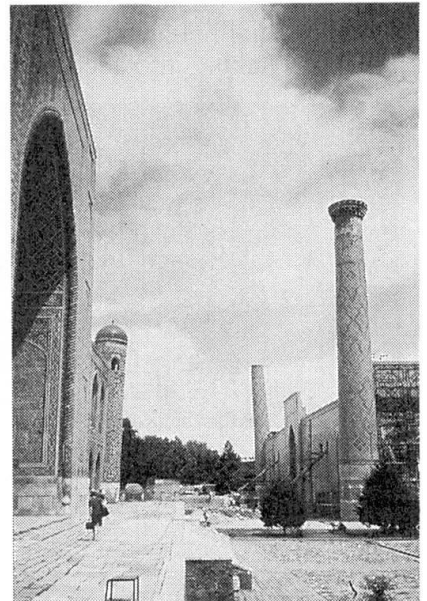
Many of the monuments of Samarkand (Uzbekistan) are affected in this way and both minarets and disconnected walls have dangerous cracks or lean heavily. In the Tilla Kari Mosque on Registan Square (Figures 9 and 10) is an example in which the outward top displacements amount to tens of centimetres, creating unstable situations for both the walls and the connected vaults.

Fig. 9, 10: Leaning and deformations in minarets and mosques, Samarkand

The solution consists in removing a certain amount of soil inside and outside the walls of the mosque and filling the spaces with empty reinforced concrete boxes, which are connected to the masonry foundations, so as to create a continuous rigid raft.

This has the dual advantage of reducing the weight and enlarging the foundations. A further significant advantage is obtained by placing a movable foundation slab on the bottom of the concrete boxes, loaded using provisional jacks (Figure 11 and 12) in order to induce and regulate the pressure necessary to correct the leaning on the basis of the data recorded.

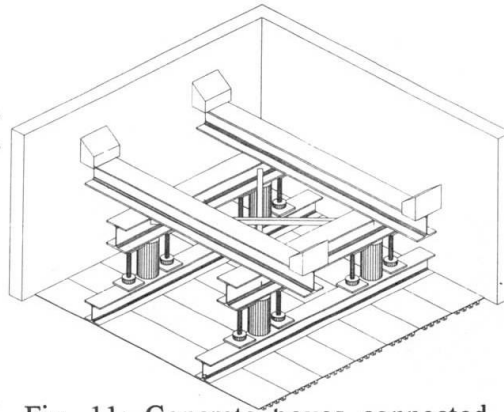
Fig. 11: Concrete boxes connected to the walls to reduce the pressure on the soil

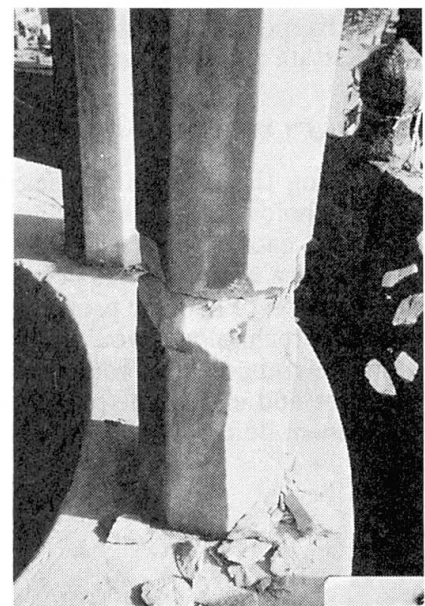
Fig. 14: Important damages in the upper part of a minaret

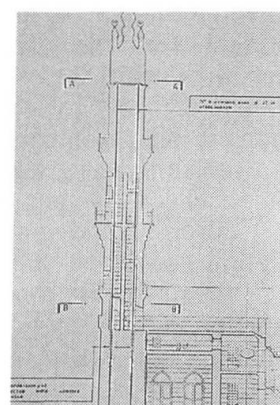
Fig. 17: Prestressed cables for the reinforcement of the minaret

Besides offering an indispensable improvement in the masonry in specific areas where it has deteriorated, the reinforcement can usually be accomplished by tie bars, prestressed cables, etc. placed so as to confer appropriate tensile resistance. Figure 17 shows the strengthening of a minaret using prestressed vertical cables inserted inside the wall and requiring only small holes on the perimeter of the winding staircase. If the bearing capacity of the foundations is insufficient and if, as often happens, some degree of leaning is present, the cables can be anchored in deeper and more solid strata and a higher level of prestressing applied on the opposite side to the slant.

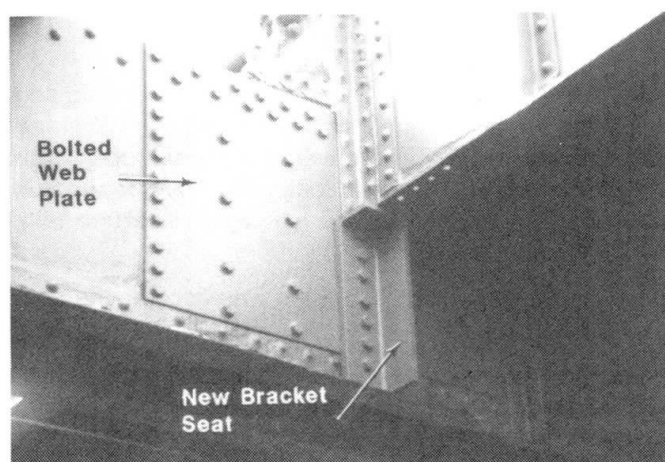
Fig. 2 Bolted web and bracket seat repairs using existing and new holes

The shear strength of high-strength bolts is greater than the existing rivets. Bearing connections using high-strength bolts, with and without shear plane thread exclusion, were often specified to increase

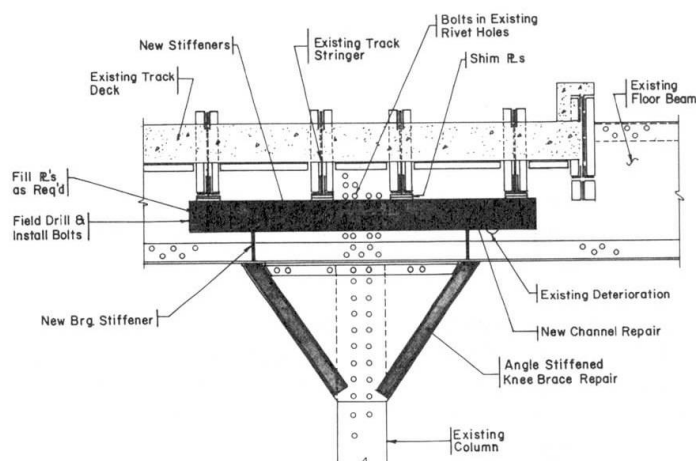
Fig. 4 Alternate load path repair utilizing a channel and stiffened knee brace plate

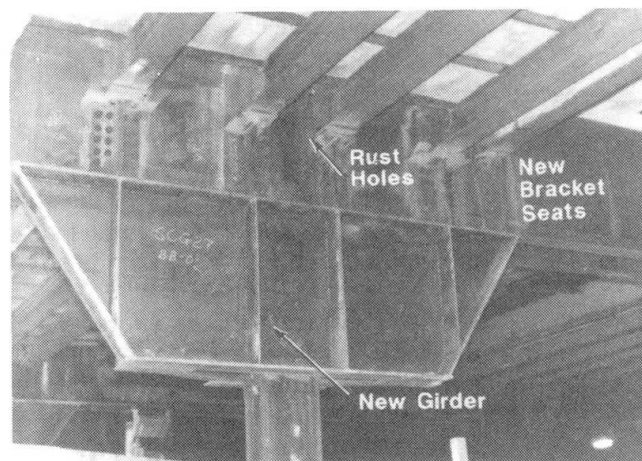
New sister girders (Figure 5) were used where web deterioration on floor beams was quite extensive, and transverse framing members and the concrete trackbed precluded using bolted web plates. The sister beams were installed from below when the track above was closed.

Fig. 5 Supplemental girder below the existing floor beam

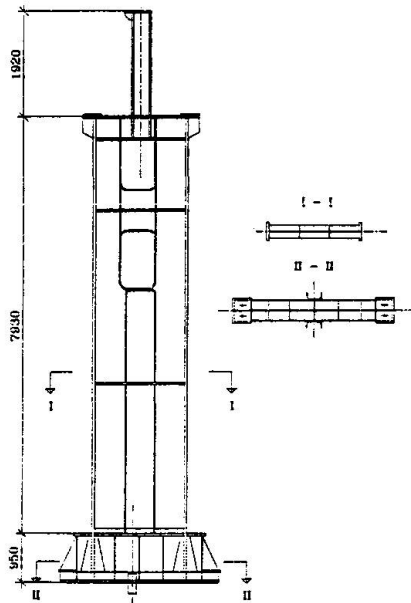
Fig. 6 Repaired main column

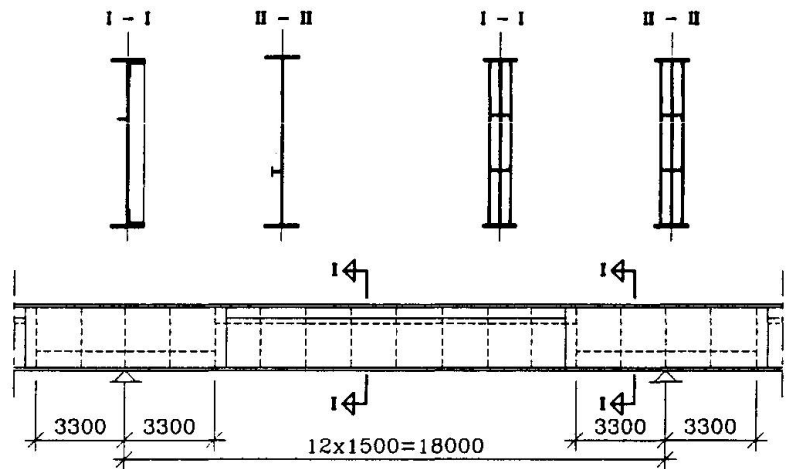
Fig. 7 Repaired crane girder

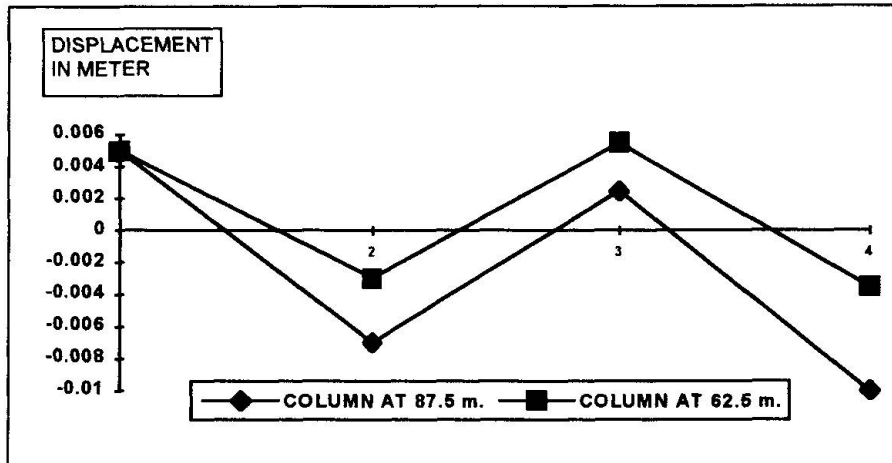
Fig.(2) : Displacement of the columns
