Zeitschrift: IABSE reports = Rapports AIPC = IVBH Berichte
Band: 73/1/73/2 (1995)
Rubrik: Session C3: General repair of buildings

General Repair of Buildings

Extending the Lifespan of the Architectural Heritage

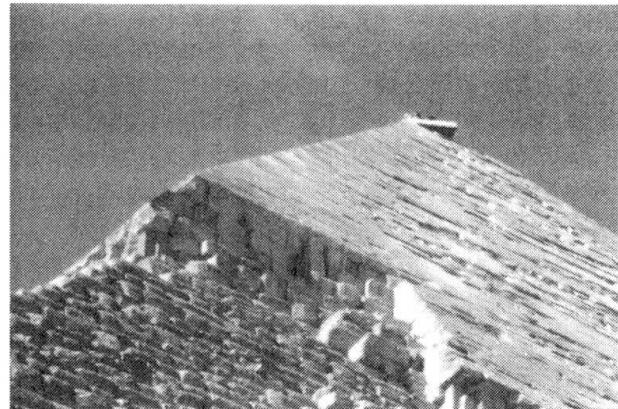
On 17 November 1994, a scientific mission made an ascent of Chephren's Pyramid (Figure 1) to evaluate the role of temperature and wind in the decay of the stone and to assess the stability of some blocks that have been shifted by earthquakes in the past (Figure 2). On the one hand the survey contributed new and important elements for deeper understanding of the construction of the pyramid and, on the other, showed that, apart from the problem of weathering, no radical structural interventions were necessary, it being sufficient to add some supports in the same limestone to ensure the stability of blocks at risk.

Fig. 2: Shifting of a block on the top of Chephren's Pyramid

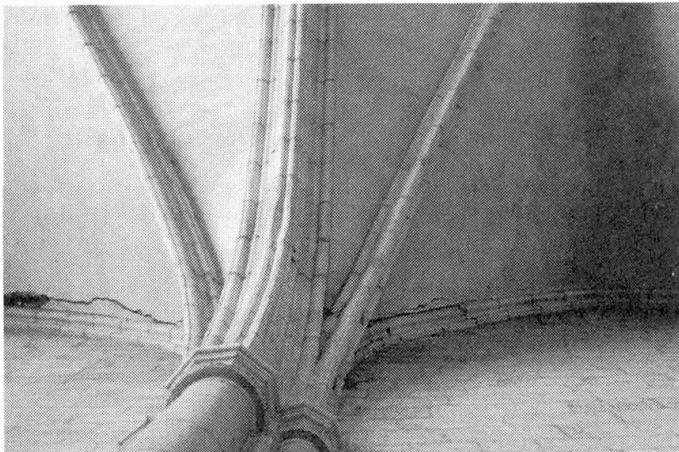
In the cathedral of Vitoria in Spain the main columns have been affected by significant levels of curvature and deformations: at mid-column level, these measure about 30 cm (Figure 3) and the deformations have detached some of the vaults (Figure 4).

Fig. 4: Disconnections between the vaults and walls

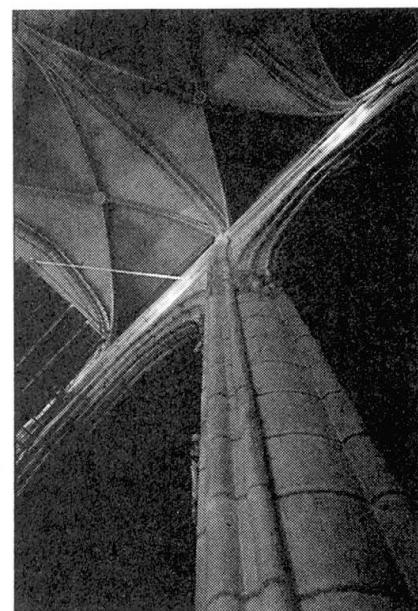
Fig. 3: Deformations on the columns of Vitoria Cathedral

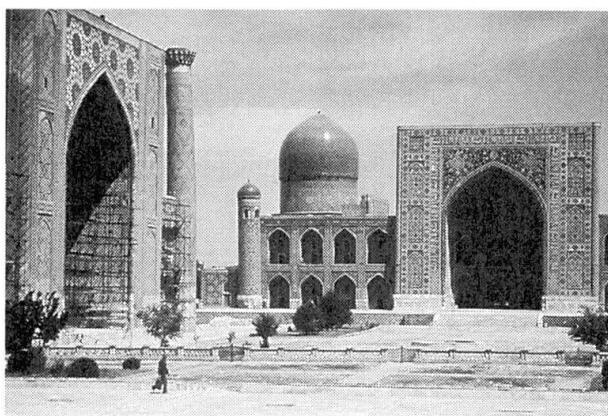
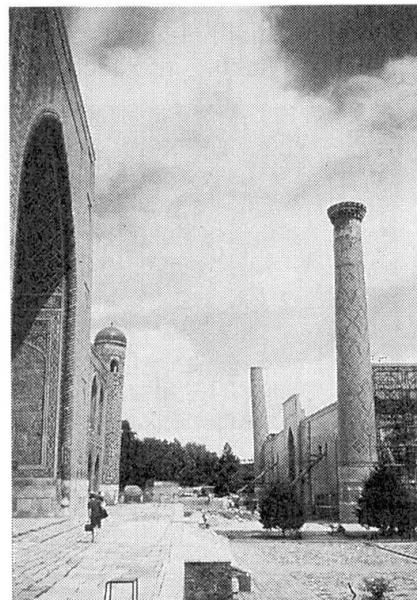
Many of the monuments of Samarkand (Uzbekistan) are affected in this way and both minarets and disconnected walls have dangerous cracks or lean heavily. In the Tilla Kari Mosque on Rejistan Square (Figures 9 and 10) is an example in which the outward top displacements amount to tens of centimetres, creating unstable situations for both the walls and the connected vaults.

Figg. 9, 10: Leaning and deformations in minarets and mosques, Samarkand

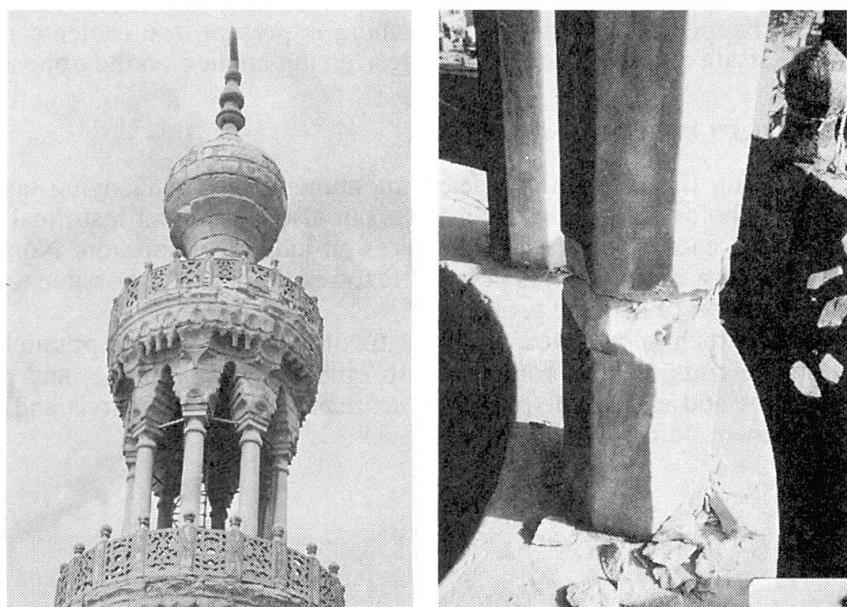
General measures to mitigate the effects of disasters can prevent much of the loss involving ancient monuments. Earthquakes are the most prevalent phenomena for which preventive measures can substantially reduce damage and avoid collapses. The damage to monuments in Cairo caused by the earthquake of 12 October '92 offers an interesting example. Many minarets collapsed not only because the masonry was of poor quality but also on account of the intrinsic weakness of the structural behaviour, especially in the upper parts where slender columns cannot withstand both flexural and twisting actions (Figures 13 and 14). The connection between the minaret and the main part of the mosque is another weak zone, as is shown both by mathematical

Fig. 13: Slender columns in some minarets

Fig. 14: Important damages in the upper part of a minaret

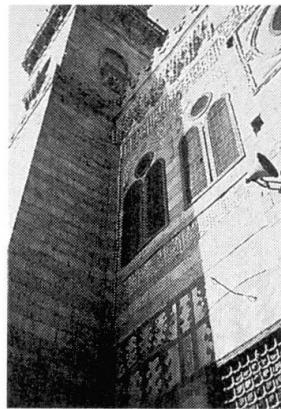
models (Figure 15) and direct observations, although the spontaneous cracks (Figure 16) automatically mitigate the seismic effects.

Fig. 16: Crack in a joint between the minaret and the mosque

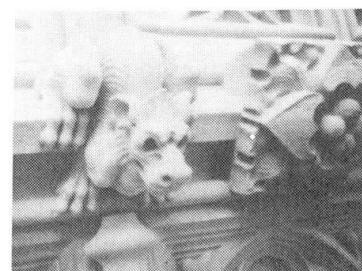
5.1 After cleaning, each area was reinspected and a detailed schedule of repairs was prepared. Defects included sulphate attack, stone spalling, clay beds and faults within the stone, missing pieces and water traps. The aim was to retain as much of the original stonework as possible, accepting weathered profiles. Repairs were undertaken where failure was likely during the 40 year maintenance cycle, to prevent water traps, to reduce the rate of decay and to reinstate important architectural details.

Fig.3 New Carvings

5.2 The stone repairs ranged from repointing, to dressing out water traps, repairing with stone dust mortar, piecing in small areas, the renewal of ashlar blocks and the replacement of elaborate carvings. For the Victoria Tower, which was by far the largest phase and included particularly rich ornamentation, a stone carving workshop was established on site staffed by masons and stone carvers who were able to recreate accurately the decayed decorative carvings, heraldic devices, statues and building details which it was necessary to cut out and replace.

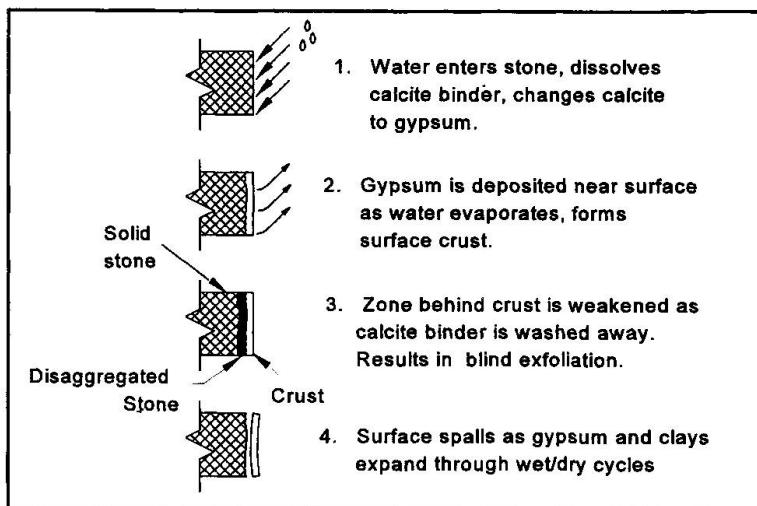
The most severe deterioration was found in areas experiencing frequent wet-dry cycles. The resurvey revealed that once a stone forms surface cracks, more water can penetrate behind the surface and the deterioration spreads rapidly into the stone. The most common forms of deterioration include:

Figure 2: Deterioration Mechanism

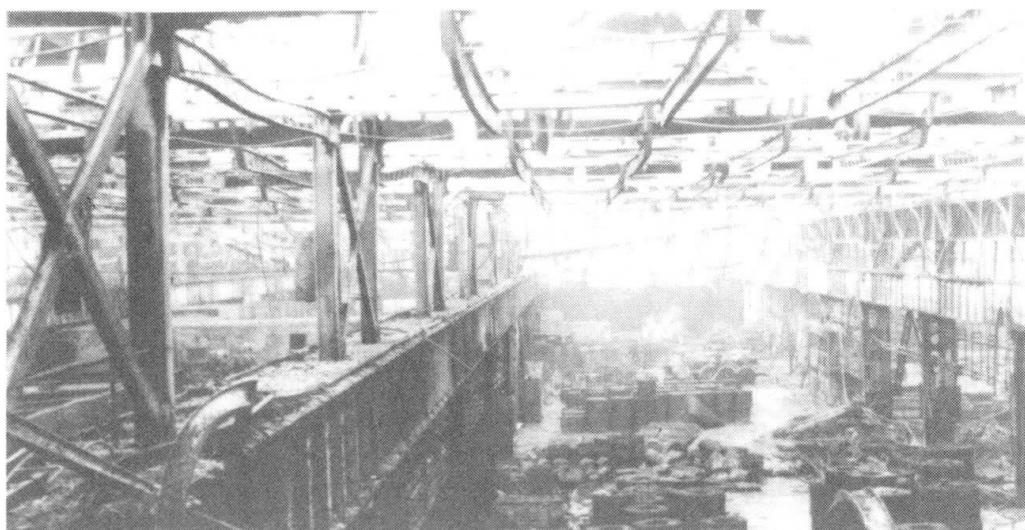
Fig. 4 Building structure damaged by fire

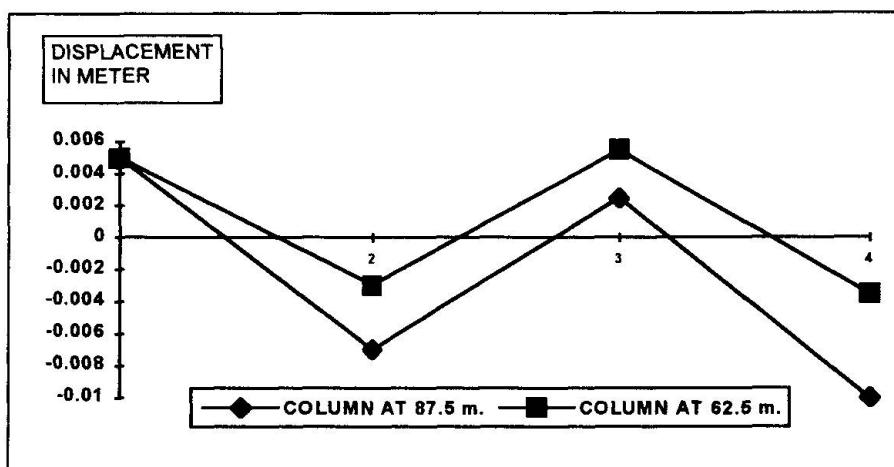
Fig.(2) : Displacement of the columns
