Stone Restoration at the Houses of Parliament in London

Henry WEBBER
Director
Parliamentary Works
London, England

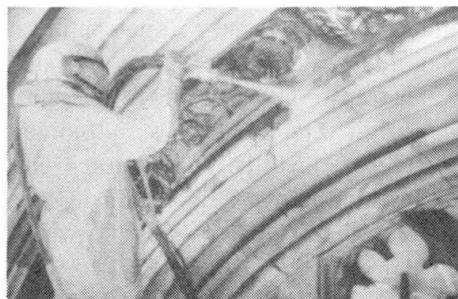
Fig.2 Blast Cleaning

4.2.1 For some parts of the building such as the libraries, oak panelled fine rooms and air conditioned archives of irreplaceable historic documents, the risk of water penetration could not be accepted and semi-dry blast cleaning was adopted using silica grit graded from 0.5mm down. The grit was selected after trials of various gradings and of other abrasives such as aluminium oxide and crushed nut shells.

4.2.2 A disadvantage of blast cleaning is that the natural crust on the stone is damaged. Other disadvantages are the noise and dust, and a mottled shading which is sometimes caused by the way the gun nozzle is manipulated or by markings beneath the original surface of the stone. Advantages are that work can continue through the winter and the rate of progress is more predictable than for water washing.

4.2.2 The technique entails a variety of nozzle sizes and careful control of the pressure and water content depending on the stone characteristics and whether the surface is ashlar or fine carving. The pressures used were of the order of 1.5 bar with water at the rate of 1 litre/minute. Staff responsible for specifying and supervising the work were given practical experience off-site before the contract began so that they could appreciate the difficulties of working in heavy protective clothing with air fed helmets in a confined space, dust and noise. This experience led to a decision to use pressure gauges on hypodermic needles to insert into the air lines for independent pressure checks.

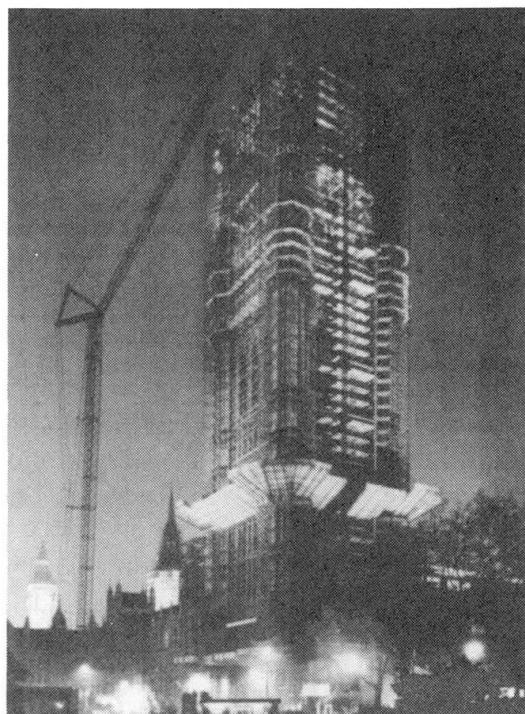
Fig.4 Victoria Tower Scaffold

6.1.1 The access scaffolding for the 119m high Victoria Tower, which weighed 1000T and used 110km of scaffold tube, was founded on bored piles and supported over the adjacent roofs of the Palace on Bailey bridge towers and trusses. In view of the prominence and importance of the site, it was designed to the wind loading and other standards of a permanent structure. At upper levels the scaffold was tied back into the masonry using stainless steel drill anchors which were later made good with stone plugs and the positions were recorded for future use.

6.1.2 A safety fan projected from the scaffold just above Palace roof level. Slurry gutters were installed below alternative working platforms, with gullies and downpipes leading to settling tanks at ground level. The working areas of the scaffold were totally enclosed with fire resistant translucent sheeting and the leaded windows were protected with plywood cut to the gothic profiles. To ensure that stable environmental conditions were maintained for the archive rooms within the tower, a mechanical ventilation and filtration system was provided to feed air through the working area to the existing air conditioning plants.

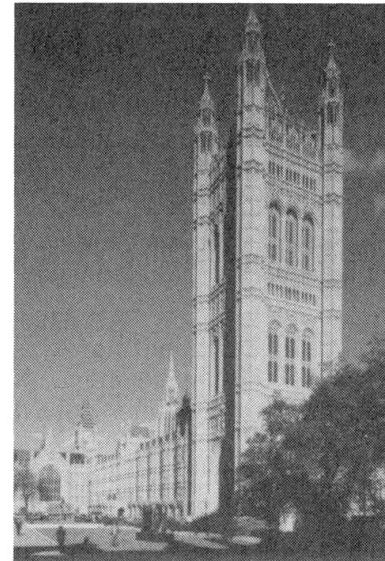
6.2.1 The Victoria Tower is roofed with large cast iron tiles on a trussed framework of cast and wrought iron. This is surmounted by a 28m high flag mast supported by ornate ironwork. Originally the tiles had a zinc anti-corrosion treatment which had failed very quickly in the acid Victorian city air and had been overcoated with a patent treatment. Research showed that many layers of lead based paint had also been applied over the years.

Fig.5 Restoration Complete

6.2.2 The aim was to put the roof in repair and provide a protective treatment which would last some 40 years. The accumulated layers of dirt and paint were removed back to bare metal by air abrasive blasting. Lead precautions included a full working enclosure, protective suits with air supply, air sampling outside the enclosure, disposal of the spent grit and dirt under controlled conditions and a decontamination unit for workmen. Broken cast iron tiles and jointing rolls were repaired by stitching, cold cast welding and off-site welding in an oven with controlled heating and cooling. Some new iron tiles, rolls and missing decorative features were cast, and after reassembly the roof surface was shot blasted and hot zinc sprayed. Pitting in the metal surface was stopped with an epoxy filler, followed by a sealing coat and finally a colour finish of vinyl co-polymer paint.

From analysis of paint scrapings, research in the Public Record Office, old photographs and contemporary descriptions it became clear that the gilding had originally been much more extensive and it was decided to restore the original decorative scheme. The gilding design was faithfully restored using 4,000 sheets of gold leaf and the completed scheme achieves a balance with the restored clock tower at the opposite end of the building, as Barry and Pugin originally intended.
