Artikel: Stone restoration at the Houses of Parliament in London

Stone Restoration at the Houses of Parliament in London

Henry WEBBER

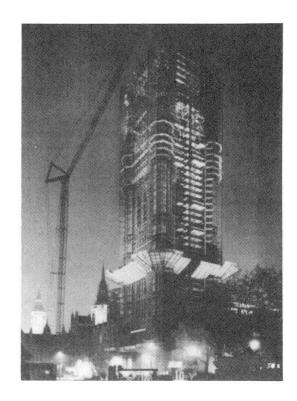
Fig.4 Victoria Tower Scaffold

6.1.1 The access scaffolding for the 119m high Victoria Tower, which weighed 1000T and used 110km of scaffold tube, was founded on bored piles and supported over the adjacent roofs of the Palace on Bailey bridge towers and trusses. In view of the prominence and importance of the site, it was designed to the wind loading and other standards of a permanent structure. At upper levels the scaffold was tied back into the masonry using stainless steel drill anchors which were later made good with stone plugs and the positions were recorded for future use.

- 6.1.2 A safety fan projected from the scaffold just above Palace roof level. Slurry gutters were installed below alternative working platforms, with gullies and downpipes leading to settling tanks at ground level. The working areas of the scaffold were totally enclosed with fire resistant translucent sheeting and the leaded windows were protected with plywood cut to the gothic profiles. To ensure that stable environmental conditions were maintained for the archive rooms within the tower, a mechanical ventilation and filtration system was provided to feed air through the working area to the existing air conditioning plants.
- 6.1.3 The tower floodlighting remained in operation during the works and there was favourable press comment on the scaffold as a work of art in itself.
