## **Stone Restoration at the Houses of Parliament in London**

**Henry WEBBER**  
Director  
Parliamentary Works  
London, England

This paper describes the deterioration which occurred in the masonry of the Houses of Parliament in London as a result of air pollution, and the restoration program which has been carried out over twelve years. The policy governing the conservation work is set out and details are given of stone cleaning and repair techniques. The temporary works adopted for the restoration of the Victoria Tower are described, with an outline of the cast iron roof repairs and regilding. Dynamic methods are described for testing the structural integrity of slender pinnacles.

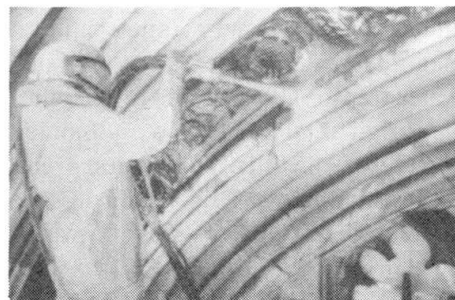
Fig.2 Blast Cleaning

4.2.1 For some parts of the building such as the libraries, oak panelled fine rooms and air conditioned archives of irreplaceable historic documents, the risk of water penetration could not be accepted and semi-dry blast cleaning was adopted using silica grit graded from 0.5mm down. The grit was selected after trials of various gradings and of other abrasives such as aluminium oxide and crushed nut shells.

4.2.2 A disadvantage of blast cleaning is that the natural crust on the stone is damaged. Other disadvantages are the noise and dust, and a mottled shading which is sometimes caused by the way the gun nozzle is manipulated or by markings beneath the original surface of the stone. Advantages are that work can continue through the winter and the rate of progress is more predictable than for water washing.

4.2.2 The technique entails a variety of nozzle sizes and careful control of the pressure and water content depending on the stone characteristics and whether the surface is ashlar or fine carving. The pressures used were of the order of 1.5 bar with water at the rate of 1 litre/minute. Staff responsible for specifying and supervising the work were given practical experience off-site before the contract began so that they could appreciate the difficulties of working in heavy protective clothing with air fed helmets in a confined space, dust and noise. This experience led to a decision to use pressure gauges on hypodermic needles to insert into the air lines for independent pressure checks.

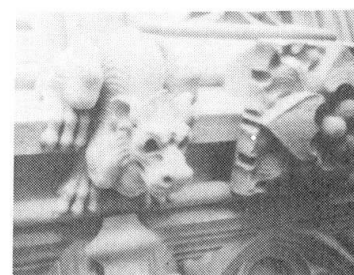
5.1 After cleaning, each area was reinspected and a detailed schedule of repairs was prepared. Defects included sulphate attack, stone spalling, clay beds and faults within the stone, missing pieces and water traps. The aim was to retain as much of the original stonework as possible, accepting weathered profiles. Repairs were undertaken where failure was likely during the 40 year maintenance cycle, to prevent water traps, to reduce the rate of decay and to reinstate important architectural details.

Fig.3 New Carvings

5.2 The stone repairs ranged from repointing, to dressing out water traps, repairing with stone dust mortar, piecing in small areas, the renewal of ashlar blocks and the replacement of elaborate carvings. For the Victoria Tower, which was by far the largest phase and included particularly rich ornamentation, a stone carving workshop was established on site staffed by masons and stone carvers who were able to recreate accurately the decayed decorative carvings, heraldic devices, statues and building details which it was necessary to cut out and replace.

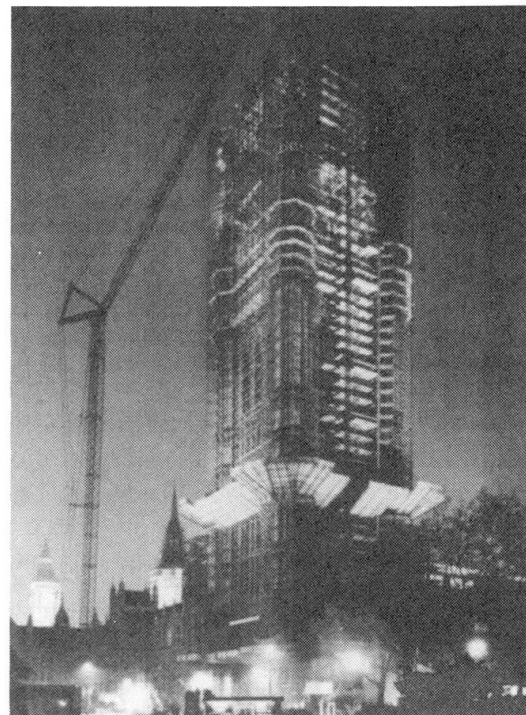
Fig.4 Victoria Tower Scaffold

6.1.1 The access scaffolding for the 119m high Victoria Tower, which weighed 1000T and used 110km of scaffold tube, was founded on bored piles and supported over the adjacent roofs of the Palace on Bailey bridge towers and trusses. In view of the prominence and importance of the site, it was designed to the wind loading and other standards of a permanent structure. At upper levels the scaffold was tied back into the masonry using stainless steel drill anchors which were later made good with stone plugs and the positions were recorded for future use.

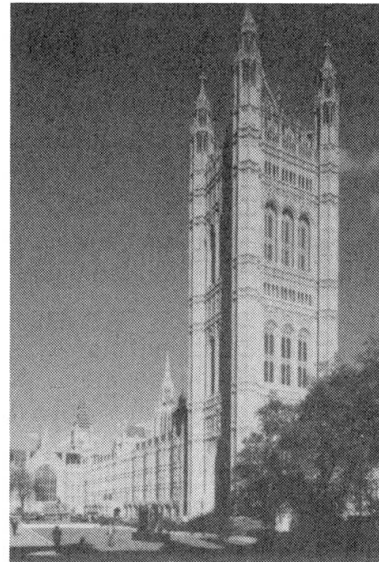
6.2.1 The Victoria Tower is roofed with large cast iron tiles on a trussed framework of cast and wrought iron. This is surmounted by a 28m high flag mast supported by ornate ironwork. Originally the tiles had a zinc anti-corrosion treatment which had failed very quickly in the acid Victorian city air and had been overcoated with a patent treatment. Research showed that many layers of lead based paint had also been applied over the years.

Fig.5 Restoration Complete

6.2.2 The aim was to put the roof in repair and provide a protective treatment which would last some 40 years. The accumulated layers of dirt and paint were removed back to bare metal by air abrasive blasting. Lead precautions included a full working enclosure, protective suits with air supply, air sampling outside the enclosure, disposal of the spent grit and dirt under controlled conditions and a decontamination unit for workmen. Broken cast iron tiles and jointing rolls were repaired by stitching, cold cast welding and off-site welding in an oven with controlled heating and cooling. Some new iron tiles, rolls and missing decorative features were cast, and after reassembly the roof surface was shot blasted and hot zinc sprayed. Pitting in the metal surface was stopped with an epoxy filler, followed by a sealing coat and finally a colour finish of vinyl co-polymer paint.
