Stone Restoration at the Houses of Parliament in London

Henry WEBBER
Director
Parliamentary Works
London, England

This paper describes the deterioration which occurred in the masonry of the Houses of Parliament in London as a result of air pollution, and the restoration program which has been carried out over twelve years. The policy governing the conservation work is set out and details are given of stone cleaning and repair techniques. The temporary works adopted for the restoration of the Victoria Tower are described, with an outline of the cast iron roof repairs and regilding. Dynamic methods are described for testing the structural integrity of slender pinnacles.

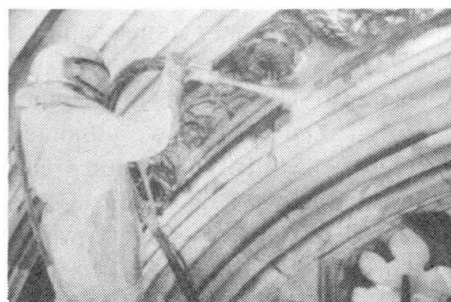
Fig.2 Blast Cleaning

4.2.1 For some parts of the building such as the libraries, oak panelled fine rooms and air conditioned archives of irreplaceable historic documents, the risk of water penetration could not be accepted and semi-dry blast cleaning was adopted using silica grit graded from 0.5mm down. The grit was selected after trials of various gradings and of other abrasives such as aluminium oxide and crushed nut shells.

4.2.2 A disadvantage of blast cleaning is that the natural crust on the stone is damaged. Other disadvantages are the noise and dust, and a mottled shading which is sometimes caused by the way the gun nozzle is manipulated or by markings beneath the original surface of the stone. Advantages are that work can continue through the winter and the rate of progress is more predictable than for water washing.

4.2.2 The technique entails a variety of nozzle sizes and careful control of the pressure and water content depending on the stone characteristics and whether the surface is ashlar or fine carving. The pressures used were of the order of 1.5 bar with water at the rate of 1 litre/minute. Staff responsible for specifying and supervising the work were given practical experience off-site before the contract began so that they could appreciate the difficulties of working in heavy protective clothing with air fed helmets in a confined space, dust and noise. This experience led to a decision to use pressure gauges on hypodermic needles to insert into the air lines for independent pressure checks.
