**Artikel:** Repair methods for deteriorated sandstone facades  
**Autor:** Searls, Carolyn L. / Eilbeck, Daniel  
**DOI:** <https://doi.org/10.5169/seals-55252>

## Repair Methods for Deteriorated Sandstone Facades

A local sandstone was used to clad many San Francisco buildings constructed around the turn of the century. Today, many of these facades are deteriorating, and the stone is cracking, spalling and weathering away, creating a hazard for those walking below. This paper describes the field and laboratory investigations and the facade repair at the St. Francis Hotel. The sandstone cladding had deteriorated due to the effects of water on the stone's mineral constituents. The lifespan of the facade was extended by repairing damaged areas, applying a surface treatment to the stone and by reducing the water infiltration into the stone at horizontal ledges.

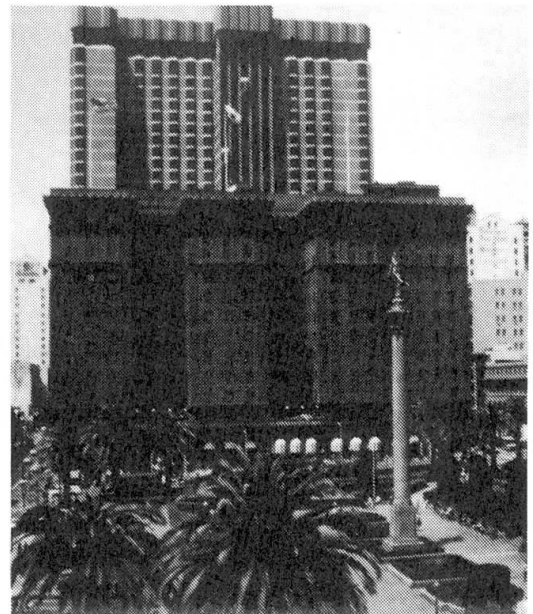
Figure 1 - St. Francis Hotel

The St. Francis Hotel, shown in Figure 1, is a thirteen-story steel framed structure with brick infill and sandstone cladding on the street facades, and brick walls on the west facade. The typical sandstone walls have 30 cm courses with alternate courses projected out 2.5 cm (projecting course). The building was constructed in three stages: 1904, 1907, and 1913. The original drawings of the building were not available.

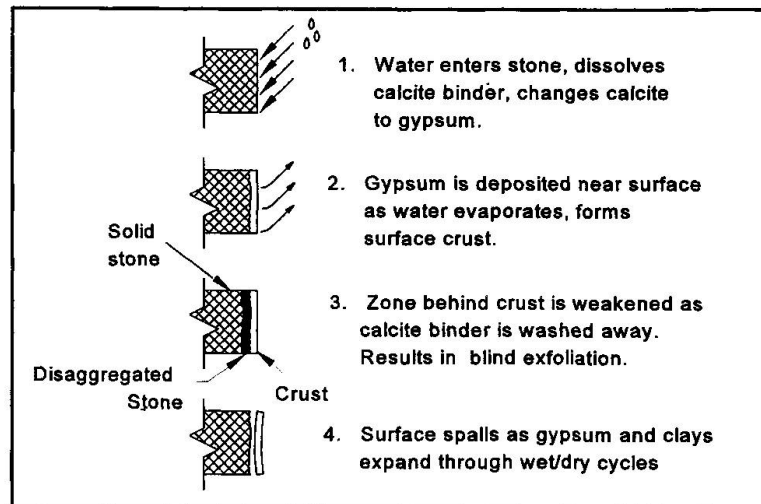
Figure 2: Deterioration Mechanism

The deterioration mechanism, shown in Figure 2, begins when water enters the stone. The water dissolves elements in the binding matrix while acidic pollutants in the water alter the calcite portion of the binder into gypsum. As the water evaporates during repeated wet-dry cycling, the gypsum is deposited at the surface of the stone and forms a surface crust approximately 2 mm thick. The process of forming the surface crust is known as "surface induration." Behind the crust, a layer of disaggregated stone is formed as the calcite binder is lost. Once formed, the crust will expand in all directions due to two mechanisms: -1 the gypsum expands as it incorporates water into its crystal structure, and -2 the montmorillinite clay expands in the presence of water. The crust is not as hard as the original stone, but it is much harder than the layer of disaggregated stone. Expansion of the crust cannot be restrained by the stone and eventually the crust exfoliates, and falls away from the body of the stone.
