Artikel: Repair methods for deteriorated sandstone facades
Autor: Searls, Carolyn L. / Eilbeck, Daniel
DOI: <https://doi.org/10.5169/seals-55252>

Repair Methods for Deteriorated Sandstone Facades

Carolyn L. SEARLS

Daniel EILBECK

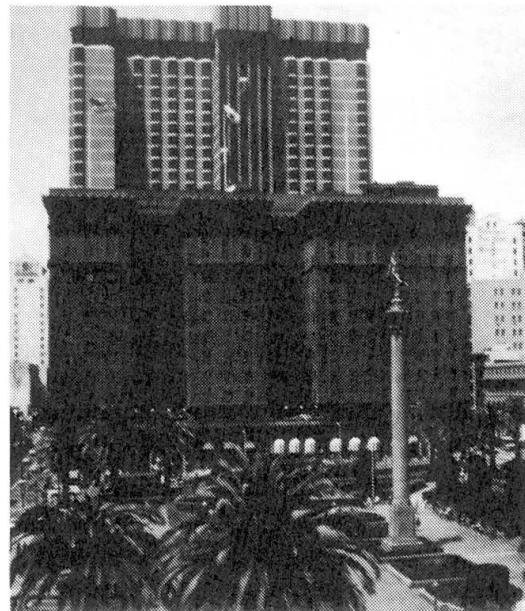
Figure 1 - St. Francis Hotel

The St. Francis Hotel, shown in Figure 1, is a thirteen-story steel framed structure with brick infill and sandstone cladding on the street facades, and brick walls on the west facade. The typical sandstone walls have 30 cm courses with alternate courses projected out 2.5 cm (projecting course). The building was constructed in three stages: 1904, 1907, and 1913. The original drawings of the building were not available.

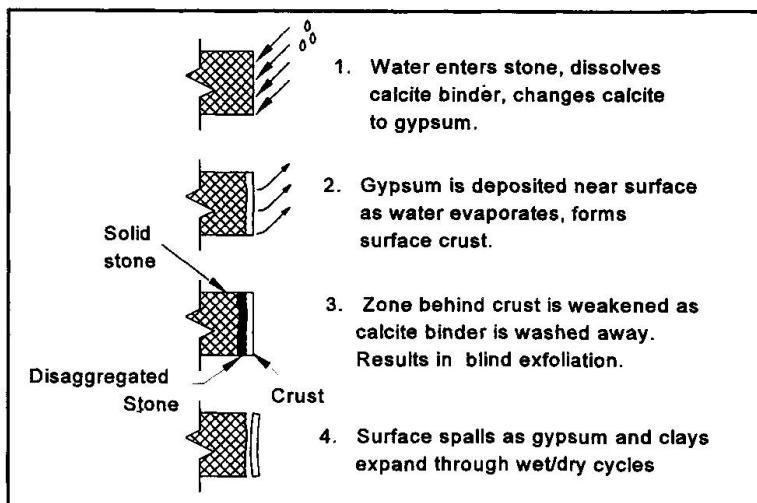
Figure 2: Deterioration Mechanism

The deterioration mechanism, shown in Figure 2, begins when water enters the stone. The water dissolves elements in the binding matrix while acidic pollutants in the water alter the calcite portion of the binder into gypsum. As the water evaporates during repeated wet-dry cycling, the gypsum is deposited at the surface of the stone and forms a surface crust approximately 2 mm thick. The process of forming the surface crust is known as "surface induration." Behind the crust, a layer of disaggregated stone is formed as the calcite binder is lost. Once formed, the crust will expand in all directions due to two mechanisms: -1 the gypsum expands as it incorporates water into its crystal structure, and -2 the montmorillonite clay expands in the presence of water. The crust is not as hard as the original stone, but it is much harder than the layer of disaggregated stone. Expansion of the crust cannot be restrained by the stone and eventually the crust exfoliates, and falls away from the body of the stone.
