Zeitschrift: IABSE reports = Rapports AIPC = IVBH Berichte
Band: 73/1/73/2 (1995)

Artikel: Riveted steel repair methods at a historic train station
Autor: Anderson, Neal S. / Klein, Gary J.
DOI: <https://doi.org/10.5169/seals-55254>

Riveted Steel Repair Methods at a Historic Train Station

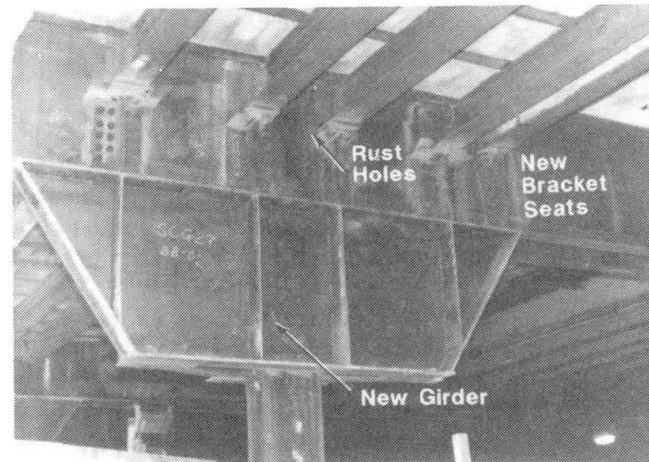
Fig. 5 Supplemental girder below the existing floor beam

New sister girders (Figure 5) were used where web deterioration on floor beams was quite extensive, and transverse framing members and the concrete trackbed precluded using bolted web plates. The sister beams were installed from below when the track above was closed.
