Zeitschrift: IABSE reports = Rapports AIPC = IVBH Berichte
Band: 73/1/73/2 (1995)

Artikel: Riveted steel repair methods at a historic train station
Autor: Anderson, Neal S. / Klein, Gary J.
DOI: <https://doi.org/10.5169/seals-55254>

Riveted Steel Repair Methods at a Historic Train Station

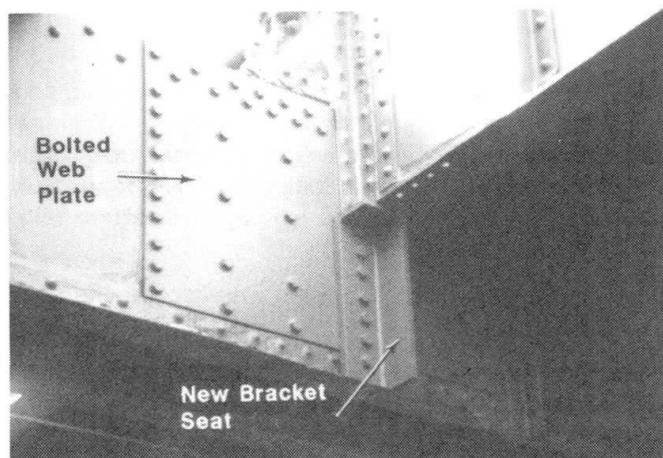
Fig. 2 Bolted web and bracket seat repairs using existing and new holes

Reusing existing rivet holes for bolting provided an efficient repair means to address difficult repair situations containing many interferences, as shown in Figure 2. The rivet pattern was field measured before fabricating repair plates or flange angles. Additional bolts and interior stitch fasteners used on these repairs were field drilled. On bolted repairs without existing rivet holes, new holes were field drilled in the existing steel using the new repair plate with holes as a template.

Supplementing members to strengthen deteriorated connection regions or provide alternate load paths was a repair method used on numerous floor beams at the trainshed, as an economical alternative to member replacement. In its most basic form, this repair consisted of adding bearing brackets or stiffeners below deteriorated framed beam connections (Figure 2).

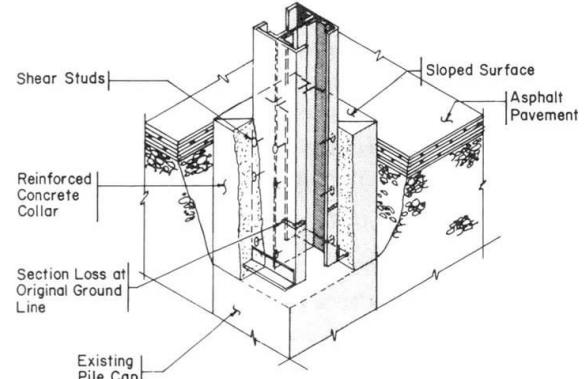
Fig. 3 Composite concrete column encasement

To address column base corrosion, the column bases were excavated to their foundation and steel studs were attached. Concrete column encasements were then cast to the final grade elevation, while founded on the footing. The composite column encasement provided a supplemental load path for any minor section loss and gave the deteriorated column steel additional protection (Figure 3). At locations of severe section loss, welded and bolted repair plates were installed prior to stud installation.

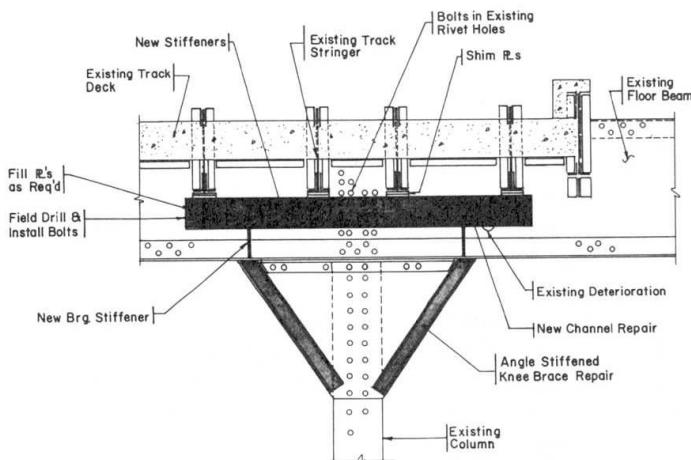
Fig. 4 Alternate load path repair utilizing a channel and stiffened knee brace plate

Figure 4 illustrates an example of two innovative means used to supplement the column to floor beam connection region by providing an alternate load path. At many locations, this connection experienced various degrees of deterioration, and using standard repairs was very impractical. Each trainshed column contained a knee brace plate directly below the floor beam connection. Instead of using a bolted web plate in this region with extensive shoring, the knee brace plate was stiffened with angles to give an alternate load path. Besides providing lateral resistance, the knee brace plates were activated to carry a portion of the gravity load.

Another repair shown in Figure 4 consisted of placing a channel against the deteriorated floor beam web. This repair supplemented the existing connection region by providing an alternate live load path that bypassed the original connection; additional live load was transferred to the stiffened knee brace below.

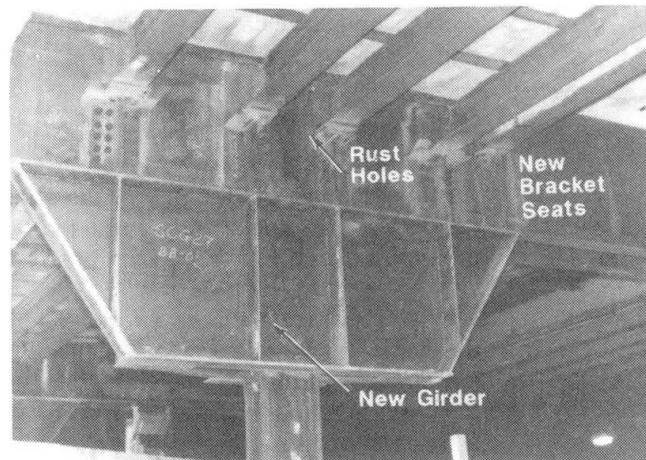
Fig. 5 Supplemental girder below the existing floor beam

New sister girders (Figure 5) were used where web deterioration on floor beams was quite extensive, and transverse framing members and the concrete trackbed precluded using bolted web plates. The sister beams were installed from below when the track above was closed.
