**Artikel:** Riveted steel repair methods at a historic train station  
**Autor:** Anderson, Neal S. / Klein, Gary J.  
**DOI:** <https://doi.org/10.5169/seals-55254>

## Riveted Steel Repair Methods at a Historic Train Station

This paper describes the variety of methods used to repair the 85-year-old riveted steel in a historic train station in downtown Chicago. Exposure to salt-laden moisture took a severe toll on the steel members. Corrosion damage was extensive; complete flange angle deterioration and large web rust holes were a common occurrence. The steel rehabilitation approach on this project is addressed. Factors influencing repair need and guidelines for repair selection are provided. Examples of repair design and details are described, including a discussion of welding criteria, replacing rivets with bolts, composite construction and supplemental members.

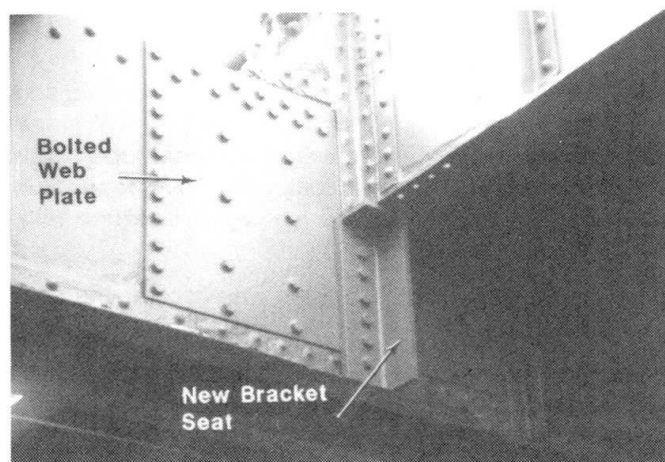
Reusing existing rivet holes for bolting provided an efficient repair means to address difficult repair situations containing many interferences, as shown in Figure 2. The rivet pattern was field measured before fabricating repair plates or flange angles. Additional bolts and interior stitch fasteners used on these repairs were field drilled. On bolted repairs without existing rivet holes, new holes were field drilled in the existing steel using the new repair plate with holes as a template.

**Fig. 2** Bolted web and bracket seat repairs using existing and new holes

Supplementing members to strengthen deteriorated connection regions or provide alternate load paths was a repair method used on numerous floor beams at the trainshed, as an economical alternative to member replacement. In its most basic form, this repair consisted of adding bearing brackets or stiffeners below deteriorated framed beam connections (Figure 2).

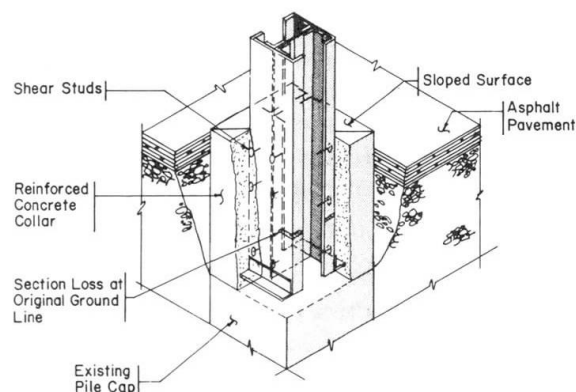
Street level corrosion damage was also a problem. In each street viaduct, salt water splashing on the exposed steel columns gradually reduced their cross-sections at the ground line. Moreover, water flowing through track level breaches oftentimes collected at interior column bases, sometimes causing rust holes.

**Fig. 3** Composite concrete column encasement

To address column base corrosion, the column bases were excavated to their foundation and steel studs were attached. Concrete column encasements were then cast to the final grade elevation, while founded on the footing. The composite column encasement provided a supplemental load path for any minor section loss and gave the deteriorated column steel additional protection (Figure 3). At locations of severe section loss, welded and bolted repair plates were installed prior to stud installation.

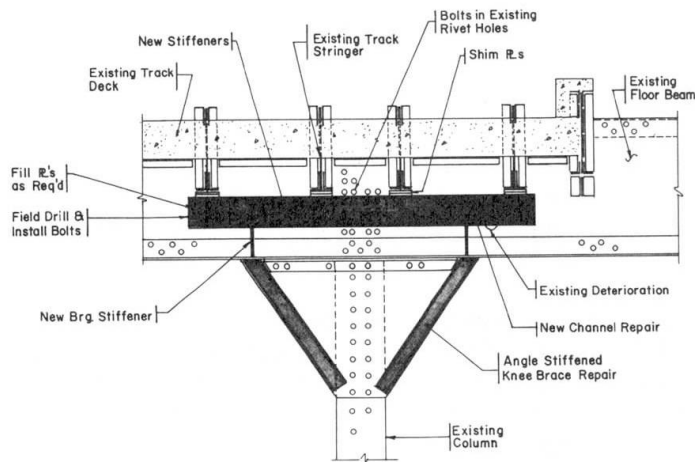
**Fig. 4** Alternate load path repair utilizing a channel and stiffened knee brace plate

Figure 4 illustrates an example of two innovative means used to supplement the column to floor beam connection region by providing an alternate load path. At many locations, this connection experienced various degrees of deterioration, and using standard repairs was very impractical. Each trainshed column contained a knee brace plate directly below the floor beam connection. Instead of using a bolted web plate in this region with extensive shoring, the knee brace plate was stiffened with angles to give an alternate load path. Besides providing lateral resistance, the knee brace plates were activated to carry a portion of the gravity load.

Another repair shown in Figure 4 consisted of placing a channel against the deteriorated floor beam web. This repair supplemented the existing connection region by providing an alternate live load path that bypassed the original connection; additional live load was transferred to the stiffened knee brace below.

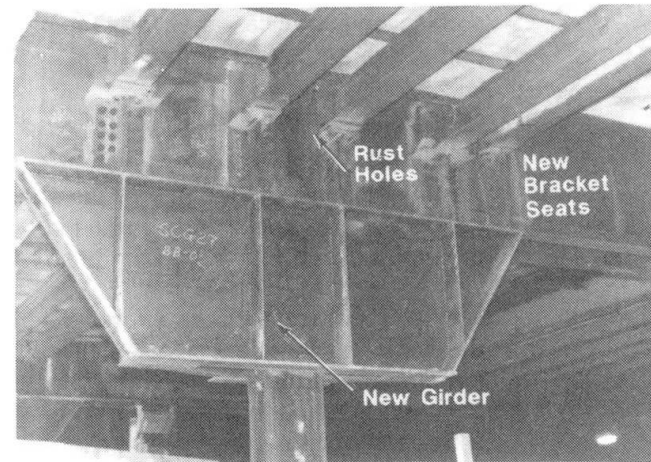
**Fig. 5** Supplemental girder below the existing floor beam

New sister girders (Figure 5) were used where web deterioration on floor beams was quite extensive, and transverse framing members and the concrete trackbed precluded using bolted web plates. The sister beams were installed from below when the track above was closed.
