**Artikel:** Strengthening and repair of a large industrial building  
**Autor:** Budjevac, Dragan / Stipanac, Bratislav  
**DOI:** <https://doi.org/10.5169/seals-55255>

## Strengthening and Repair of a Large Industrial Building

The strengthening and repair of a large industrial building for cold mill plant (over 100'000 m<sup>2</sup>), built in structural steelwork, is presented. The main columns and crane girders were strengthened because of the increased loading due to the change of plant technology. The structural components of the industrial building were repaired because of damages due to a fire. The applied strengthening and repair interventions are described.

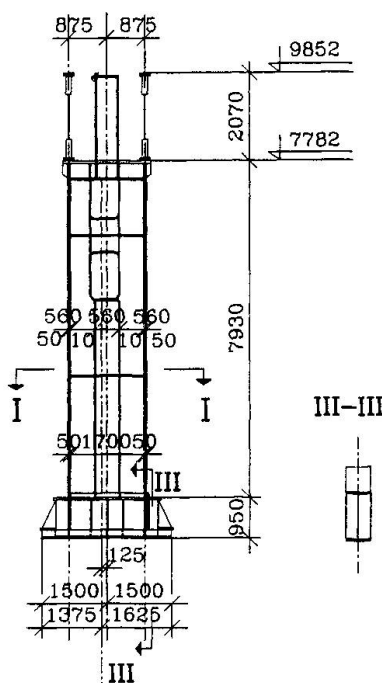
Fig. 2 Strengthened main column

The partial strengthening of main columns F8-F27 as well as the strengthening of column bases (transformation into box section) of main columns D9-D17, E8-E17 were carried out (Fig. 2). The additional longitudinal web stiffeners were welded in all columns. The amount of the additional steel material for the main columns is 44,4 t ( i.e. 4,1% more steel in columns).

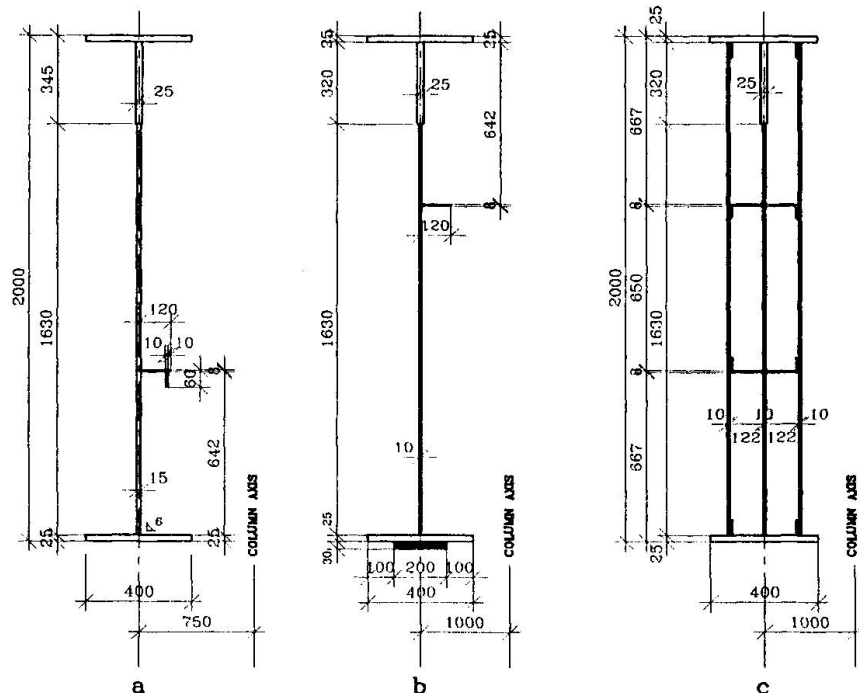
Fig. 3 Strengthened crane girders

The numerous different types (31) of the crane girders (total number 502), were applied in the original building. Thus the crane girders were classified in three types, concerning the strengthening works. The type "a" represented the crane girders (411 pieces) where the additional elements were put in for the longitudinal web stiffeners; the crane girders of type "b" required the additional plate to be welded on the bottom flange; the transformation of plate girder into box girder was applied to the crane girders (81 pieces) of type "c" (Fig. 3). The expansion joints of crane girders were strengthened as well. The additional steel material for the strengthening of crane girders amounts 256,1 t (i.e. 10,0% more steel in crane girders).

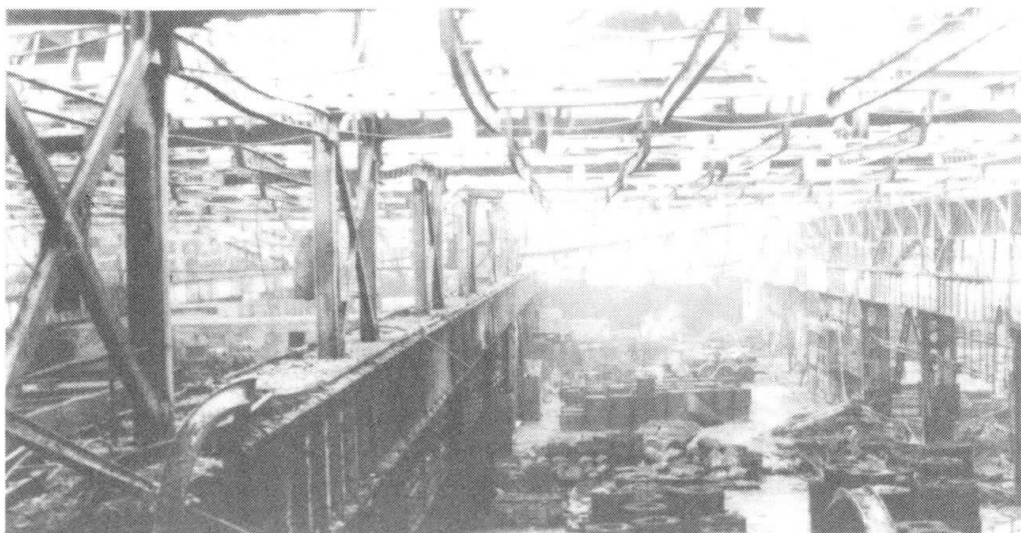
Fig. 4 Building structure damaged by fire

- Roof cladding is either completely destroyed (aluminum profiled sheets), or partly damaged remaining on the roof (steel profiled sheets).
- More than 90% of purlins are largely deformed and they should be changed.
- About 50% of roof trusses and supporting roof structures were significantly deformed (Fig 4.). The roof trusses in the zone of the greatest damages (bays: D-E, E-F and F-G between the columns 20 - 28) fell down.
- The global and local deformations of the main columns were noticed, especially large deformations were present in the column row F, where the crane girders were located on different levels, with the presence of the column twisting consequently.
- The crane girders underwent the significant global and local deformations. The expansion joints were open excessively, some of them even more than 500 mm.

- The brake bracing structures, especially in the field 21-22, got excessive deformations, that somewhere resulted in the member ruptures.
- The wall cladding was damaged in the large area of external walls.
