Artikel: Strengthening and repair of a large industrial building
Autor: Budjevac, Dragan / Stipanic, Bratislav
DOI: <https://doi.org/10.5169/seals-55255>

Strengthening and Repair of a Large Industrial Building

Dragan BUDJEVAC
Associate Professor
Belgrade University
Belgrade

Bratislav STIPANIC
Associate Professor
Belgrade University
Belgrade

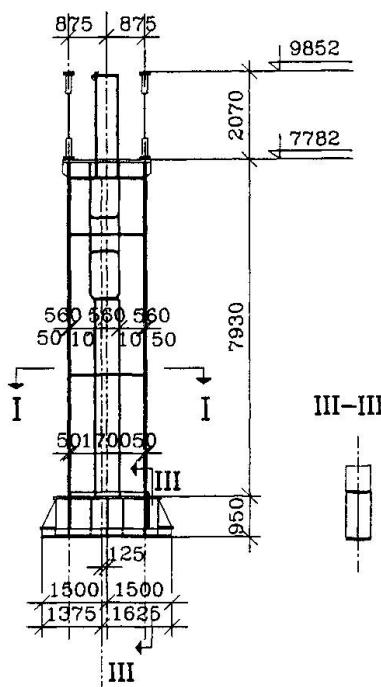
Fig. 2 Strengthened main column

The partial strengthening of main columns F8-F27 as well as the strengthening of column bases (transformation into box section) of main columns D9-D17, E8-E17 were carried out (Fig. 2). The additional longitudinal web stiffeners were welded in all columns. The amount of the additional steel material for the main columns is 44,4 t (i.e. 4,1% more steel in columns).

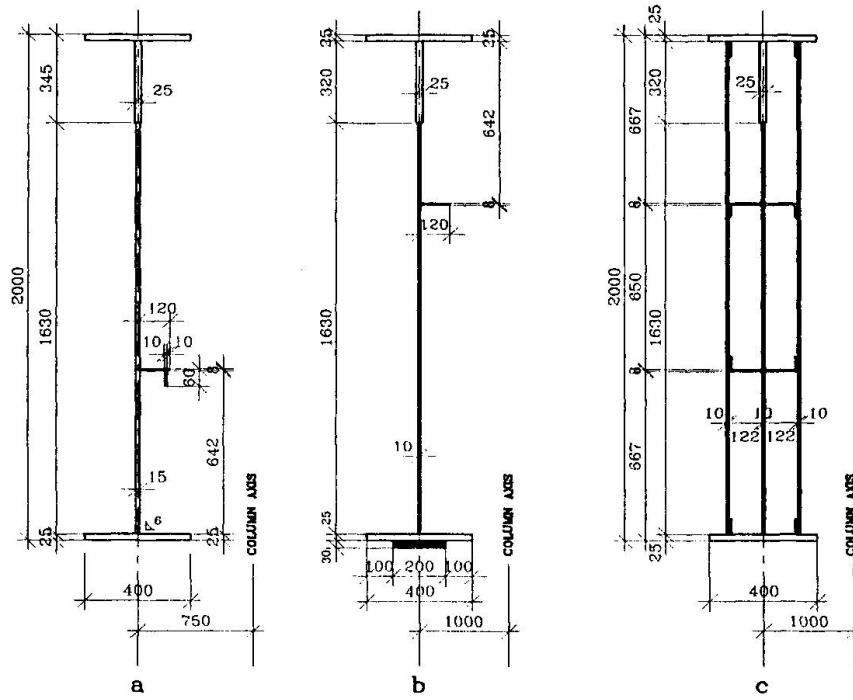
Fig. 3 Strengthened crane girders

The numerous different types (31) of the crane girders (total number 502), were applied in the original building. Thus the crane girders were classified in three types, concerning the strengthening works. The type "a" represented the crane girders (411 pieces) where the additional elements were put in for the longitudinal web stiffeners; the crane girders of type "b" required the additional plate to be welded on the bottom flange; the transformation of plate girder into box girder was applied to the crane girders (81 pieces) of type "c" (Fig. 3). The expansion joints of crane girders were strengthened as well. The additional steel material for the strengthening of crane girders amounts 256,1 t (i.e. 10,0% more steel in crane girders).

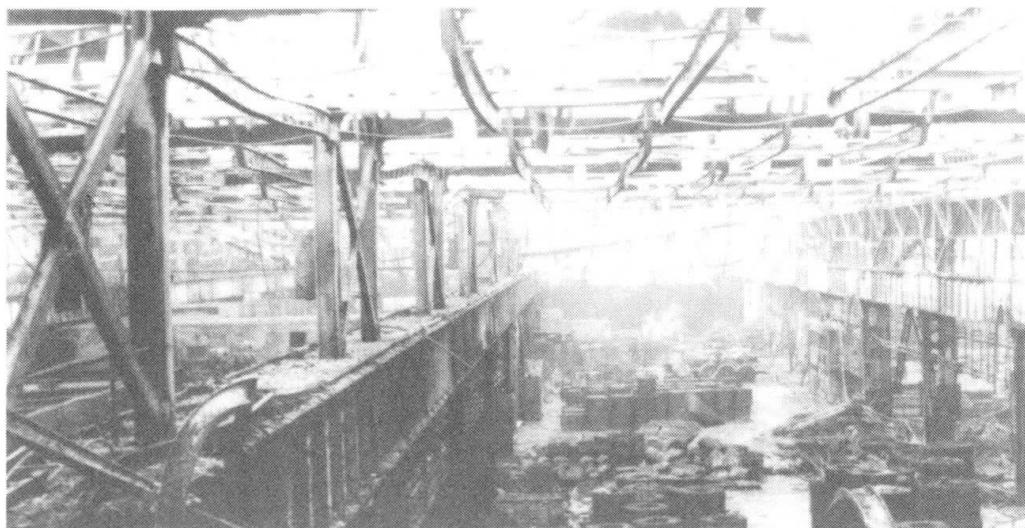
Fig. 4 Building structure damaged by fire

- Roof cladding is either completely destroyed (aluminum profiled sheets), or partly damaged remaining on the roof (steel profiled sheets).
- More than 90% of purlins are largely deformed and they should be changed.
- About 50% of roof trusses and supporting roof structures were significantly deformed (Fig 4.). The roof trusses in the zone of the greatest damages (bays: D-E, E-F and F-G between the columns 20 - 28) fell down.
- The global and local deformations of the main columns were noticed, especially large deformations were present in the column row F, where the crane girders were located on different levels, with the presence of the column twisting consequently.
- The crane girders underwent the significant global and local deformations. The expansion joints were open excessively, some of them even more than 500 mm.

- The brake bracing structures, especially in the field 21-22, got excessive deformations, that somewhere resulted in the member ruptures.
- The wall cladding was damaged in the large area of external walls.
