Zeitschrift: IABSE reports = Rapports AIPC = IVBH Berichte
Band: 73/1/73/2 (1995)
Rubrik: Session A1: General repair of bridges I

Session A1

General Repair of Bridges I

Strengthening of the 120-Year-Old Substructure of a Railway Bridge

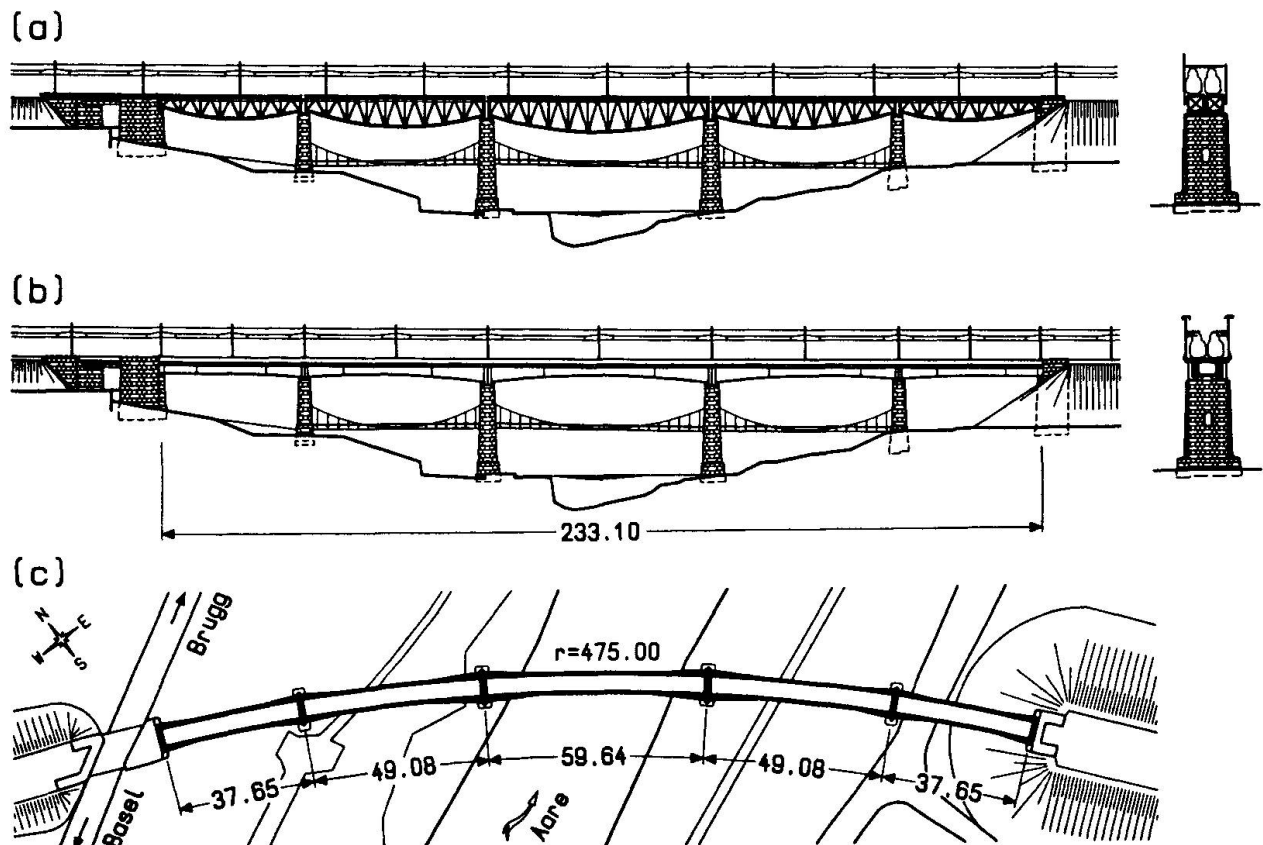
The steel superstructure of a 233 m long double track railway bridge over the river Aare at Brugg, Switzerland, is being replaced by a post-tensioned concrete box girder (Fig. 1). The substructure built in 1875 has been strengthened and the pedestrian suspension bridge is being reconstructed.

Fig. 1 Overview: (a) Steel superstructure on natural stone masonry substructure; (b) New post-tensioned concrete box girder on strengthened substructure; (c) Plan view of new bridge. Note: Dimensions in metres.

Compared to the open-decked steel structure the average dead load of the new concrete girder (including ballast) increased from 69 to 490 kNm^{-1} , i.e. by 610%. Design values for usual live loads increased from about 110 to 160 kNm^{-1} , i.e. by 45%. Strengthening measures for the substructure had to take into account these increased loads, the projected future service life of 100 years and the condition that all construction work had to be executed under full railway traffic.

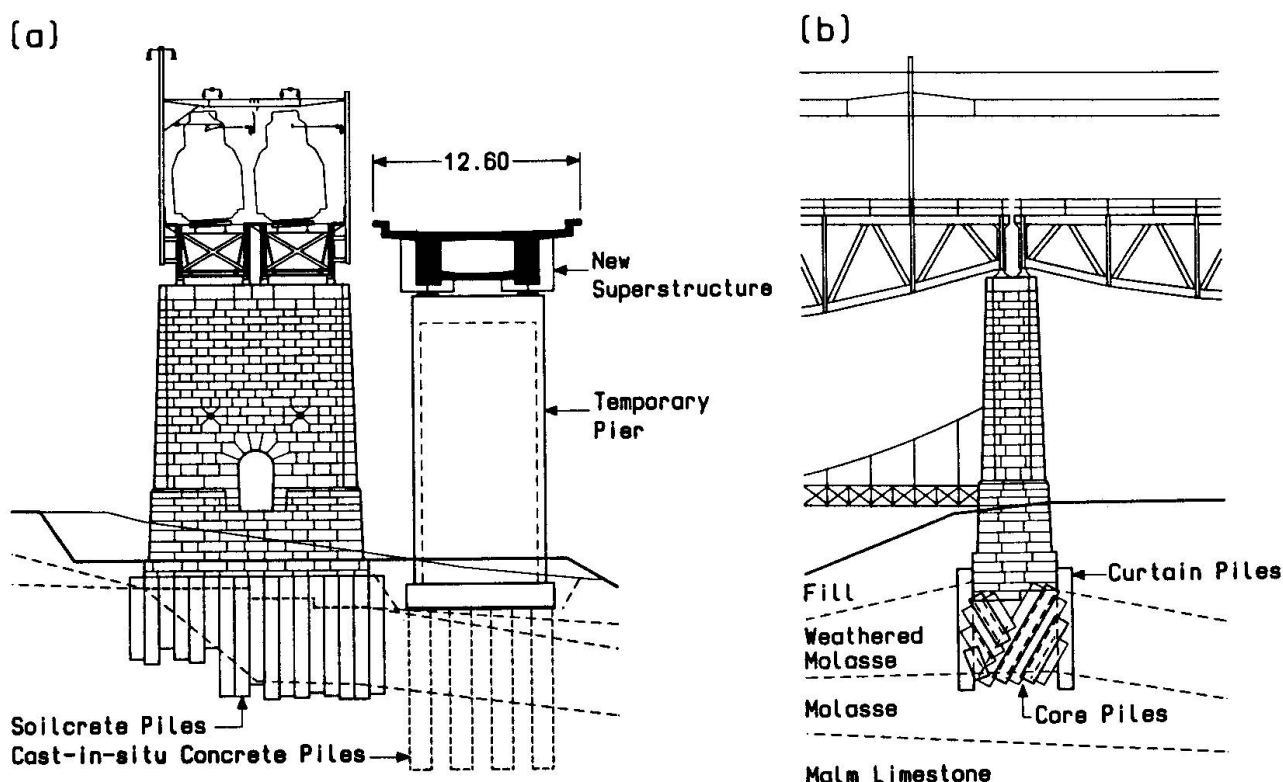
While the two 25 m high central piers are founded on solid rock the somewhat shorter side piers are founded on layers of weathered molasse with a high clay content. These soft layers have a variable thickness of 1 to 8 m (Fig. 2).

Currently, average (extreme) soil pressures without traffic and with maximum traffic loads amount to 0.38 (0.45) and 0.55 (1.29) MPa, respectively. In the future, these values will increase to 0.62 (1.16) and 0.80 (1.50) MPa, respectively. In order to avoid unacceptable settlements and inclinations of the piers it was decided to replace the weathered molasse by a material with considerably higher modulus of elasticity and strength.

Fig. 2 Soilcrete pile foundation of side piers: (a) Cross-section; (b) Elevation.

Traditional underpinning was discarded because of high costs and risks for railway traffic during execution. The soilcrete technique was chosen after a feasibility test had shown that piles of sufficient quality could be made despite the soil's high clay content. It was decided to complete a curtain along the perimeter of the pier base prior to filling the core underneath the foundation. The curtain piles served to encase the material underneath the pier and allowed to gain further experience on the actual soil conditions. Construction of the core piles began only after the curtain piles had passed severe quality control test. Pier settlements and inclinations were continually monitored during the execution of the soilcrete piles.

The quality of the soilcrete piles was checked by means of coring. While the average (minimum) values of the modulus of elasticity and of the compressive strength were found to be equal to 5 (2) GPa and 6 (2) MPa, respectively, the average density of the piles amounted to 16 to 20 kNm⁻³. These values met the specifications and it was verified that the quality was sufficiently uniform throughout the soilcrete body.

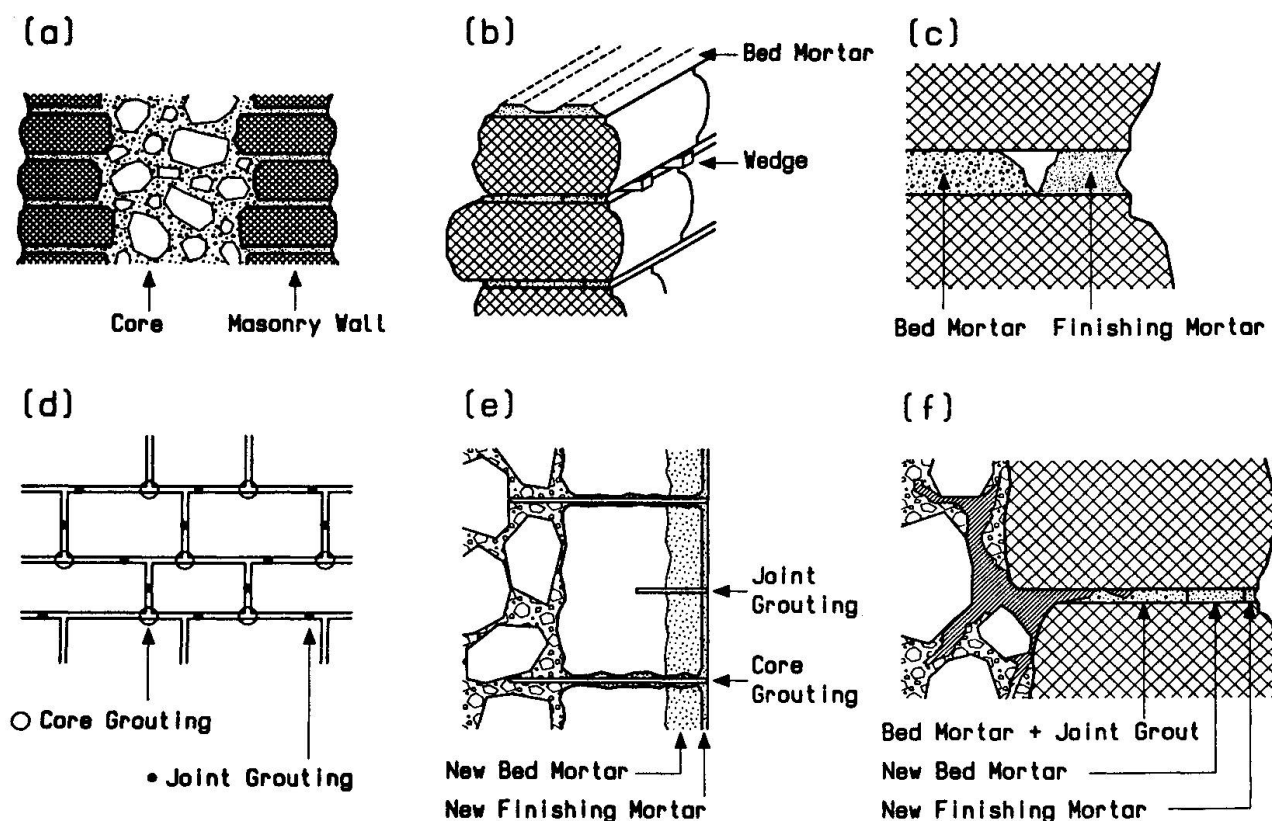
Examination of the condition of the piers and abutments revealed the usual damage due to weathering, i.e. deterioration of the outermost 100 to 200 mm of the joints, cracking of a few single blocks and overall wear of the surface. The exterior masonry wall has a thickness of about 750 mm and is made of limestone blocks with a compressive strength of 150 MPa. Due to the new superstructure, the average permanent stress in the exterior wall will increase from 0.35 to 1.6 MPa in the upper portion of the pier and from 1.4 to 2.4 MPa at its base.

Fig. 3 Natural stone masonry: (a) Vertical section through pier; (b) Placing of masonry blocks; (c) Bed joint; (d) Elevation showing grouting locations; (e) Plan view; (f) Cross-section through bed joint.

The exterior walls have been prepared for the higher loads by reconditioning the existing mortar joint and by filling the voids in the mortar to allow for a smoother stress distribution in the joint. The head of the piers will be replaced by a massive 2.5 m high reinforced concrete block that transfers the forces from the bearings to the exterior walls. This concrete block also serves as a "roof" preventing water from entering into the pier.

The requirements for the new bed mortar included a maximum value of the modulus of elasticity of 10 to 15 GPa and a limitation of the alkali-content of the cement to 0.6% to avoid crystallisation with subsequent damage in the stone material. Modern mortar and injection materials were used and adjusted to achieve the low modulus of elasticity required in the present application. In hindsight,

Work was carried out in portions of about 40 m² of pier or abutment surface, alternating between front and side faces. The East abutment was used to gain experience and to refine the working procedures for the piers and the West abutment. The main difficulty was to find the right workability and technique to bring the new bed mortar into the joint. For quality control, cores were taken from the joints; remaining voids and mechanical properties of the new joint material were found to be satisfactory.

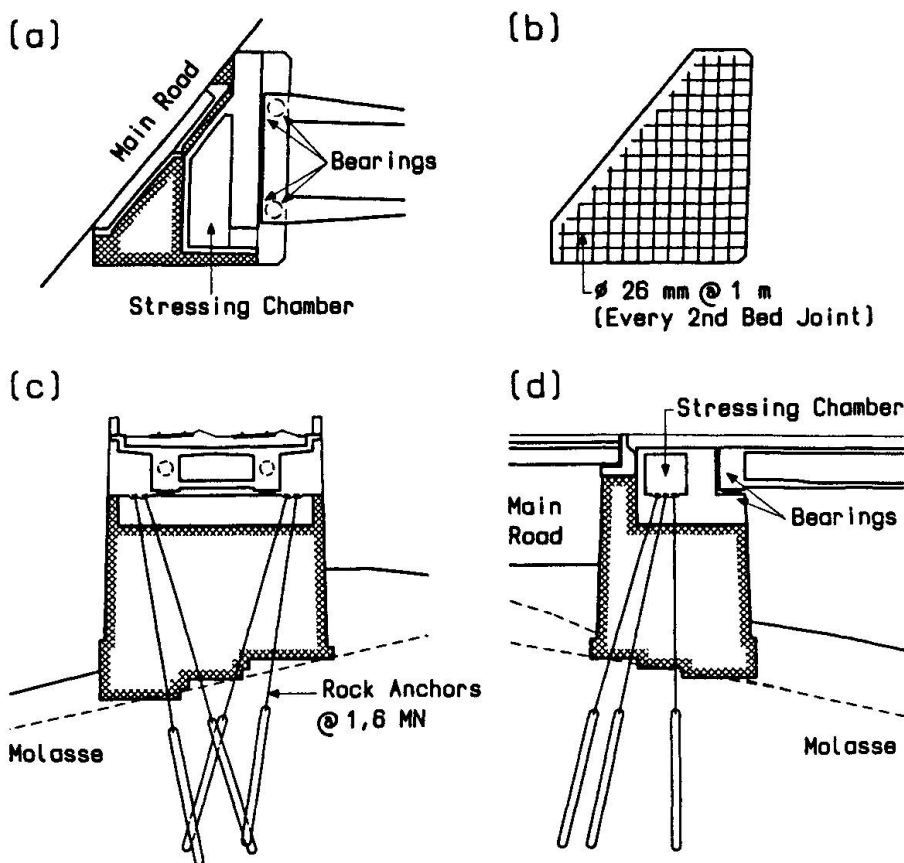
In spite of the congested space for the execution, [Fig. 4(a)] the West abutment was chosen as the fixed support of the bridge since it is of moderate height and founded on rock, while the pier-like East abutment is embedded in an earthfill dam.

Fig. 4 West abutment: (a) Plan view; (b) Orthogonal reinforcement in bed-joints; (c) Cross-section; (d) Elevation.

After reconditioning the masonry, the abutment was strengthened by horizontally placed steel reinforcing bars to obtain a solid abutment block [Fig. 4(b)]. In addition, vertical steel reinforcement is placed to interlock the abutment block and the concrete block housing the bridge bearings. The required resistance to the horizontal design load of 11 MN, acting 13 m above the solid rock, is provided by the weight of 38 MN of the abutment block as well as by a number of inspectable and replaceable ground anchors with a total anchor force in service of 16 MN [Figs. 4(c) and (d)].

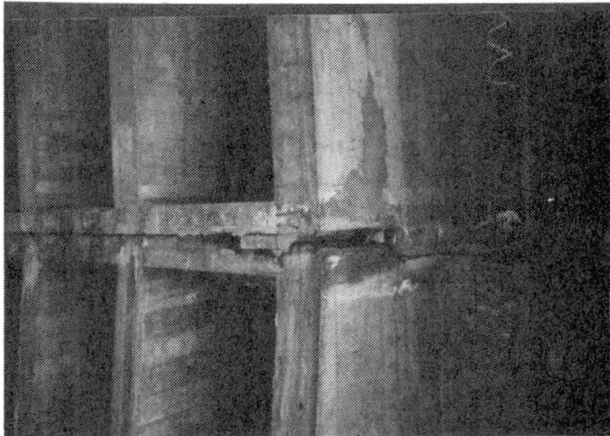
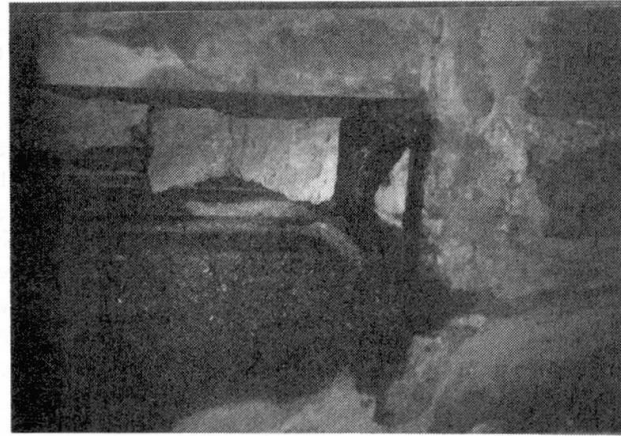
On account of the severe environmental conditions (marine salts in the rain water, wide temperature ranges, heavy traffic) and poor maintenance, the degradation has affected mainly structural elements such as the Gerber joints, in which the steel bars are completely uncovered and deeply corroded

photo 4 - Fiumara di Gallico Viaduct
Gerber joint (lower view)

photo 5 - Fiumara di Gallico
Gerber joint (detail)

(photo n. 4-5). The seat of the supported beams - which is further restricted by degradation - is so reduced as to cast doubt on the stability of the beams. Weathering has also removed the concrete bar covering in many areas of the decks, particularly on the west side, towards the coast. A detailed program of in situ tests (pull-out tests, carbonation tests, microdrilling and sampling of concrete, endoscopic tests, etc.) on the structure was carried out to evaluate the actual state of alteration of the material, their strength and the efficiency of the supports apparatus.

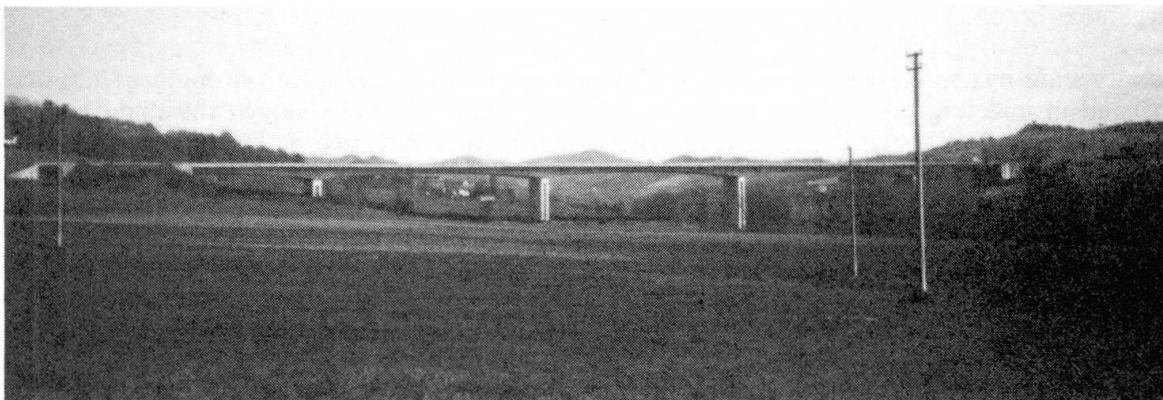
photo 10 - Reggia Viaduct - General view

The phenomena observed are related to creep processes that cannot easily be predicted at the design stage. On account of the construction method, based on a cantilevered section-by-section procedure that involved building a structure with provisional boundary conditions that differed from the final ones, the creep effects have produced a redistribution of the stress for permanent loads and, in particular, an increase in positive bending moments in the middle of the spans and a reduction near the piers (figure 12). The individual sections of the cantilevers were poured in different stages, with non-homogeneous pouring and weathering conditions, so that they presented different creep functions. Even minor uncertainties in calculating the dead or prestressing loads could also have led to considerable variations in the creep deformations, bearing in mind the effective reciprocal influences between the creep and the steel relaxation of the prestressing cables. Another factor that should be considered is the possible effect of the insertion of provisional hydraulic jacks in the middle of the central span, which may have partially compensated the creep deformations of the third span, jeopardizing the second and fourth spans.

The strengthening measures were designed to enhance the bending and shear strength of the deck and consisted in inserting prestressing cables in the lower part of the section in the middle of the

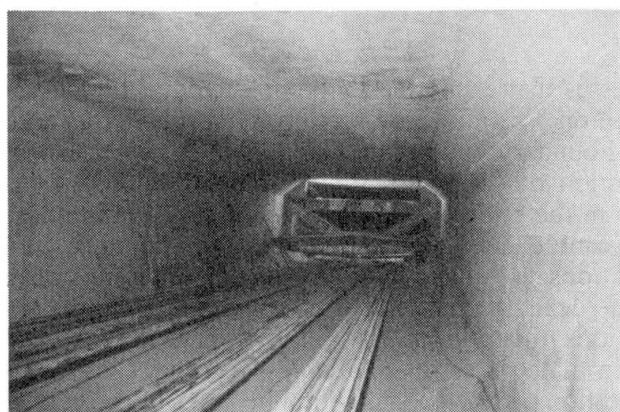
photo 13 - Prestressing cable system
and deviation device frame

some cables are continuous from the first pier-head to the last, whilst others have only the length of one of the lateral spans. The only deviation device inside the box-girder, at midspan level (figure 14), consists of a steel frame connected to the ribs of the caisson to which the cable was connected after tensioning, so as to ensure continuity to the transversal section. Three devices were used for each span, one for each of the three cells of the box-girder. The frames were assembled with steel profiles and plates connected by high-strength bolts in order to allow transport and the mounting inside the

box-girder. A horizontal strut with St. Andrew's crosses was provided in order to resist to the friction component of the prestressing forces. The work was successfully carried out without restriction traffic and restored about 10% of the previous deformations. The increase in safety levels was assessed at around 30%. Thus the measures adopted significantly increased the durability of the structure by closing the cracks caused by creep. The load test performed on the bridge on completion of the work also showed an increase of the overall stiffness of the whole structure of about 20%.

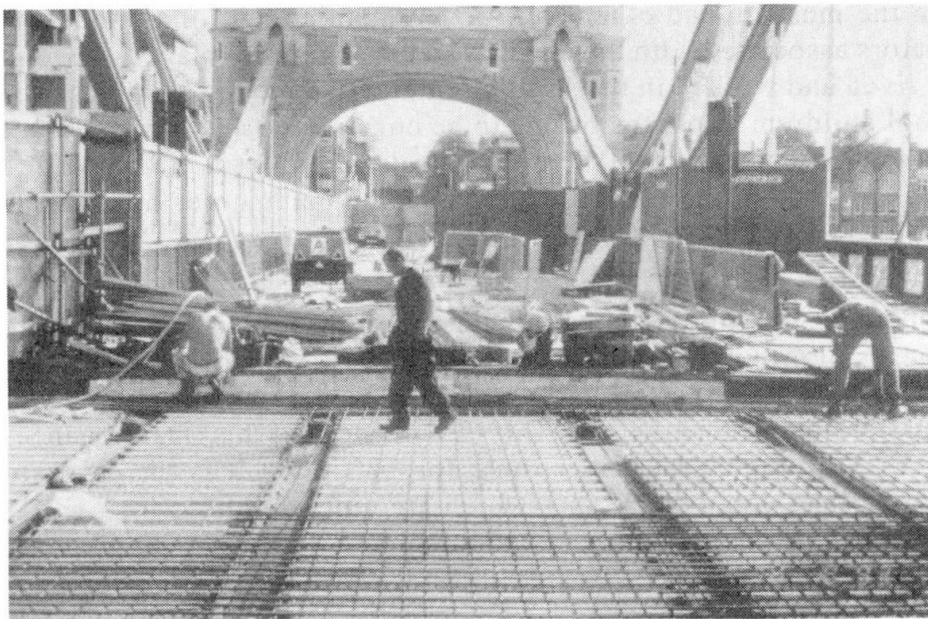
Extensive redecoration was carried out in 1992 in preparation for the celebration of the Bridge's centenary and it was during this operation that timber bulkheads were removed within the base of the towers, exposing parts of the steelwork not normally accessible.⁵ Corrosion was observed and the removal of steel plating exposed internal voids and areas of corroded steelwork which had probably not been observed for 100 years. In some places there was no remaining capacity whatever and repairs were therefore necessary to restore the load carrying capacity while minimising the disruption to traffic and preserving both appearance and as much of the original structure as reasonably possible. For thirteen weeks in the summer of 1993 the bridge was closed to road traffic and the road deck under the towers was removed, exposing the underlying steelwork and enabling extensive cleaning, repairs and replacements to be effected.⁶

1993 Deck
Repairs

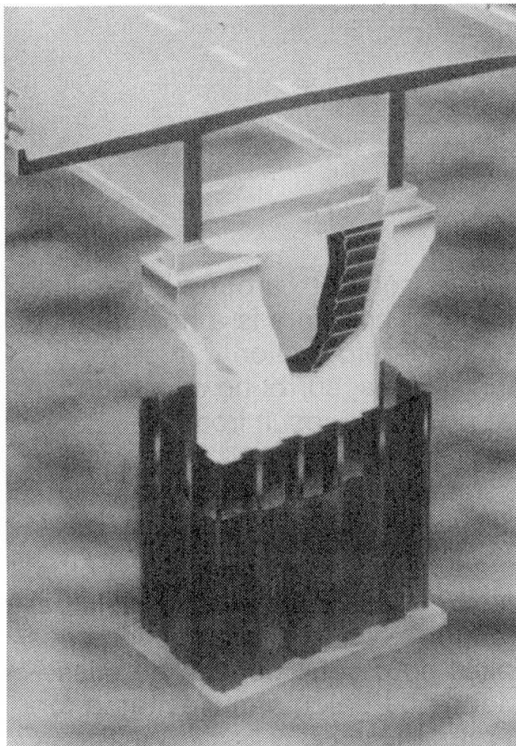
Fig. 1 The work is done under dry conditions in a cofferdam which stands on the base plate. A sliding layer is placed between the old pier and surround concrete structure.

The piers have been repaired by casting new concrete around them down to the base plate. The existing piers are regarded as ineffective. The concrete shell has a thickness of 40 cm on the long side and 50 cm on the short sides. The work is done mostly below water level in special cofferdams, see Fig 1.

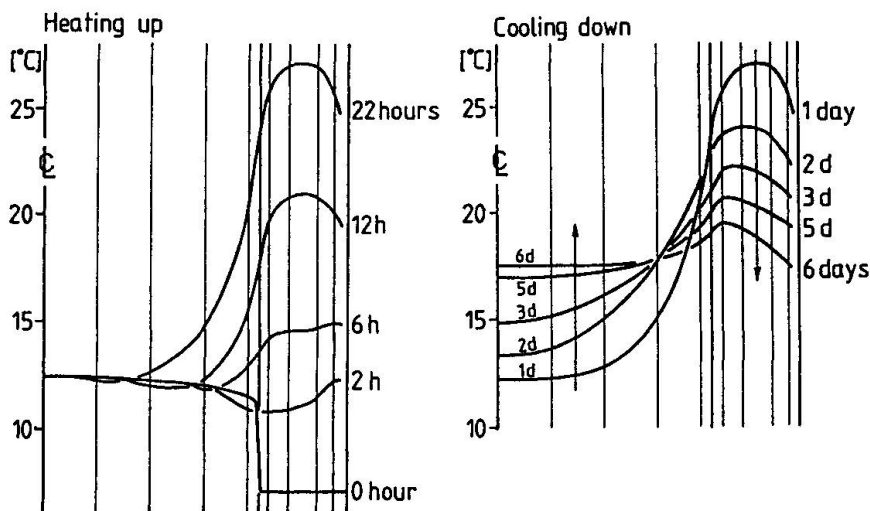
Initially one pier, No 108, was tested without a sliding layer. The casting temperature was 7°C. Fig.4 shows measured temperatures in a central section. While the surround concrete is cooling, the old pier is heating up. The accompanying contraction and expansion result in a demand for measures to ensure that the concrete would not crack. Fig.5 shows how pier 108 cracked.

Fig. 4 Measured temperature distribution in a central section of pier No 108 during heating and cooling of the surrounding concrete.

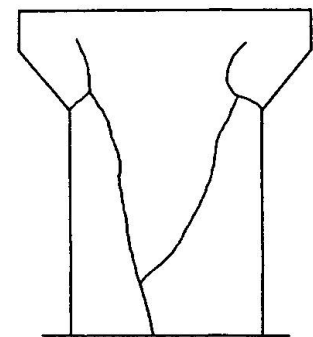
Fig. 5 Crack pattern for test pier No 108.

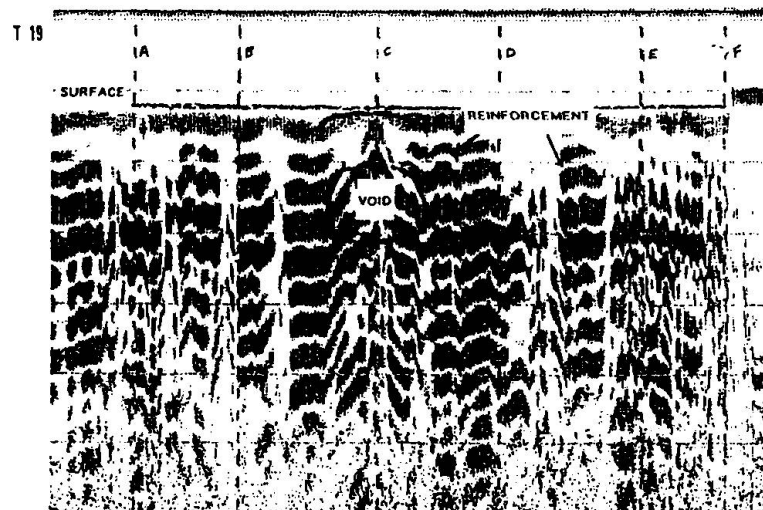
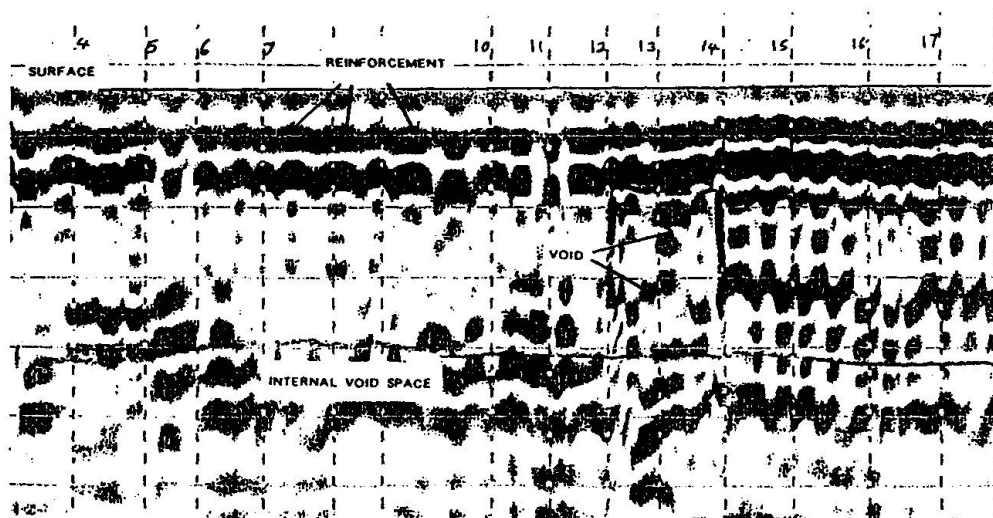
Fig. 3 Radar Output for Longitudinal Scanning Profile (Span 5).
