**Zeitschrift:** IABSE reports = Rapports AIPC = IVBH Berichte  
**Band:** 73/1/73/2 (1995)

**Rubrik:** Session A1: General repair of bridges I

## Strengthening of the 120-Year-Old Substructure of a Railway Bridge

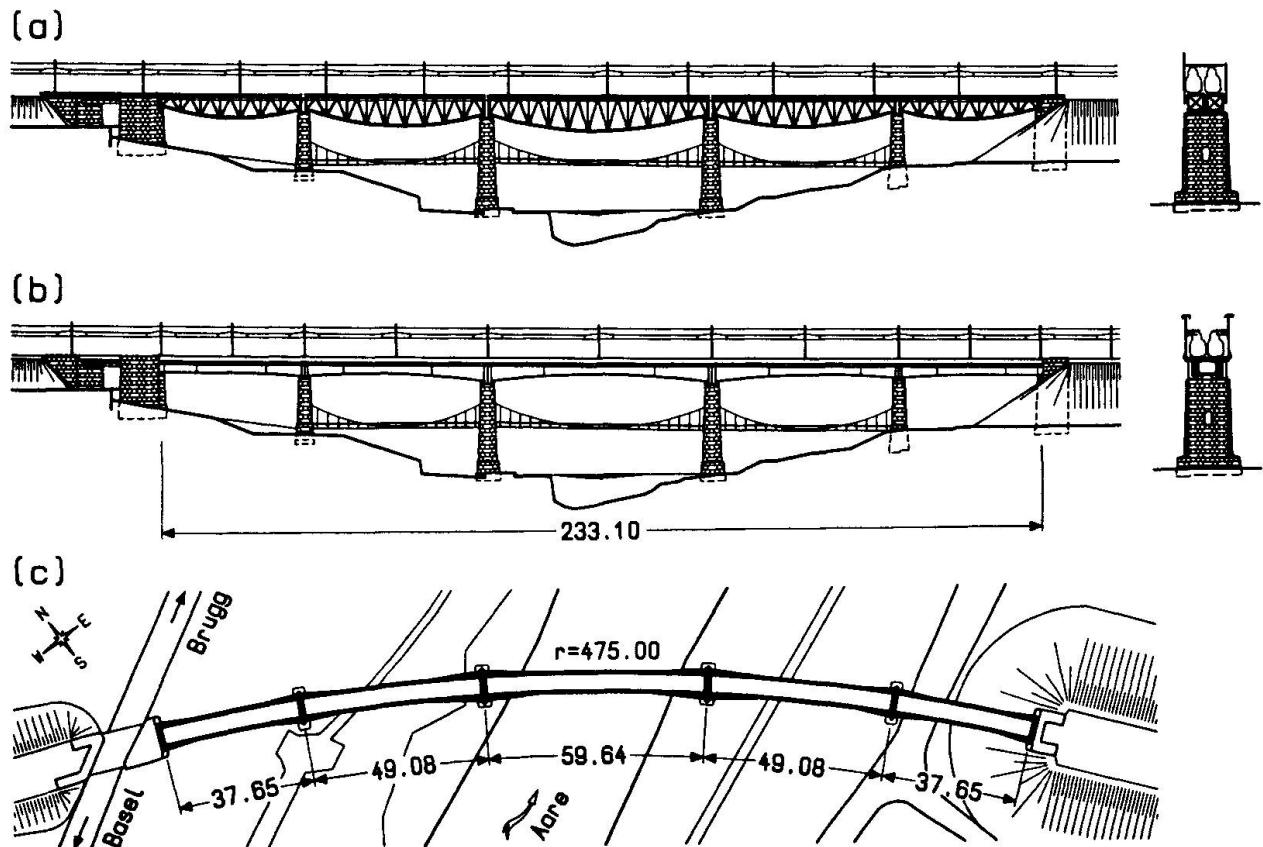
**Fig. 1** Overview: (a) Steel superstructure on natural stone masonry substructure; (b) New post-tensioned concrete box girder on strengthened substructure; (c) Plan view of new bridge. Note: Dimensions in metres.

The steel superstructure of a 233 m long double track railway bridge over the river Aare at Brugg, Switzerland, is being replaced by a post-tensioned concrete box girder (Fig. 1). The substructure built in 1875 has been strengthened and the pedestrian suspension bridge is being reconstructed.

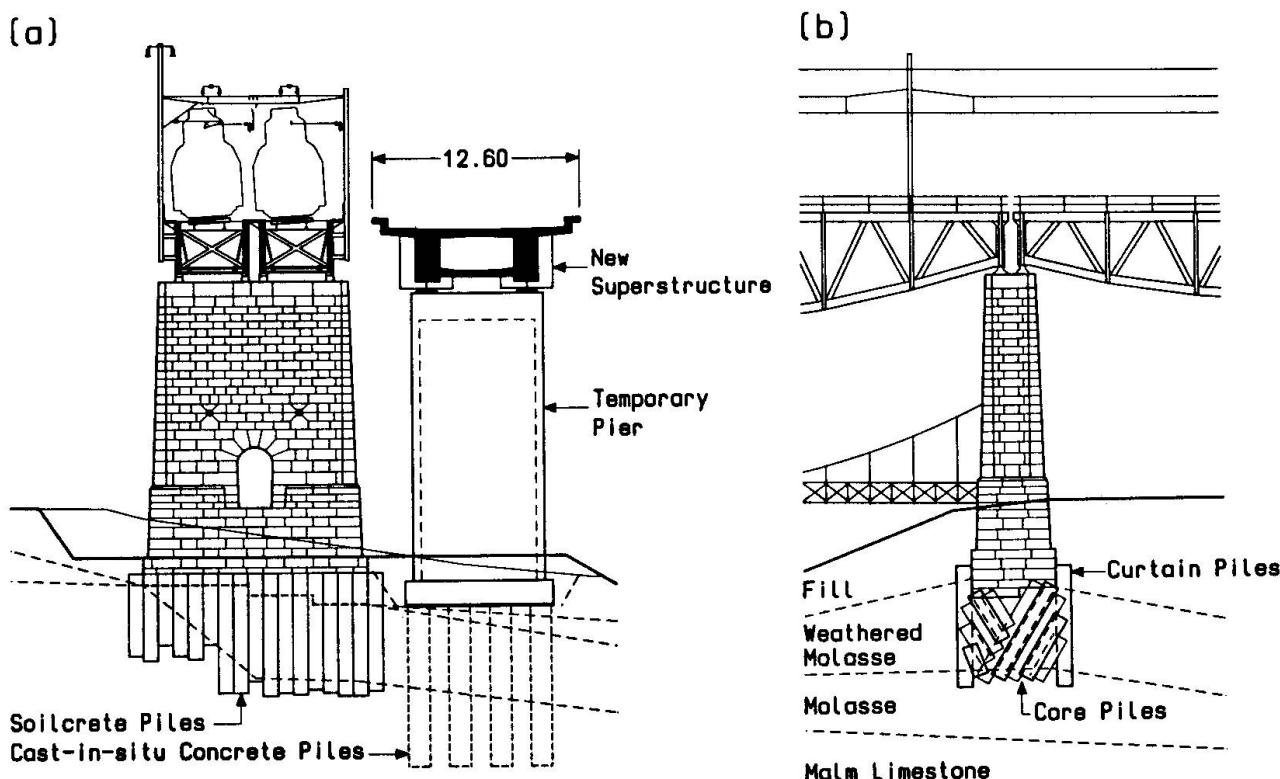
While the two 25 m high central piers are founded on solid rock the somewhat shorter side piers are founded on layers of weathered molasse with a high clay content. These soft layers have a variable thickness of 1 to 8 m (Fig. 2).

Fig. 2 Soilcrete pile foundation of side piers: (a) Cross-section; (b) Elevation.

Traditional underpinning was discarded because of high costs and risks for railway traffic during execution. The soilcrete technique was chosen after a feasibility test had shown that piles of sufficient quality could be made despite the soil's high clay content. It was decided to complete a curtain along the perimeter of the pier base prior to filling the core underneath the foundation. The curtain piles served to encase the material underneath the pier and allowed to gain further experience on the actual soil conditions. Construction of the core piles began only after the curtain piles had passed severe quality control test. Pier settlements and inclinations were continually monitored during the execution of the soilcrete piles.

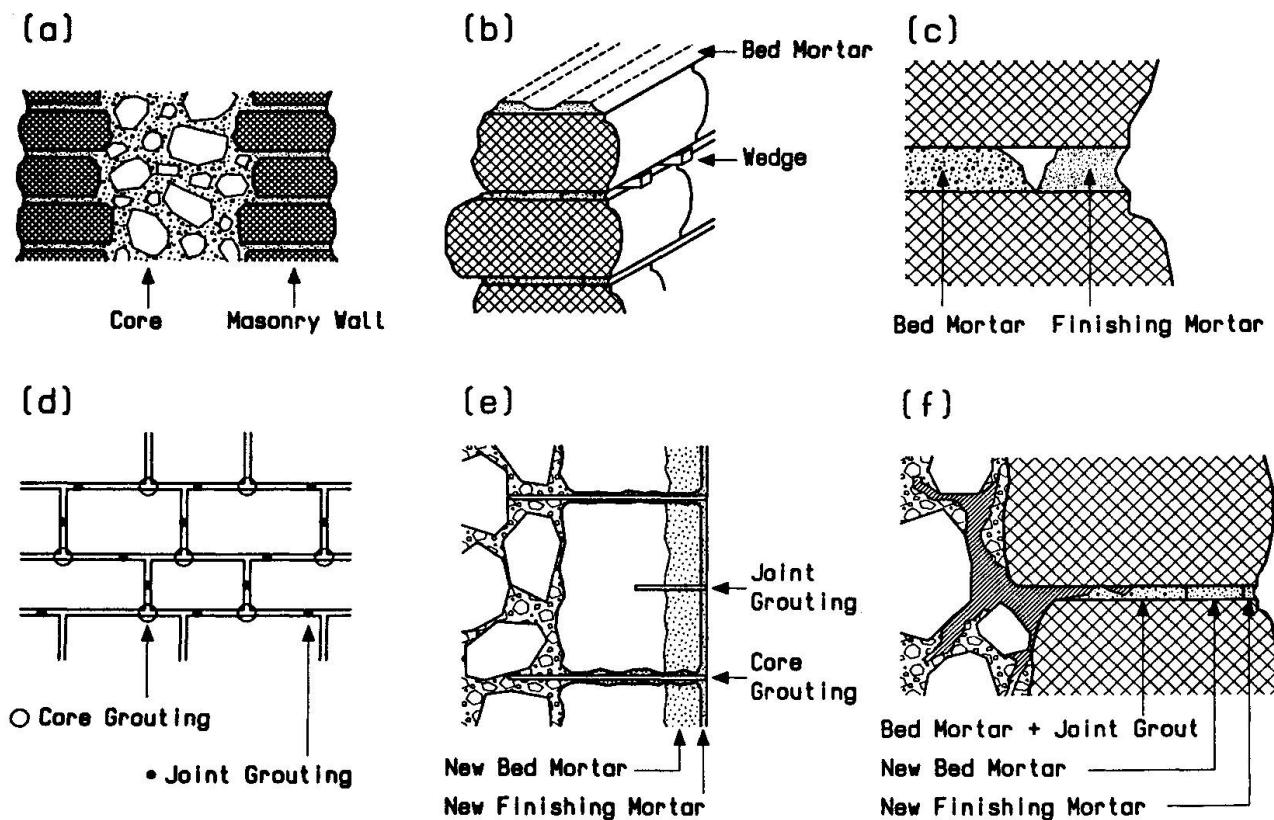
Examination of the condition of the piers and abutments revealed the usual damage due to weathering, i.e. deterioration of the outermost 100 to 200 mm of the joints, cracking of a few single blocks and overall wear of the surface. The exterior masonry wall has a thickness of about 750 mm and is made of limestone blocks with a compressive strength of 150 MPa. Due to the new superstructure, the average permanent stress in the exterior wall will increase from 0.35 to 1.6 MPa in the upper portion of the pier and from 1.4 to 2.4 MPa at its base.

**Fig. 3** Natural stone masonry: (a) Vertical section through pier; (b) Placing of masonry blocks; (c) Bed joint; (d) Elevation showing grouting locations; (e) Plan view; (f) Cross-section through bed joint.

The exterior walls have been prepared for the higher loads by reconditioning the existing mortar joint and by filling the voids in the mortar to allow for a smoother stress distribution in the joint. The head of the piers will be replaced by a massive 2.5 m high reinforced concrete block that transfers the forces from the bearings to the exterior walls. This concrete block also serves as a "roof" preventing water from entering into the pier.

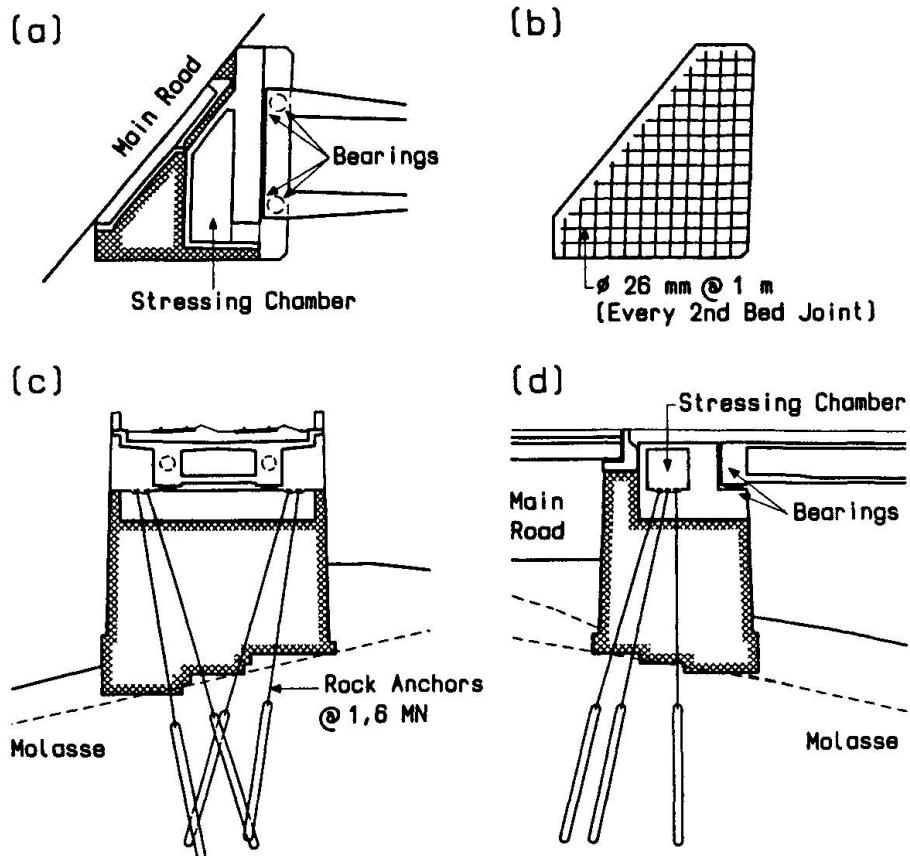
**Fig. 4** West abutment: (a) Plan view; (b) Orthogonal reinforcement in bed-joints; (c) Cross-section; (d) Elevation.

After reconditioning the masonry, the abutment was strengthened by horizontally placed steel reinforcing bars to obtain a solid abutment block [Fig. 4(b)]. In addition, vertical steel reinforcement is placed to interlock the abutment block and the concrete block housing the bridge bearings. The required resistance to the horizontal design load of 11 MN, acting 13 m above the solid rock, is provided by the weight of 38 MN of the abutment block as well as by a number of inspectable and replaceable ground anchors with a total anchor force in service of 16 MN [Figs. 4(c) and (d)].

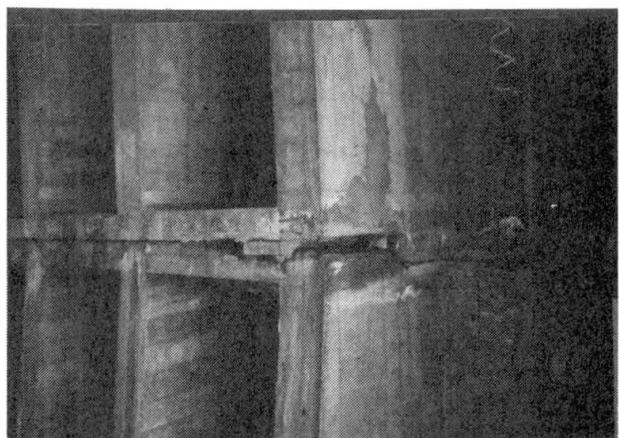
On account of the severe environmental conditions (marine salts in the rain water, wide temperature ranges, heavy traffic) and poor maintenance, the degradation has affected mainly structural elements such as the Gerber joints, in which the steel bars are completely uncovered and deeply corroded

photo 4 - Fiumara di Gallico Viaduct  
Gerber joint (lower view)

photo 5 - Fiumara di Gallico  
Gerber joint (detail)

(photo n. 4-5). The seat of the supported beams - which is further restricted by degradation - is so reduced as to cast doubt on the stability of the beams. Weathering has also removed the concrete bar covering in many areas of the decks, particularly on the west side, towards the coast. A detailed program of in situ tests (pull-out tests, carbonation tests, microdrilling and sampling of concrete, endoscopic tests, etc.) on the structure was carried out to evaluate the actual state of alteration of the material, their strength and the efficiency of the supports apparatus.

The principal objective of the intervention was to improve the seismic behaviour of the structure by creating a continuous kinematic chain between the various spans so as to transfer the horizontal actions to special purpose-built structures. In consideration of the state of the Gerber joints, it was decided to demolish these parts of the structure (figure 6) and rebuild them along more suitable geometric lines in order to ensure an adequate seat to the support, insert the bearing devices and accomplish the continuity of the structure by consolidating the upper slabs. The new structure was realized in Rheoplastic high-strength concrete connected to the remaining parts through connecting bars (figures n. 7-8). The supports on the piers were removed, after lifting the decks alternately, and replaced by mobile

unidirectional or bidirectional devices. The deck was connected at the ends to blocks built behind the abutments on special foundations with micropiles and steel tie-anchors. The connection was ensured through special shock-transmitting devices placed horizontally so as to permit slow displacements due to temperature variations and prevent impulsive actions. Two 1200 KN shock transmitters were inserted behind the abutments on each deck, capable of resisting an overall seismic force of little less than 5000 KN without damage (figure n. 9). In this way, the structure became an axially continuous beam whose longitudinal seismic forces are transferred to the blocks; the size of the foundations can resist such a force. Transversally, the continuity of the slabs allows most of the seismic forces to be transferred to the abutments - the most rigid supports - thus ensuring a more uniform distribution of the residual forces among the different piers. The forces acting on the head of the piers, up to about 1500 KN longitudinally and transversally, were reduced by the measures to tens of KN longitudinally (mainly friction forces) and to about 300 KN transversally. The measures thus led to an unloading of the piers in seismic conditions, so that no specific strengthening measures were required. In the National Roadway Board's strategy, the elimination of the surface joints will reduce the overall maintenance costs of the bridge. Special interventions on the deteriorated structures were also carried out. Three types of restoration were involved: the first involved the areas in which the surface concrete had been largely removed or

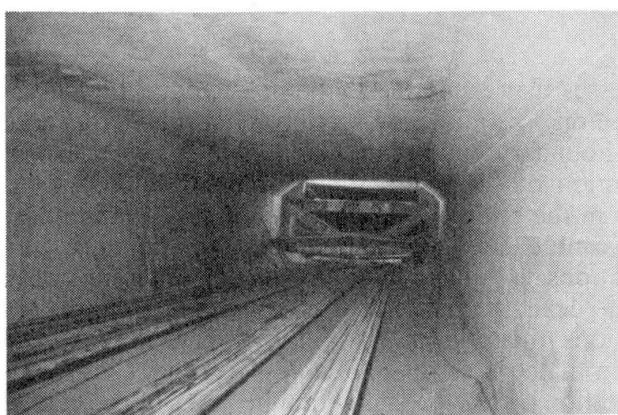
photo 13 - Prestressing cable system  
and deviation device frame

some cables are continuous from the first pier-head to the last, whilst others have only the length of one of the lateral spans. The only deviation device inside the box-girder, at midspan level (figure 14), consists of a steel frame connected to the ribs of the caisson to which the cable was connected after tensioning, so as to ensure continuity to the transversal section. Three devices were used for each span, one for each of the three cells of the box-girder. The frames were assembled with steel profiles and plates connected by high-strength bolts in order to allow transport and the mounting inside the box-girder. A horizontal strut with St. Andrew's crosses was provided in order to resist to the friction component of the prestressing forces. The work was successfully carried out without restriction traffic and restored about 10% of the previous deformations. The increase in safety levels was assessed at around 30%. Thus the measures adopted significantly increased the durability of the structure by closing the cracks caused by creep. The load test performed on the bridge on completion of the work also showed an increase of the overall stiffness of the whole structure of about 20%.

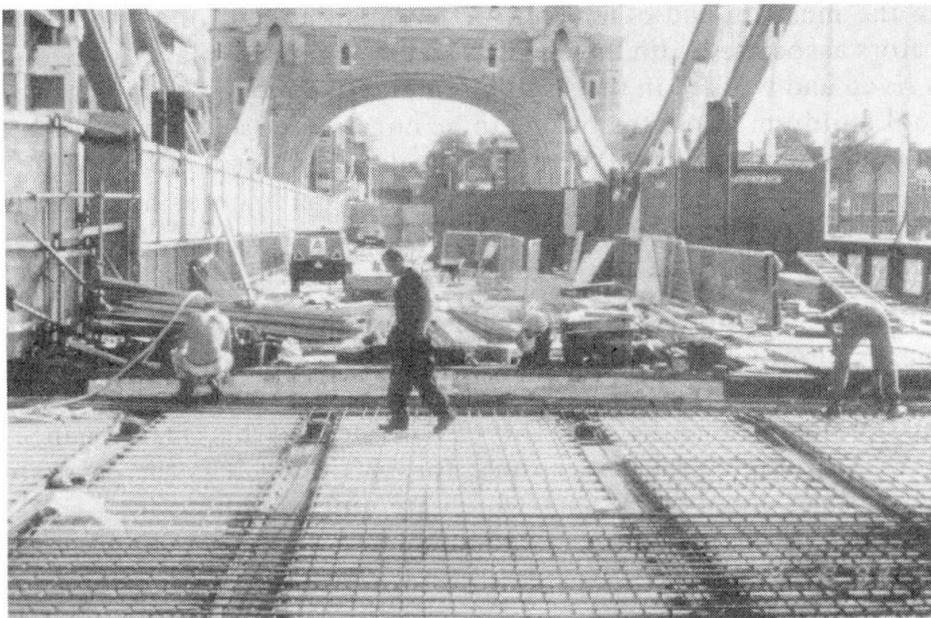
Extensive redecoration was carried out in 1992 in preparation for the celebration of the Bridge's centenary and it was during this operation that timber bulkheads were removed within the base of the towers, exposing parts of the steelwork not normally accessible.<sup>5</sup> Corrosion was observed and the removal of steel plating exposed internal voids and areas of corroded steelwork which had probably not been observed for 100 years. In some places there was no remaining capacity whatever and repairs were therefore necessary to restore the load carrying capacity while minimising the disruption to traffic and preserving both appearance and as much of the original structure was reasonably possible. For thirteen weeks in the summer of 1993 the bridge was closed to road traffic and the road deck under the towers was removed, exposing the underlying steelwork and enabling extensive cleaning, repairs and replacements to be effected.<sup>6</sup>

1993 Deck  
Repairs

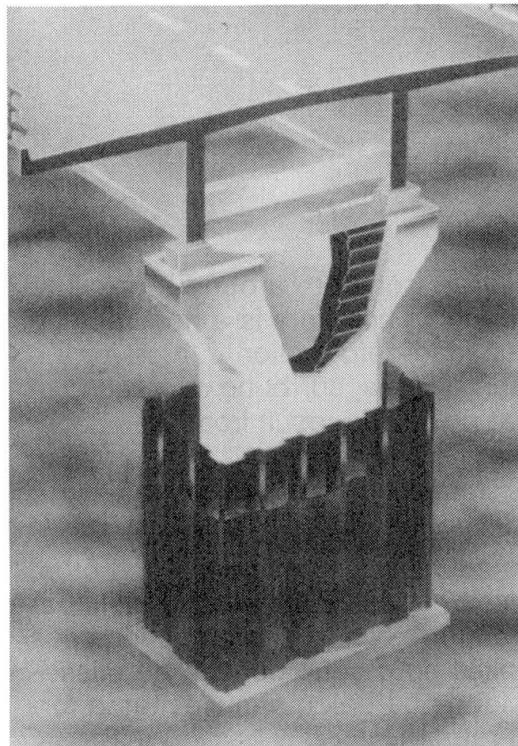
Fig. 1 The work is done under dry conditions in a cofferdam which stands on the base plate. A sliding layer is placed between the old pier and surround concrete structure.

The piers have been repaired by casting new concrete around them down to the base plate. The existing piers are regarded as ineffective. The concrete shell has a thickness of 40 cm on the long side and 50 cm on the short sides. The work is done mostly below water level in special cofferdams, see Fig 1.

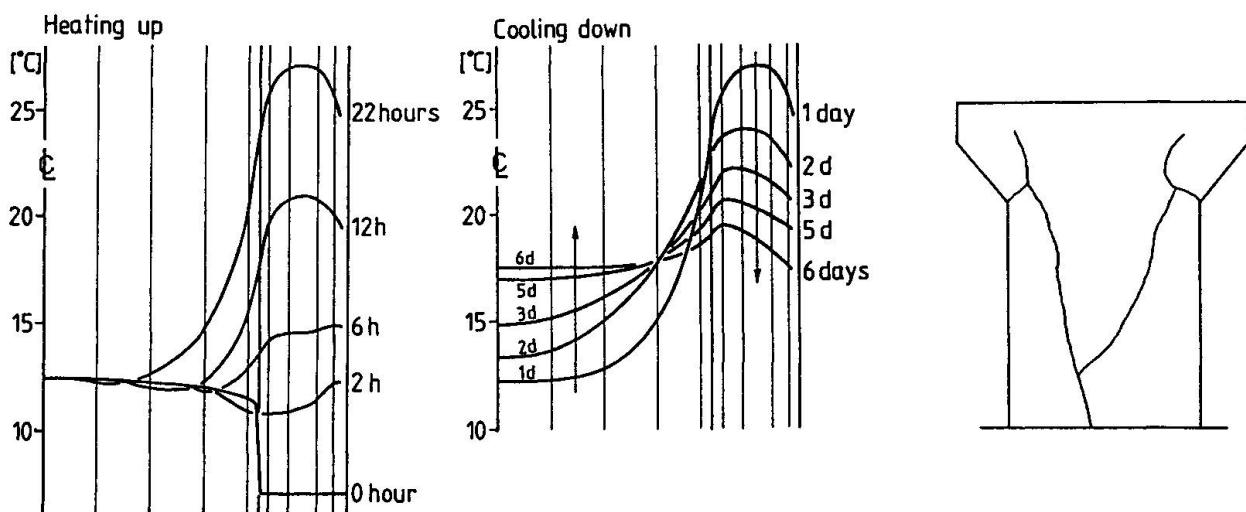
The accompanying contraction and expansion result in a demand for measures to ensure that the concrete would not crack. Fig.5 shows how pier 108 cracked.

Fig. 4 Measured temperature distribution in a central section of pier No 108 during heating and cooling of the surrounding concrete.
