General Repair of Bridges I

Strengthening of the 120-Year-Old Substructure of a Railway Bridge

Heinrich GERBER

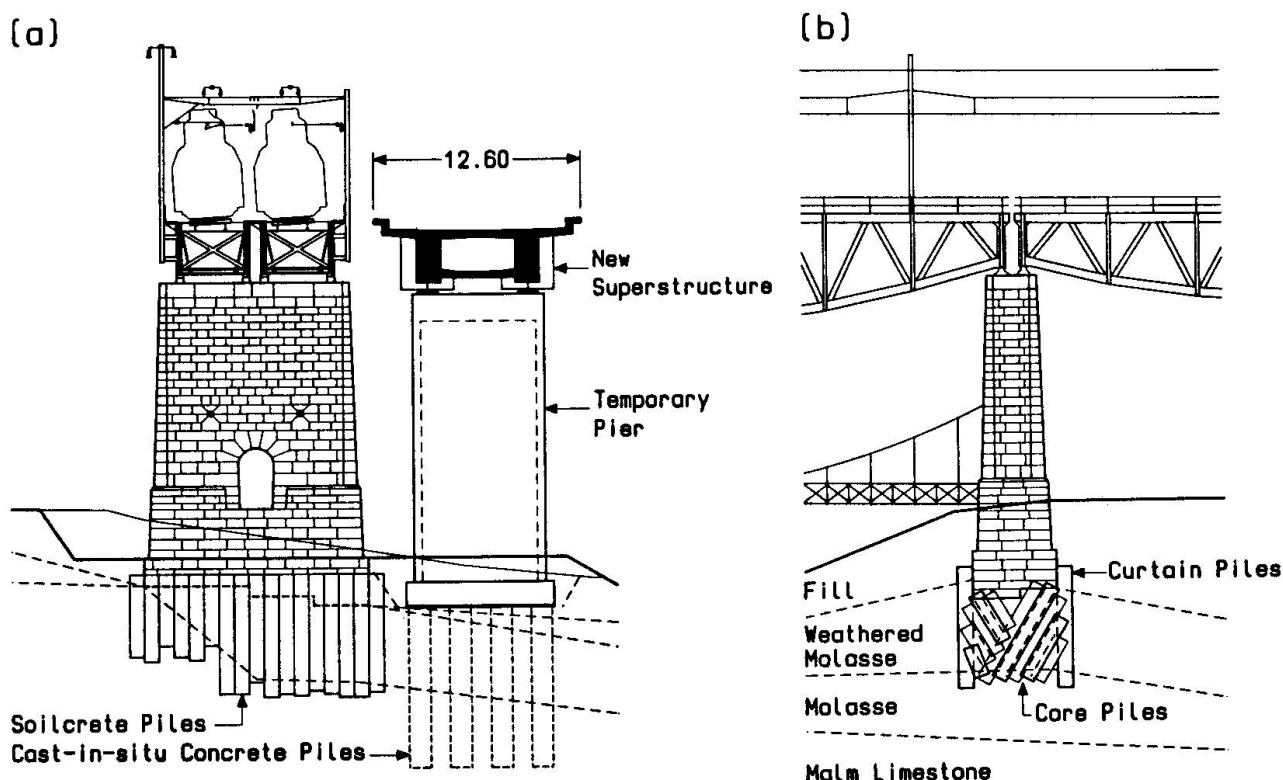
While the two 25 m high central piers are founded on solid rock the somewhat shorter side piers are founded on layers of weathered molasse with a high clay content. These soft layers have a variable thickness of 1 to 8 m (Fig. 2).

Fig. 2 Soilcrete pile foundation of side piers: (a) Cross-section; (b) Elevation.

Traditional underpinning was discarded because of high costs and risks for railway traffic during execution. The soilcrete technique was chosen after a feasibility test had shown that piles of sufficient quality could be made despite the soil's high clay content. It was decided to complete a curtain along the perimeter of the pier base prior to filling the core underneath the foundation. The curtain piles served to encase the material underneath the pier and allowed to gain further experience on the actual soil conditions. Construction of the core piles began only after the curtain piles had passed severe quality control test. Pier settlements and inclinations were continually monitored during the execution of the soilcrete piles.

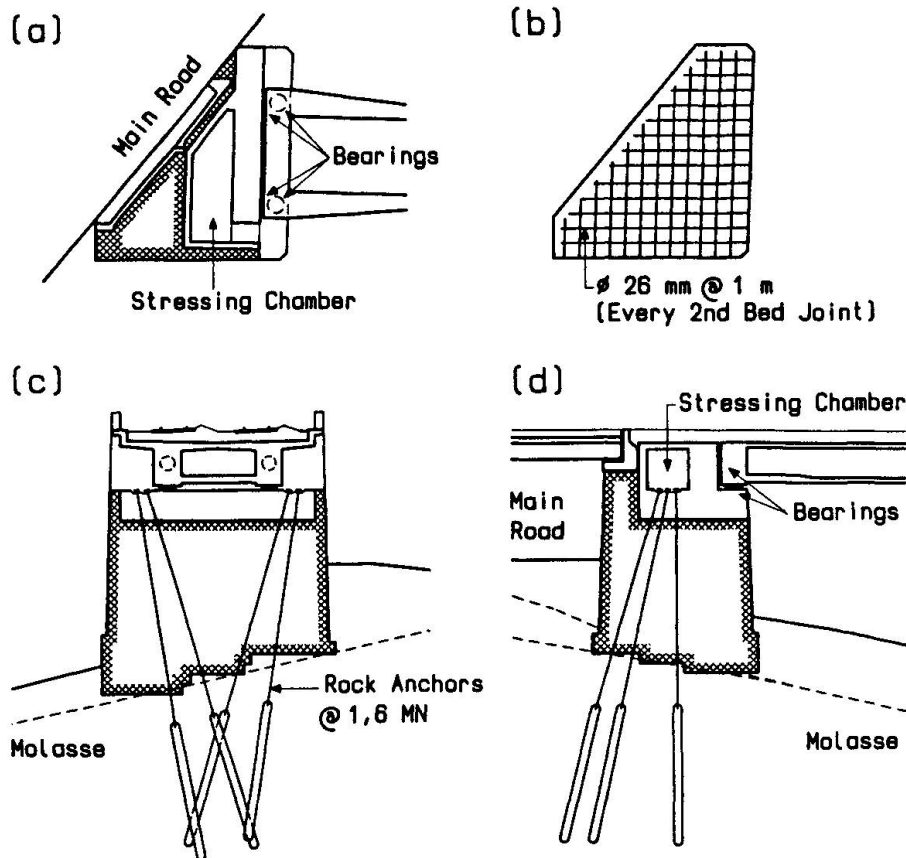
In spite of the congested space for the execution, [Fig. 4(a)] the West abutment was chosen as the fixed support of the bridge since it is of moderate height and founded on rock, while the pier-like East abutment is embedded in an earthfill dam.

Fig. 4 West abutment: (a) Plan view; (b) Orthogonal reinforcement in bed-joints; (c) Cross-section; (d) Elevation.

After reconditioning the masonry, the abutment was strengthened by horizontally placed steel reinforcing bars to obtain a solid abutment block [Fig. 4(b)]. In addition, vertical steel reinforcement is placed to interlock the abutment block and the concrete block housing the bridge bearings. The required resistance to the horizontal design load of 11 MN, acting 13 m above the solid rock, is provided by the weight of 38 MN of the abutment block as well as by a number of inspectable and replaceable ground anchors with a total anchor force in service of 16 MN [Figs. 4(c) and (d)].

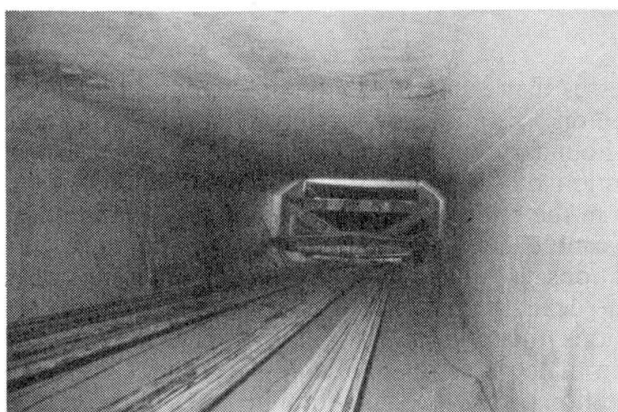
photo 13 - Prestressing cable system
and deviation device frame

some cables are continuous from the first pier-head to the last, whilst others have only the length of one of the lateral spans. The only deviation device inside the box-girder, at midspan level (figure 14), consists of a steel frame connected to the ribs of the caisson to which the cable was connected after tensioning, so as to ensure continuity to the transversal section. Three devices were used for each span, one for each of the three cells of the box-girder. The frames were assembled with steel profiles and plates connected by high-strength bolts in order to allow transport and the mounting inside the

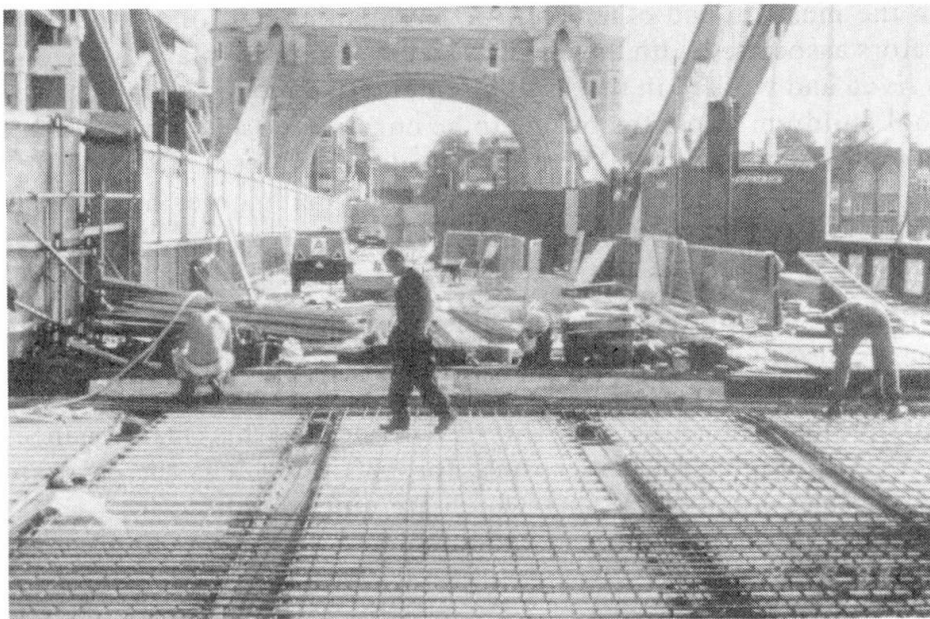
1993 Deck
Repairs

Extensive redecoration was carried out in 1992 in preparation for the celebration of the Bridge's centenary and it was during this operation that timber bulkheads were removed within the base of the towers, exposing parts of the steelwork not normally accessible.⁵ Corrosion was observed and the removal of steel plating exposed internal voids and areas of corroded steelwork which had probably not been observed for 100 years. In some places there was no remaining capacity whatever and repairs were therefore necessary to restore the load carrying capacity while minimising the disruption to traffic and preserving both appearance and as much of the original structure was reasonably possible. For thirteen weeks in the summer of 1993 the bridge was closed to road traffic and the road deck under the towers was removed, exposing the underlying steelwork and enabling extensive cleaning, repairs and replacements to be effected.⁶
