**Zeitschrift:** IABSE reports = Rapports AIPC = IVBH Berichte  
**Band:** 73/1/73/2 (1995)

**Artikel:** Structural evaluation of the leaning bell tower of S. Stefano, Venice  
**Autor:** Bettio, Carlo / Bolognini, Luca / Modena, Claudio  
**DOI:** <https://doi.org/10.5169/seals-55260>

## Structural Evaluation of the Leaning Bell Tower of S.Stefano in Venice

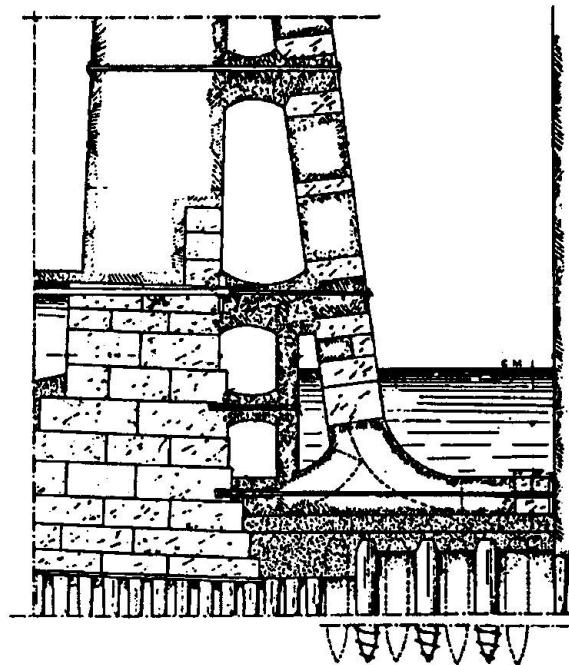
Fig. 2 Detail of the strengthening works executed in 1903-1905

Several steel ties were installed at different levels, starting from the foundation. The masonry walls were extensively repaired and strengthened by means of local reconstructions and injections of cement-water admixtures. The original foundations were first strengthened and then widened over the channel-bed constructing a 50 cm thick concrete slab over a concrete piling. New strong masonry buttresses were built with cement mortar, inclined with respect to the vertical direction as indicated in figure 1. They were securely connected to the tower walls and to the foundations, in the second case through masonry arches (Fig. 2).

The structural behavior of the tower was in this way substantially modified. The variation of the inclination was since then efficiently counteracted, even if not eliminated as expected by the designer, by the new structures as demonstrated by the sudden reduction of the increasing rate of the inclination. A mechanical pendulum was in that occasion installed to control the effectiveness of the interventions.

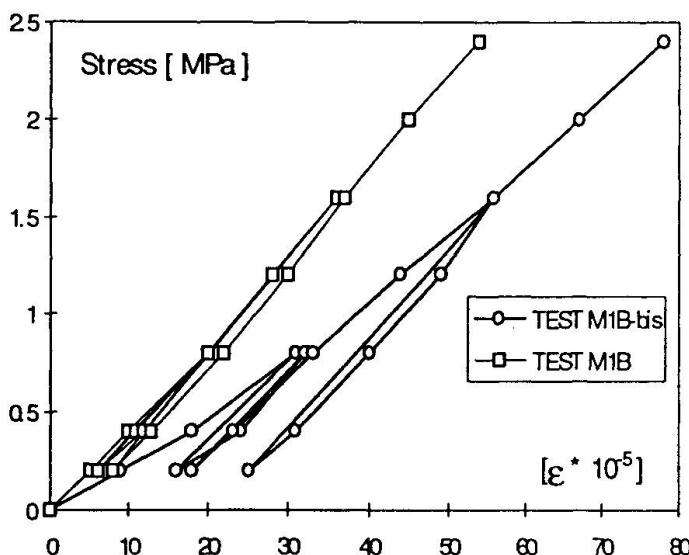
Fig. 3 Stress-strain diagram measured on the external leaf (M1B) and in the internal leaf (M1B-bis)

One of the tests was performed both in the external leaf and in the inner core of the XV century masonry. The comparison of the stress-strain curves (Fig. 3) clearly show the difference in the deformability, the inner core modulus is however greater than 2800 MPa and the behaviour is approximately linear-elastic until the maximum imposed stress level of 2.4 MPa.

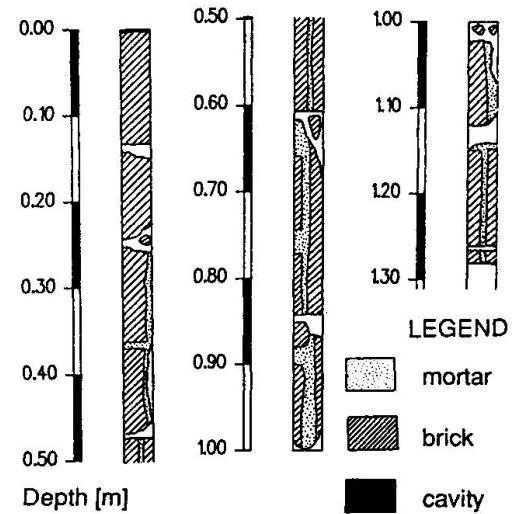
Fig.4 Typical "through-the-thickness" masonry composition

A typical example of masonry composition is shown in Figure 4, where the inner core of the wall appears similar in composition to the outer leaf and almost without voids and cavities.

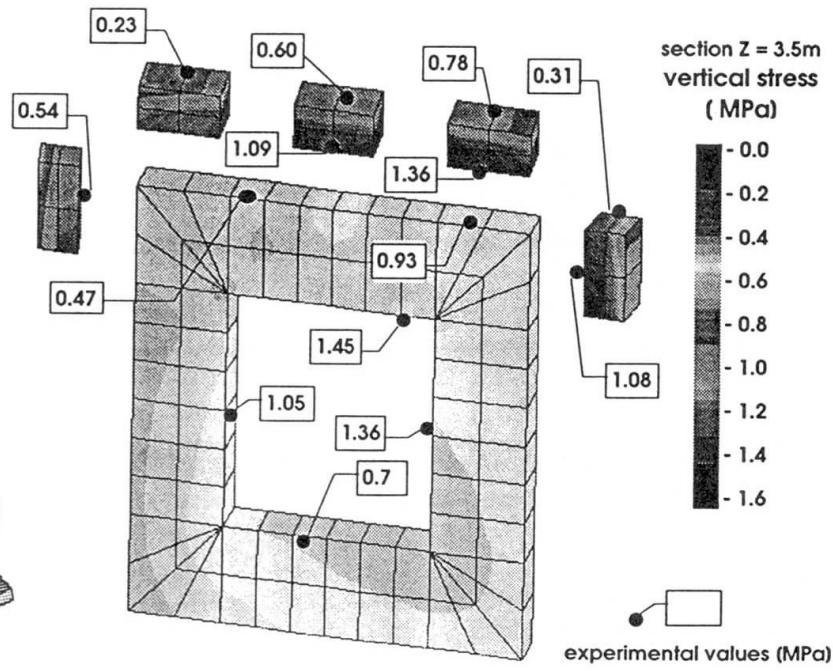
Fig. 6 Experimental and numerical stresses (horizontal section)

Figure 6 shows one example of comparison between theoretical and experimental distribution of normal stresses due to gravitational load. As it can be seen, a fairly good agreement exists between the experimental and theoretical results, except for local inconsistencies which can be explained taking into account the material inhomogeneity, experimentally demonstrated but not yet included in the model. The state of stress is in general compatible, with acceptable safety margins, with the compressive strength of the masonry.

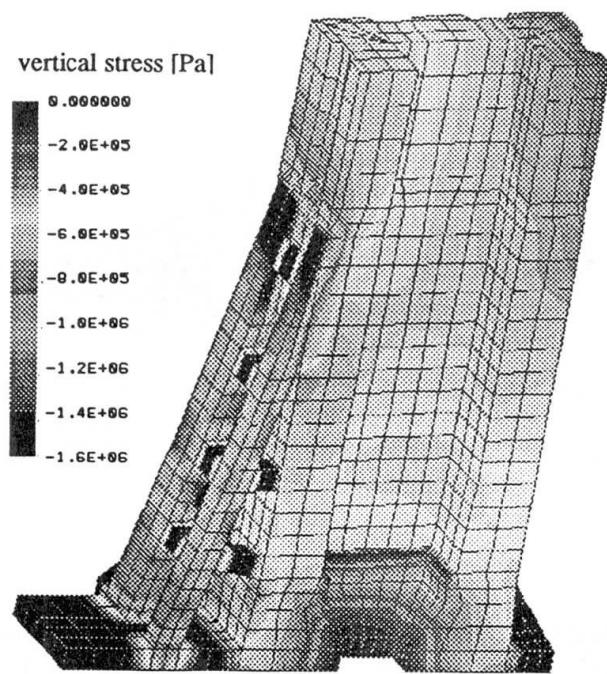
Fig.7 Vertical stresses at the base of the numerical model (vertical section)

On the model thus calibrated static analyses were performed in both linear and non-linear ranges of material behavior mainly to indagate the influence of the buttresses on the distribution of the internal stresses (Fig. 7).

The comparative analyses demonstrated that, as there are not no-tension zones, the influence of the material non-linearity is negligible.

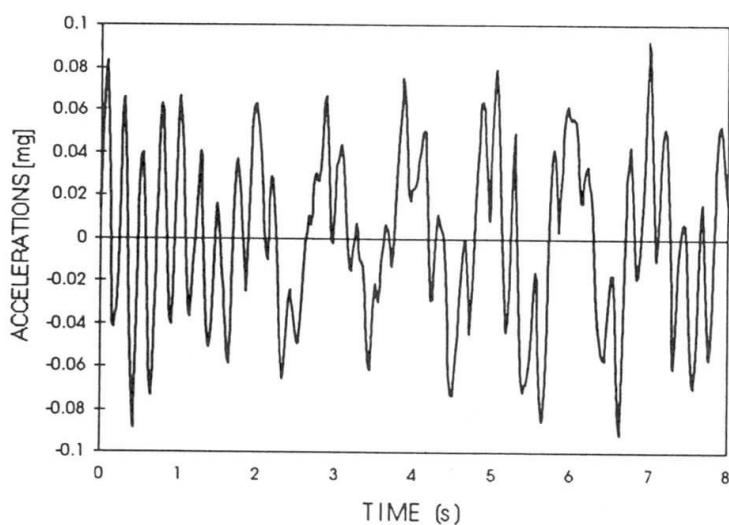
Fig. 8 Wind induced vibrations

From the analysis of wind induced vibrations the first five vibration modes of the structure (two flexural modes in both North-South and East-West direction and the first torsional mode) were determined [2].

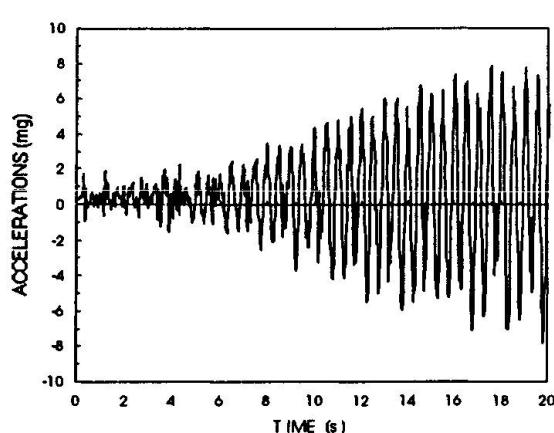
**Fig. 9** Vibrations induced by bell movements  
Acceleration Vs Time diagram

were vibrations clearly perceptible to the persons [1] with a displacement amplitude of over 1 mm. In Figure 9 and 10 a typical record of an acceleration time-history and the correspondent evolutionary power spectra are displayed, from which the above consideration were derived. Finally, the mechanical pendulum was restored allowing for a new measure of the inclination, which demonstrated that since 1933 the inclination increased at a rate of 1.3 mm per year.

The analysis of horizontal forces associated with bells (strike rate of 40 impacts/min. and swing angle of about 90°) showed that the third harmonic component of the force predominates and it is very close to the frequency of the first flexural mode of vibration of the structure causing a dangerous resonance phenomena. The effects measured on the structure

The problem of the stability of the foundations has not been however definitively solved, and adequate investigation and intervention must be carried out within the above indicated time limit. Moreover, the bell system must be changed in case it will be used again in order to avoid the previously mentioned resonance problems.
