**Artikel:** Structural evaluation of the leaning bell tower of S. Stefano, Venice  
**Autor:** Bettio, Carlo / Bolognini, Luca / Modena, Claudio  
**DOI:** <https://doi.org/10.5169/seals-55260>

## **Structural Evaluation of the Leaning Bell Tower of S.Stefano in Venice**

The San Stefano bell tower, Venice, approximately 60 m high, was constructed in two separated phases between the end of the 15th and the first half of the 16th century. It suffered severe structural deterioration due to a continuously increasing inclination caused by differential foundation settlements. The situation is not yet stabilised even after the extensive strengthening interventions executed at the beginning of the 20th century. The paper presents the main results of the experimental and theoretical investigations recently carried out in order to assess the actual safety conditions of the tower and, if needed, to suggest new interventions.

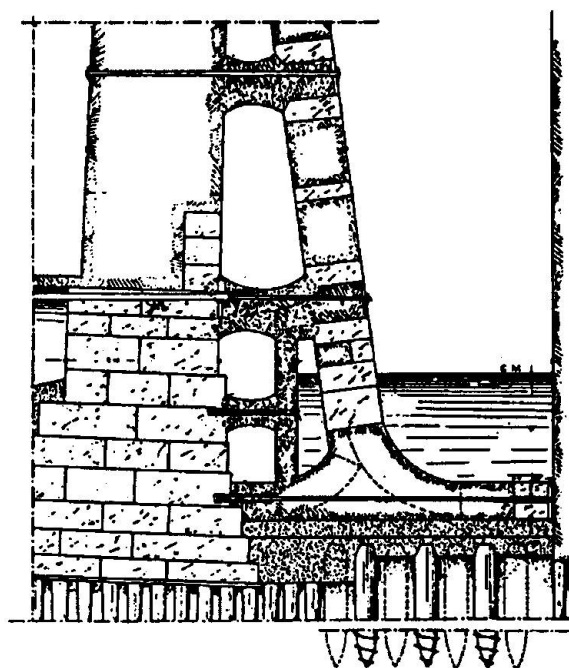
Fig. 2 Detail of the strengthening works executed in 1903-1905

Several steel ties were installed at different levels, starting from the foundation. The masonry walls were extensively repaired and strengthened by means of local reconstructions and injections of cement-water admixtures. The original foundations were first strengthened and then widened over the channel-bed constructing a 50 cm thick concrete slab over a concrete piling. New strong masonry buttresses were built with cement mortar, inclined with respect to the vertical direction as indicated in figure 1. They were securely connected to the tower walls and to the foundations, in the second case through masonry arches (Fig. 2).

The structural behavior of the tower was in this way substantially modified. The variation of the inclination was since then efficiently counteracted, even if not eliminated as expected by the designer, by the new structures as demonstrated by the sudden reduction of the increasing rate of the inclination. A mechanical pendulum was in that occasion installed to control the effectiveness of the interventions.

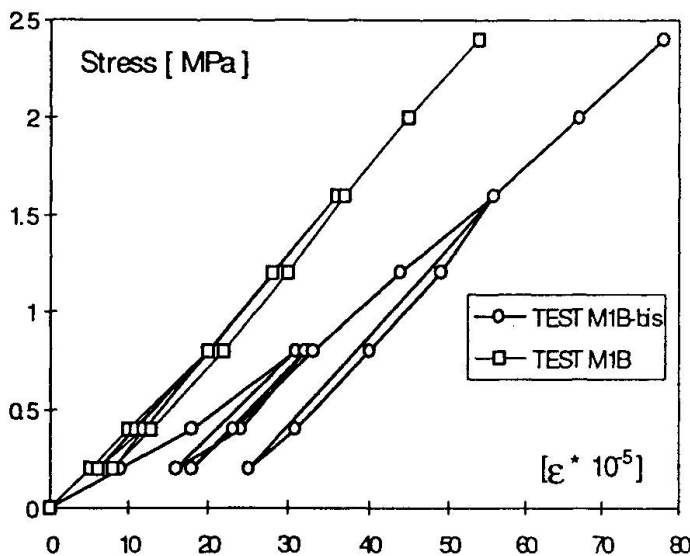
Fig. 3 Stress-strain diagram measured on the external leaf (M1B) and in the internal leaf (M1B-bis)

One of the tests was performed both in the external leaf and in the inner core of the XV century masonry. The comparison of the stress-strain curves (Fig. 3) clearly show the difference in the deformability, the inner core modulus is however greater than 2800 MPa and the behaviour is approximately linear-elastic until the maximum imposed stress level of 2.4 MPa.

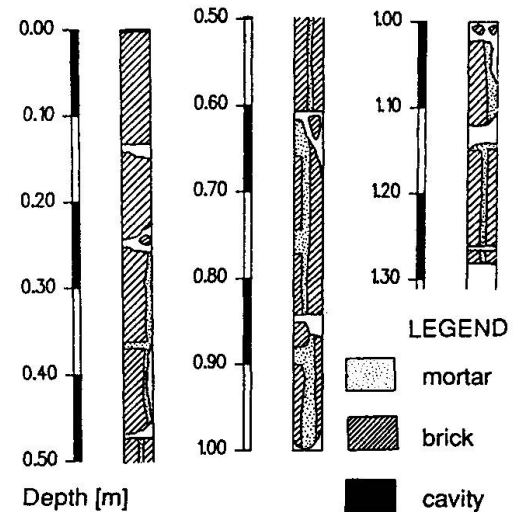
Fig. 4 Typical "through-the-thickness" masonry composition

A typical example of masonry composition is shown in Figure 4, where the inner core of the wall appears similar in composition to the outer leaf and almost without voids and cavities.

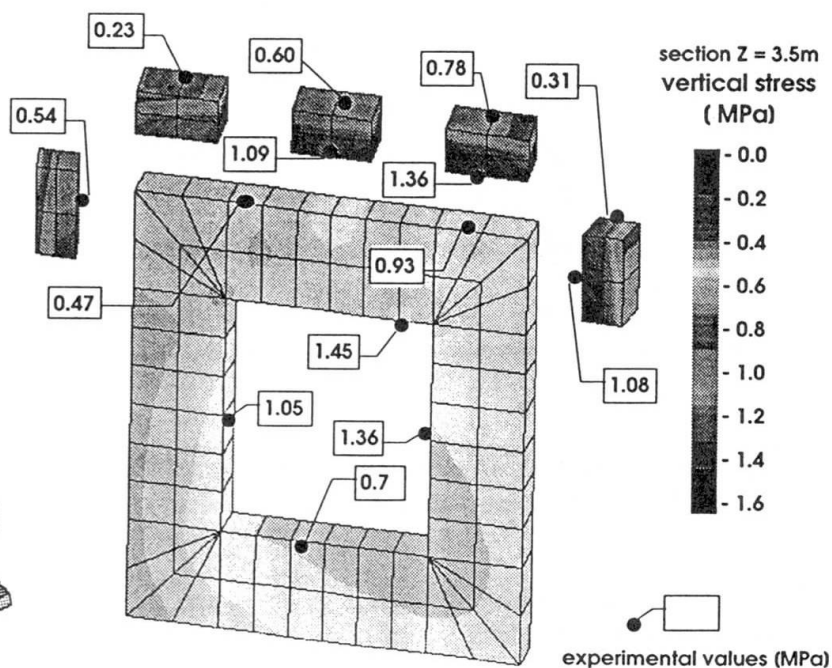
Fig. 6 Experimental and numerical stresses (horizontal section)

Figure 6 shows one example of comparison between theoretical and experimental distribution of normal stresses due to gravitational load. As it can be seen, a fairly good agreement exists between the experimental and theoretical results, except for local inconsistencies which can be explained taking into account the material inhomogeneity, experimentally demonstrated but not yet included in the model. The state of stress is in general compatible, with acceptable safety margins, with the compressive strength of the masonry.

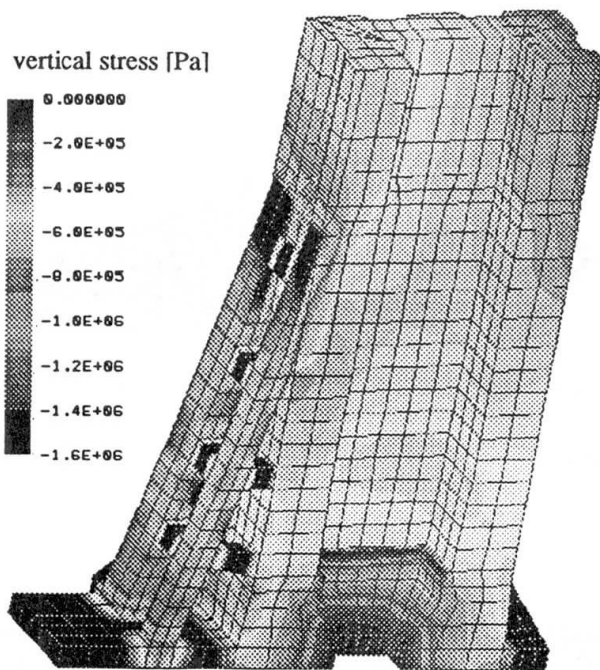
Fig.7 Vertical stresses at the base of the numerical model (vertical section)

On the model thus calibrated static analyses were performed in both linear and non-linear ranges of material behavior mainly to indagate the influence of the buttresses on the distribution of the internal stresses (Fig.7).

The comparative analyses demonstrated that, as there are not no-tension zones, the influence of the material non-linearity is negligible.

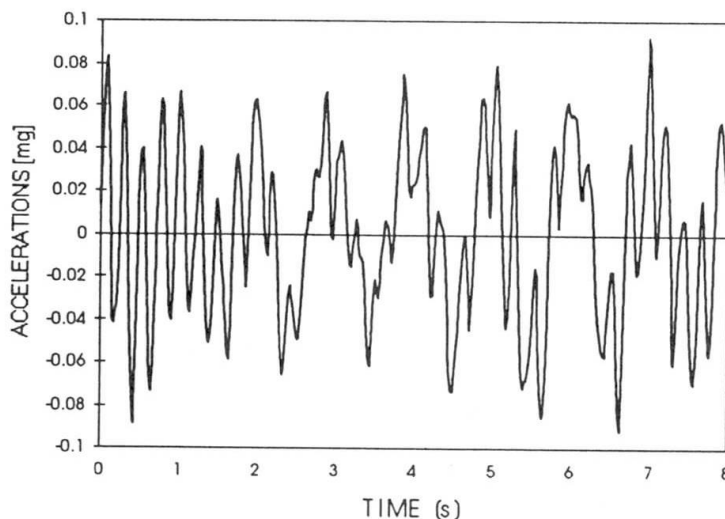
Fig. 8 Wind induced vibrations

From the analysis of wind induced vibrations the first five vibration modes of the structure (two flexural modes in both North-South and East-West direction and the first torsional mode) were determined [2].

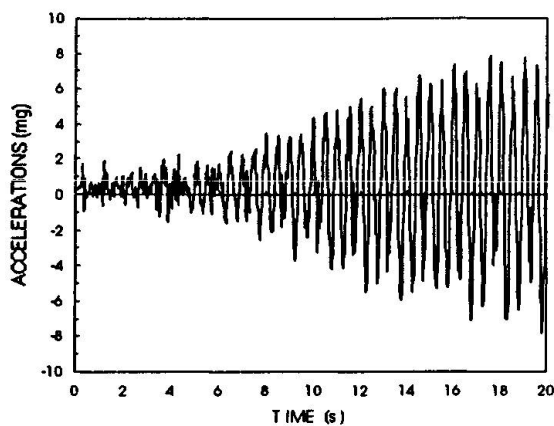
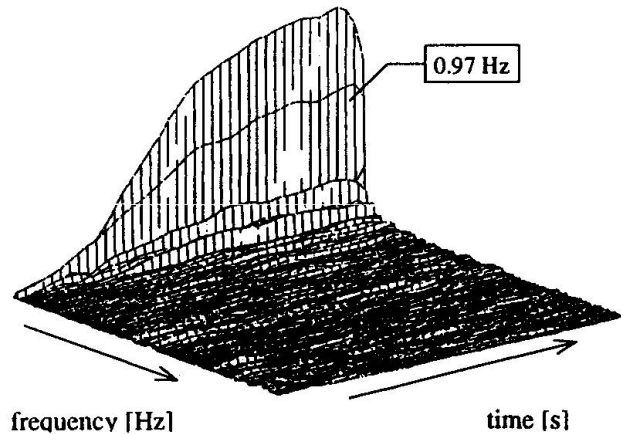
were vibrations clearly perceptible to the persons [1] with a displacement amplitude of over 1 mm. In Figure 9 and 10 a typical record of an acceleration time-history and the correspondent evolutionary power spectra are displayed, from which the above consideration were derived. Finally, the mechanical pendulum was restored allowing for a new measure of the inclination, which demonstrated that since 1933 the inclination increased at a rate of 1.3 mm per year.

The analysis of horizontal forces associated with bells (strike rate of 40 impacts/min. and swing angle of about 90°) showed that the third harmonic component of the force predominates and it is very close to the frequency of the first flexural mode of vibration of the structure causing a dangerous resonance phenomena. The effects measured on the structure

The problem of the stability of the foundations has not been however definitively solved, and adequate investigation and intervention must be carried out within the above indicated time limit. Moreover, the bell system must be changed in case it will be used again in order to avoid the previously mentioned resonance problems.
