Zeitschrift: IABSE reports = Rapports AIPC = IVBH Berichte
Band: 73/1/73/2 (1995)

Artikel: Structural evaluation of the leaning bell tower of S. Stefano, Venice
Autor: Bettio, Carlo / Bolognini, Luca / Modena, Claudio
DOI: <https://doi.org/10.5169/seals-55260>

Structural Evaluation of the Leaning Bell Tower of S.Stefano in Venice

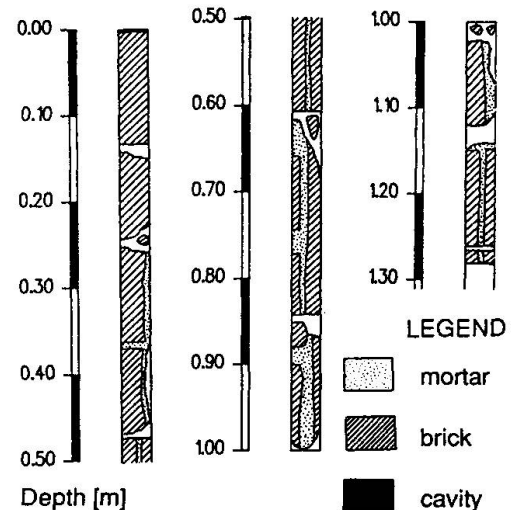
Fig. 4 Typical "through-the-thickness" masonry composition

A typical example of masonry composition is shown in Figure 4, where the inner core of the wall appears similar in composition to the outer leaf and almost without voids and cavities.

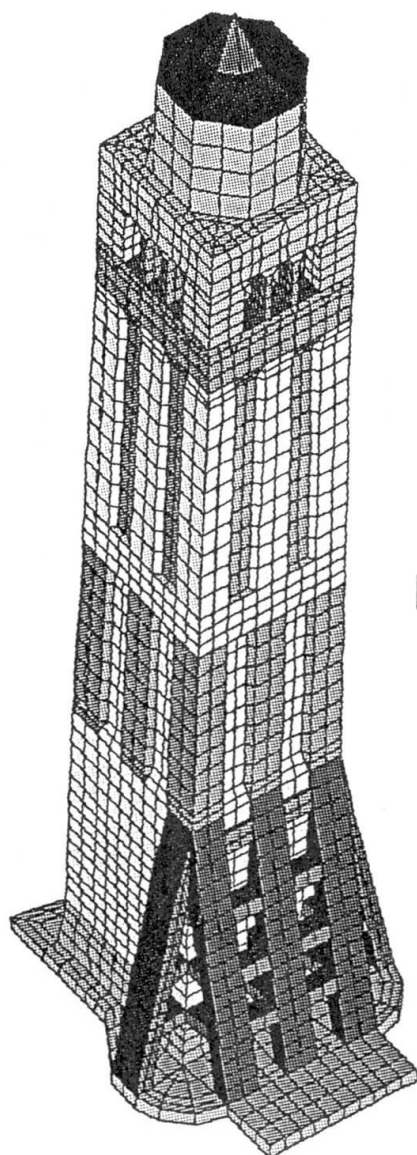
Fig. 5 Mesh of the numerical model

Such results were compared with those obtained numerically by means of a FE model (Fig. 5)

constructed assuming the mechanical properties of the materials obtained from the above tests.

The FE model has been subsequently calibrated also by comparing dynamic parameters experimentally obtained by recording and elaborating environmental and forced vibrations with the theoretical ones.
