**Artikel:** Reconstruction of reinforced concrete walls of cylindrical silos  
**Autor:** Ajdukiewicz, Andrzej B. / Kliszczewicz, Alina T.  
**DOI:** <https://doi.org/10.5169/seals-55264>

## Reconstruction of Reinforced Concrete Walls of Cylindrical Silos

Walls of reinforced concrete silos long in service can become damaged due to various external and/or internal influences. Repairs of such walls require exact appraisals and individual methods. Two examples of large cylindrical silos are presented.

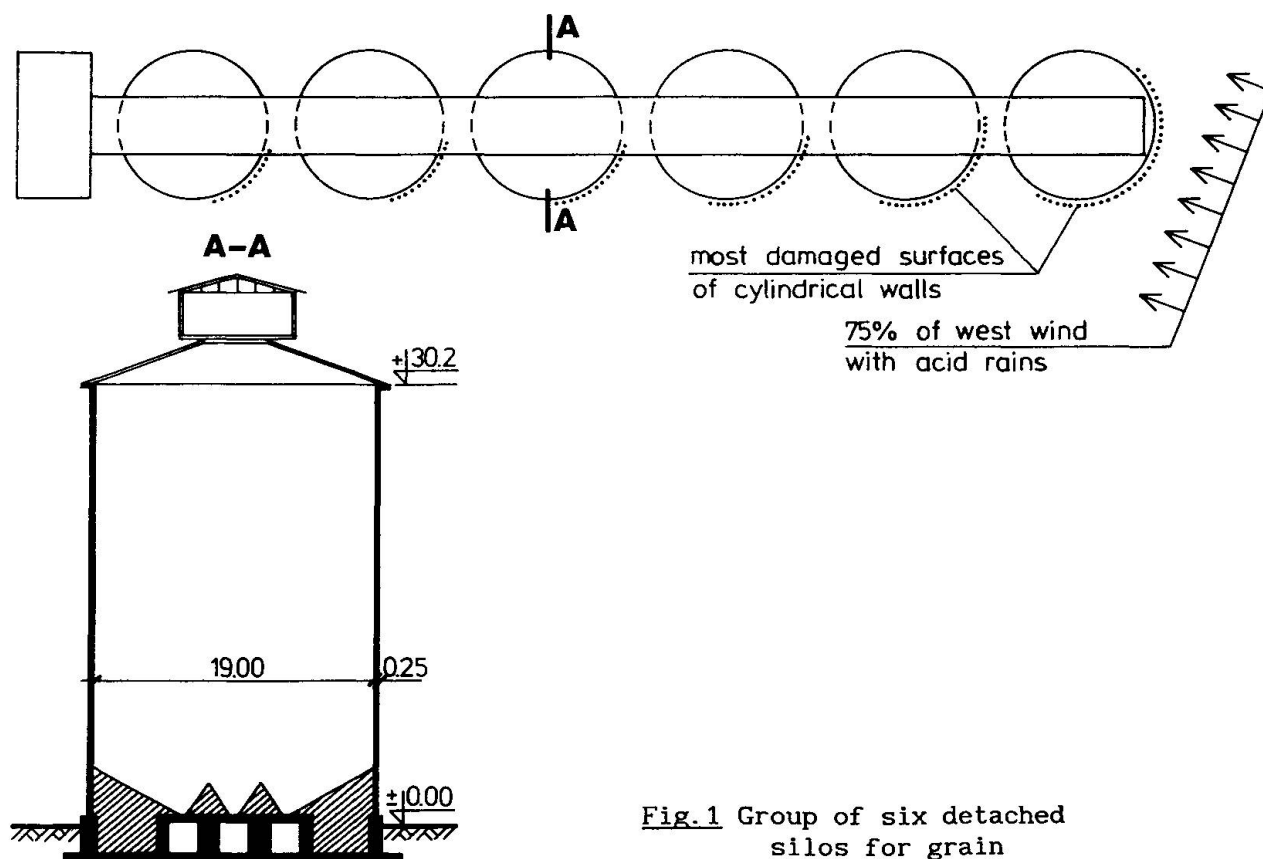
The group of six silos has been built in 1969 to store grain, mainly wheat and rye. The storage station was located at the eastern border of industrial zone and the buildings were attacked by polluted air, mainly by acid rains. The great majority of winds in that area were from west, so the surfaces of concrete in silos walls have been badly damaged, particularly from the west side (Fig.1).

Fig.1 Group of six detached silos for grain

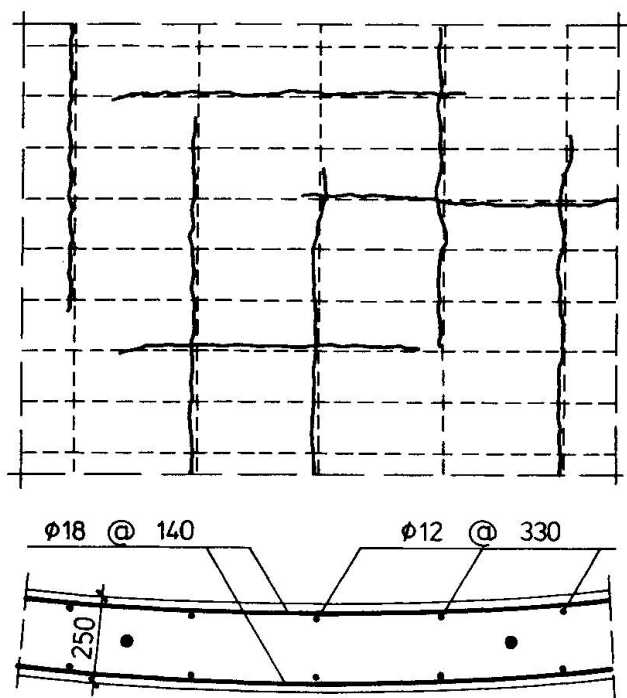
The corrosive environment in combination with porous concrete surfaces and poor cover caused on more than 1/3 of the external surface area advanced damages with corrosion of reinforcement and serious cracking of concrete along the bars (Fig.2). Some parts of reinforcement were uncovered at all.

Fig.2 Cross-section of silo wall and view of external surface with cracks width of 0.3 to 0.5mm along the bars of reinforcement

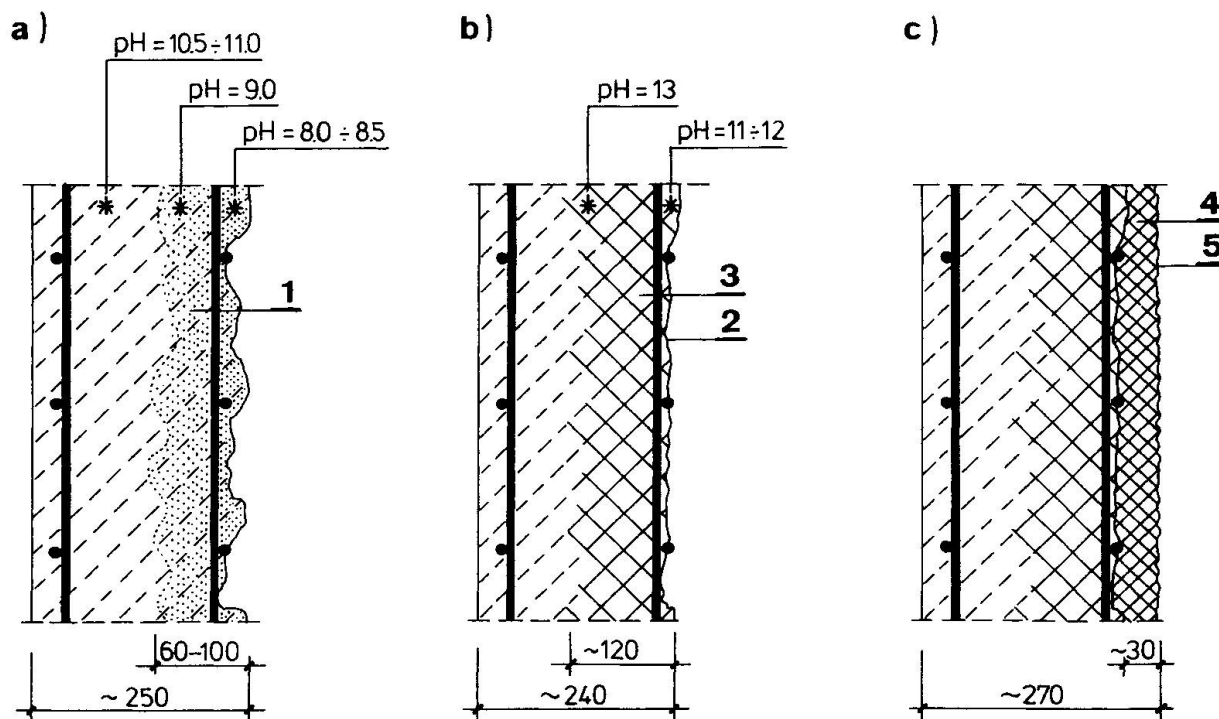
The tests of concrete samples (drilled cores throughout walls) indicated that the strength of concrete was quite sufficient but advanced processes of carbonation were measured to the depth from 60 to 100mm (Fig.3a).

Fig.3 The steps of reconstruction: a) - damaged wall, b) - after sand-blast cleaning and alkalization, c) - after full reconstruction; 1 - zone of carbonized concrete ( $pH \leq 9$ ), 2 - sand-blast cleaned concrete surface, 3 - alcalized concrete ( $pH \geq 11$ ) and filled cracks, 4 - shotcrete with microsilica admixture, 5 - protection paint with possible air penetration

The tests of samples taken from the walls after re-alkalization showed the average depth of penetration about 120mm, with effective alkali reaction ( $\text{pH} \geq 11$ ) - Fig. 3b. Final tests of the cores taken out from the repaired walls concerned the bond between old and new concrete. The results were satisfactory - more than half of samples have been broken not in the contact section but through the old concrete.

The reconstruction work has been designed and executed as follows (Fig. 3b,c):

- cleaning of concrete surfaces by sand blasting,
- re-alkalization by double or triple impregnation from outside (Consecrete CC)
- local repairs with highly adhesive mix (Sika admixtures),
- single layer of shot crete ~30mm thick, placed by dry method (microsilica additions),
- external protection with air-penetrable painting (Sarsil).

As an interesting idea introduced during reconstruction was the use of silo overloading (by filling over the nominal level with humid, heavy grain) at the impregnation of cracked concrete and at shotcrete placing and hardening. Double benefits were obtained in this way - the increased humidity of concrete, which was important for the effects of both processes and quasi-prestressing of shotcrete layer after unloading.

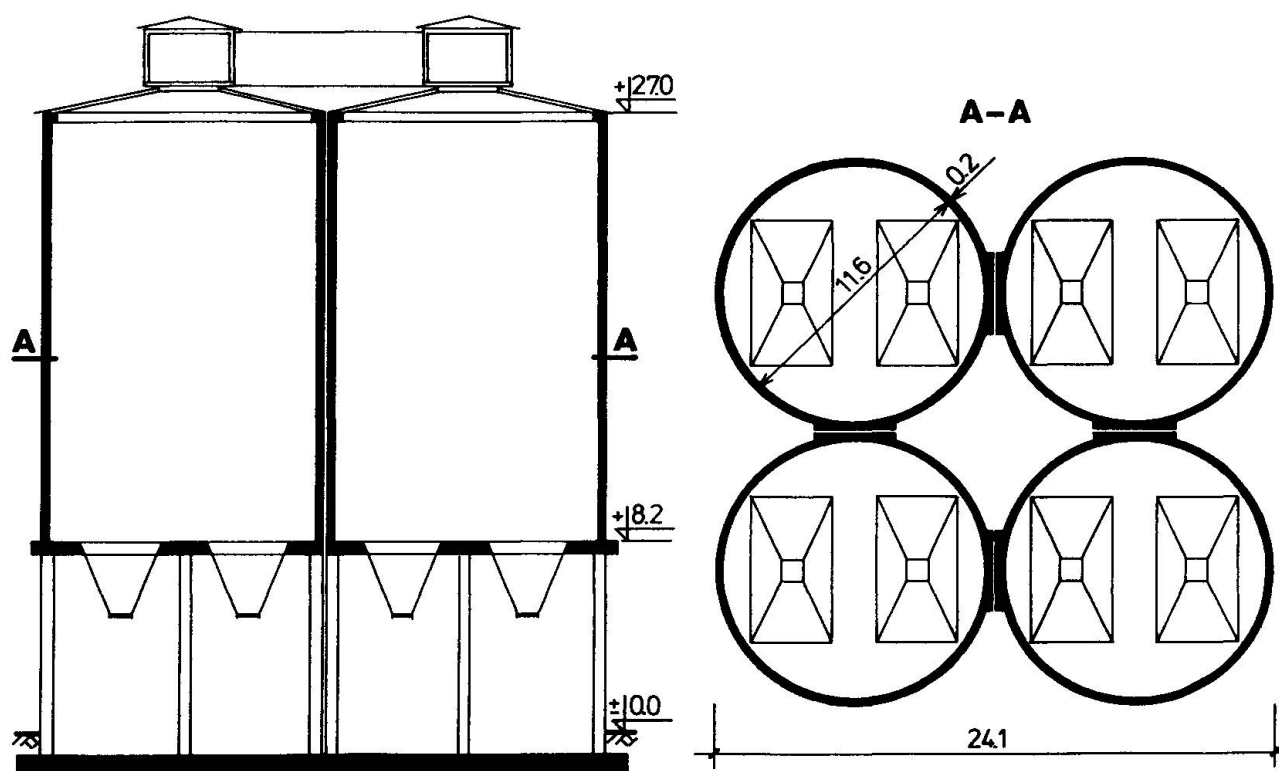
The second example of silos reconstruction refers to quite different case of damage of structure. The three groups of four cylindrical silos each have been exploited continuously for more than 15 years in the cement plant. The silos were necessary to store cement clinker before grinding (Fig. 4).

**Fig. 4** Group of silos in cement plant

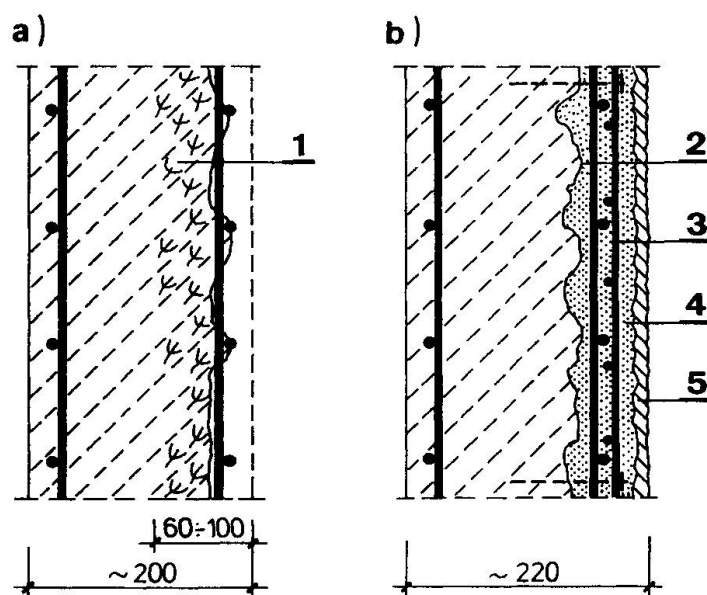
The thermal influences were taken into account by designer and over the common bottom-slab the cells were quite independent. During the proper production process the temperature of clinker at loading should not be more than  $70^{\circ}\text{C}$ . Unfortunately, very often the material of  $200^{\circ}\text{C}$  and sometimes even almost  $300^{\circ}\text{C}$  was loaded into the silos, as a result of irregularity of production. The random thermal actions were not noticed for long time. From outside almost no signals of damage could be observed, particularly in very dusty atmosphere of the cement plant. The local cracks of width up to 0.3mm were not visible without special cleaning of surface.

By accident, during the replacement of steel hoppers in one silo the part of concrete cover from internal surface fell down and uncovered the surface of seriously cracked concrete. The investigations were undertaken and completely destroyed layer of concrete up to the depth of 60 - 100mm from inside was discovered (Fig.5a). In many parts the solids of concrete (like cubes up to 100mm) could be taken away by hand, because, apart from cracking, the bond between concrete and reinforcement was entirely destroyed.

**Fig.5** The wall of cement clinker silo:  
a) damaged by multiple thermal actions,  
b) reconstructed from inside;

- 1 - zone of highly cracked/crushed concrete,
- 2 - cleaned surface of slightly cracked concrete and uncovered reinforcement,
- 3 - additional steel fabrics  $\varnothing 8@100/100\text{mm}$ ,
- 4 - shotcrete with basalt aggregate,
- 5 - anti-abrasive layer with fibers

Due to dry environment inside the steel bars were relatively in good stage, almost without signs of corrosion, but in many parts the bars were bent by mechanical action of sliding down solids of clinker.

The only problem, but very significant was the long time of process of dehydration of concrete connected with destruction due to local overheating of the wall.

The immediate general repair was necessary with replacing part of existing reinforcement and addition of reinforced shotcrete supplementary layer. The shotcrete was placed in three steps, 25 - 30mm each. The final layer of shotcrete was of particular recipe, with anti-abrasive components (basalt aggregate, reinforcing fibers and Sikacrete admixture) - Fig.5b.

Obviously, the correct process of production has been ensured parallelly by the technological changes.
