Zeitschrift: IABSE reports = Rapports AIPC = IVBH Berichte
Band: 73/1/73/2 (1995)

Artikel: Reconstruction of reinforced concrete walls of cylindrical silos
Autor: Ajdukiewicz, Andrzej B. / Kliszczewicz, Alina T.
DOI: <https://doi.org/10.5169/seals-55264>

Reconstruction of Reinforced Concrete Walls of Cylindrical Silos

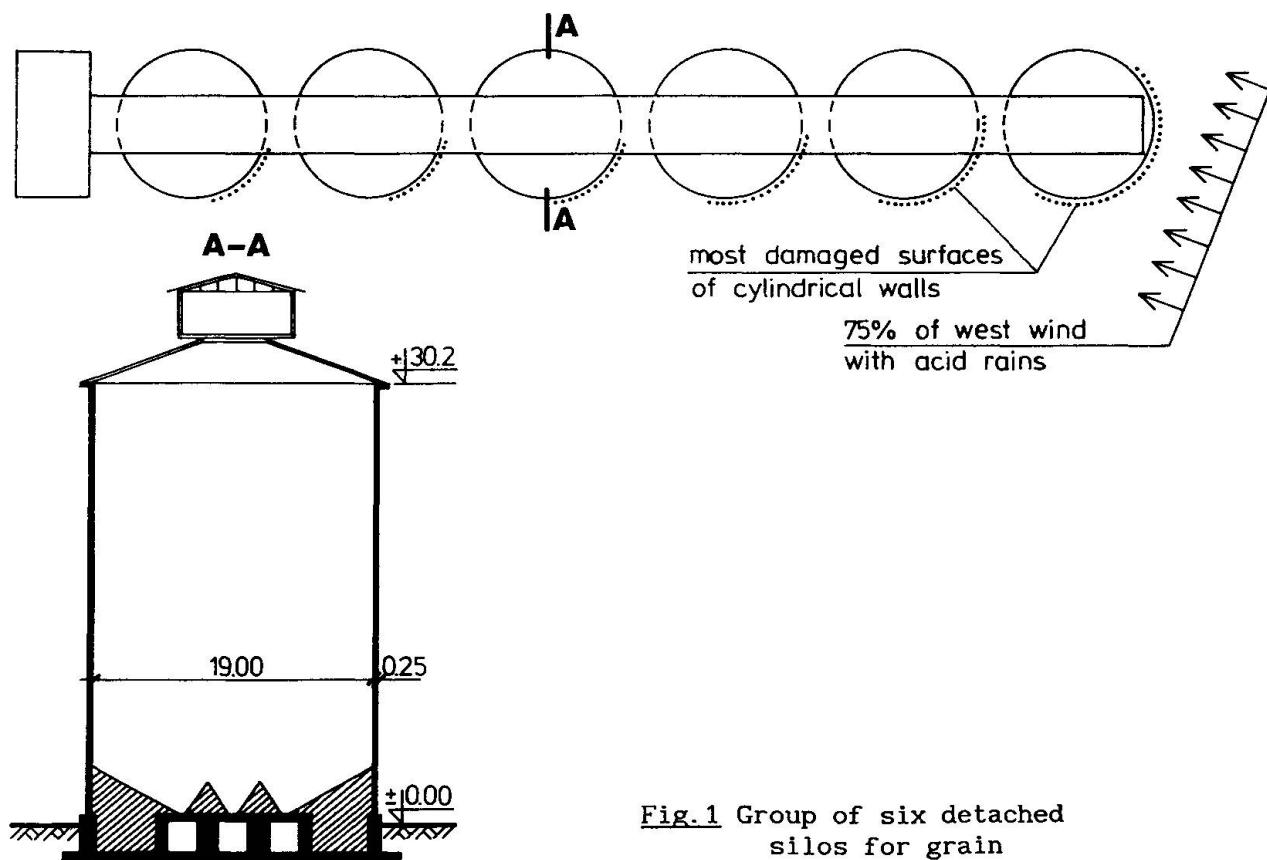
The group of six silos has been built in 1969 to store grain, mainly wheat and rye. The storage station was located at the eastern border of industrial zone and the buildings were attacked by polluted air, mainly by acid rains. The great majority of winds in that area were from west, so the surfaces of concrete in silos walls have been badly damaged, particularly from the west side (Fig. 1).

Fig. 1 Group of six detached silos for grain

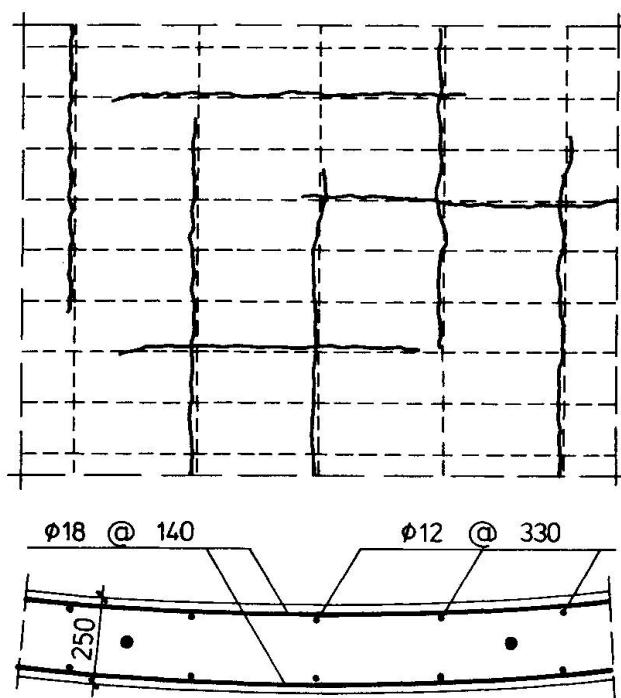
The corrosive environment in combination with porous concrete surfaces and poor cover caused on more than 1/3 of the external surface area advanced damages with corrosion of reinforcement and serious cracking of concrete along the bars (Fig. 2). Some parts of reinforcement were uncovered at all. The tests of concrete samples (drilled cores throughout walls) indicated that the strength of concrete was quite sufficient but advanced processes of carbonation were measured to the depth from 60 to 100 mm (Fig. 3a).

Fig. 2 Cross-section of silo wall and view of external surface with cracks width of 0.3 to 0.5 mm along the bars of reinforcement

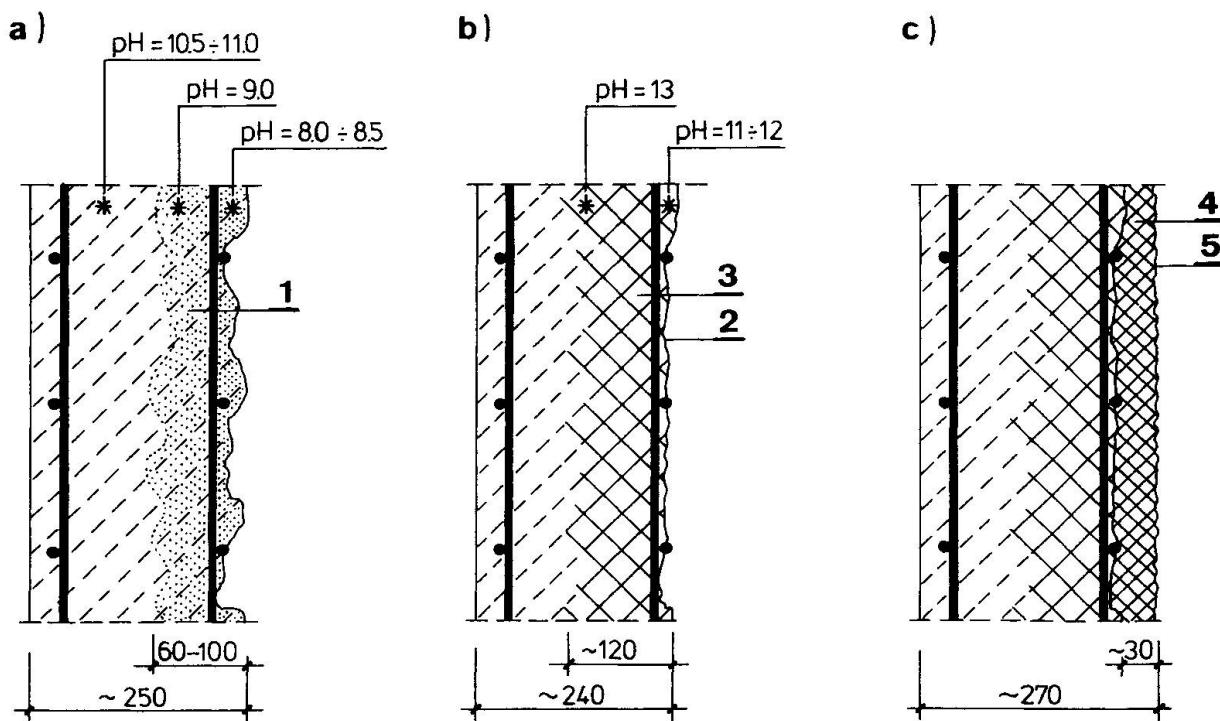
Fig. 3 The steps of reconstruction: a) - damaged wall, b) - after sand-blast cleaning and alkalization, c) - after full reconstruction;
1 - zone of carbonized concrete ($\text{pH} \leq 9$), 2 - sand-blast cleaned concrete surface, 3 - alkalinized concrete ($\text{pH} \geq 11$) and filled cracks, 4 - shotcrete with microsilica admixture, 5 - protection paint with possible air penetration

The tests of samples taken from the walls after re-alcalization showed the average depth of penetration about 120mm, with effective alkali reaction (pH \geq 11) - Fig. 3b. Final tests of the cores taken out from the repaired walls concerned the bond between old and new concrete. The results were satisfactory - more than half of samples have been broken not in the contact section but through the old concrete.

The reconstruction work has been designed and executed as follows (Fig. 3b, c):

- cleaning of concrete surfaces by sand blasting,
- re-alcalization by double or triple impregnation from outside (Consecrate CC)
- local repairs with highly adhesive mix (Sika admixtures),
- single layer of shotcrete ~30mm thick, placed by dry method (microsilica additions),
- external protection with air-penetrable painting (Sarsil).

As an interesting idea introduced during reconstruction was the use of silo overloading (by filling over the nominal level with humid, heavy grain) at the impregnation of cracked concrete and at shotcrete placing and hardening. Double benefits were obtained in this way - the increased humidity of concrete, which was important for the effects of both processes and quasi-prestressing of shotcrete layer after unloading.

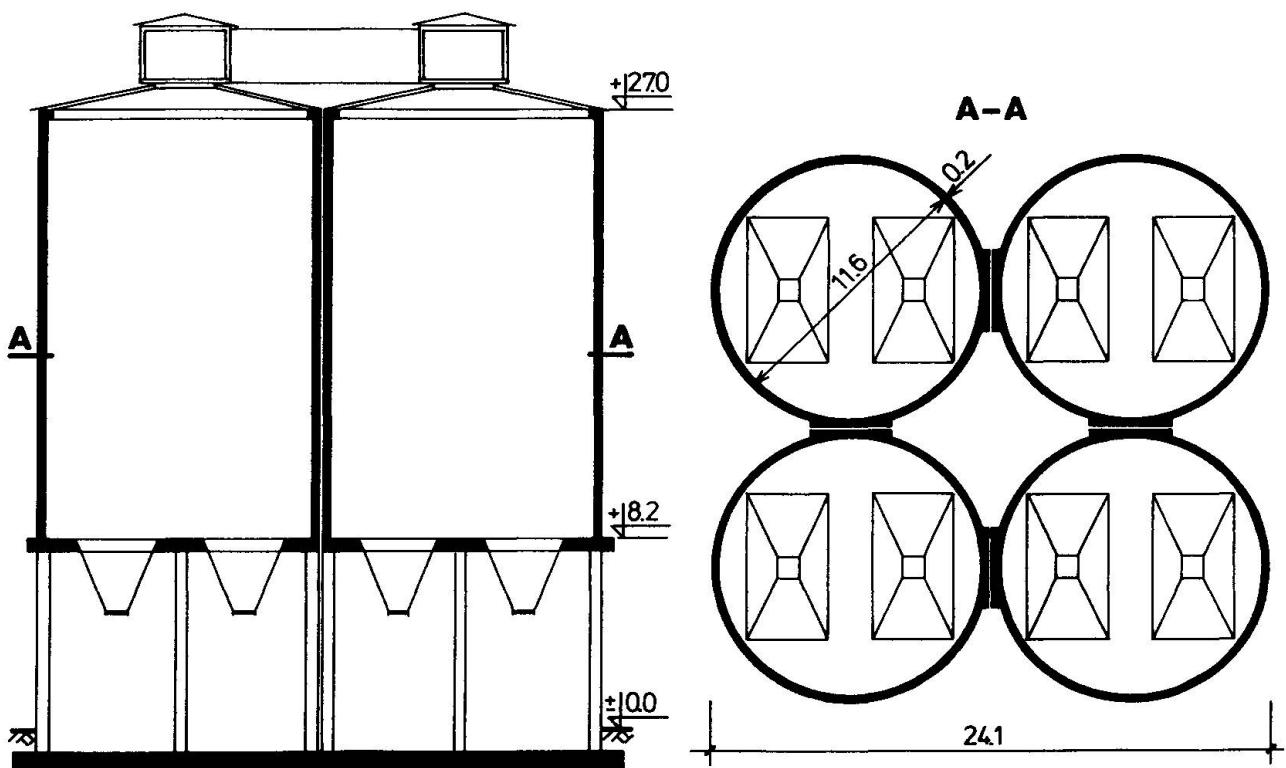
The second example of silos reconstruction refers to quite different case of damage of structure. The three groups of four cylindrical silos each have been exploited continuously for more than 15 years in the cement plant. The silos were necessary to store cement clinker before grinding (Fig. 4).

Fig. 4 Group of silos in cement plant

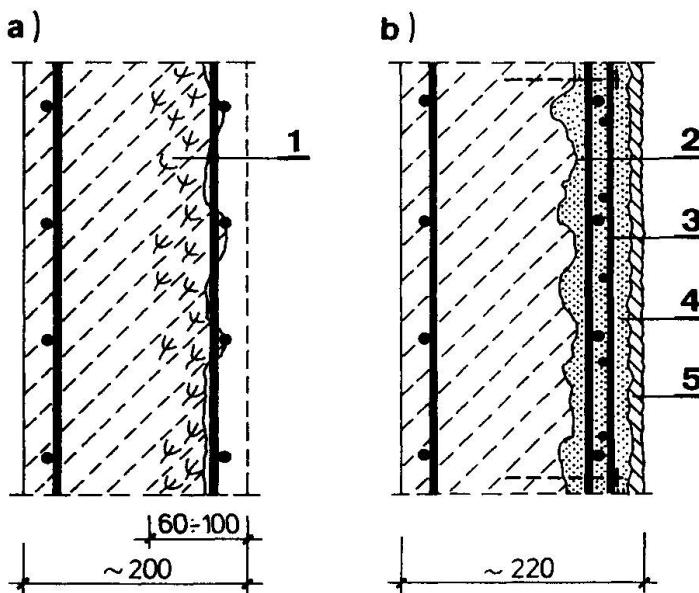
By accident, during the replacement of steel hoppers in one silo the part of concrete cover from internal surface fell down and uncovered the surface of seriously cracked concrete. The investigations were undertaken and completely destroyed layer of concrete up to the depth of 60 - 100mm from inside was discovered (Fig. 5a). In many parts the solids of concrete (like cubes up to 100mm) could be taken away by hand, because, apart from cracking, the bond between concrete and reinforcement was entirely destroyed.

Fig. 5 The wall of cement clinker silo:
a) damaged by multiple thermal actions,
b) reconstructed from inside;

- 1 - zone of highly cracked/crushed concrete,
- 2 - cleaned surface of slightly cracked concrete and uncovered reinforcement,
- 3 - additional steel fabrics $\varnothing 8@100/100\text{mm}$,
- 4 - shotcrete with basalt aggregate,
- 5 - anti-abrasive layer with fibers

Due to dry environment inside the steel bars were relatively in good stage, almost without signs of corrosion, but in many parts the bars were bent by mechanical action of sliding down solids of clinker. The only problem, but very significant was the long time of process of dehydration of concrete connected with destruction due to local overheating of the wall. The immediate general repair was necessary with replacing part of existing reinforcement and addition of reinforced shotcrete supplementary layer. The shotcrete was placed in three steps, 25 - 30mm each. The final layer of shotcrete was of particular recipe, with anti-abrasive components (basalt aggregate, reinforcing fibers and Sikacrete admixture) - Fig. 5b.
