Zeitschrift: IABSE reports = Rapports AIPC = IVBH Berichte
Band: 73/1/73/2 (1995)

Artikel: Reconstruction of reinforced concrete walls of cylindrical silos
Autor: Ajdukiewicz, Andrzej B. / Kliszczewicz, Alina T.
DOI: <https://doi.org/10.5169/seals-55264>

Reconstruction of Reinforced Concrete Walls of Cylindrical Silos

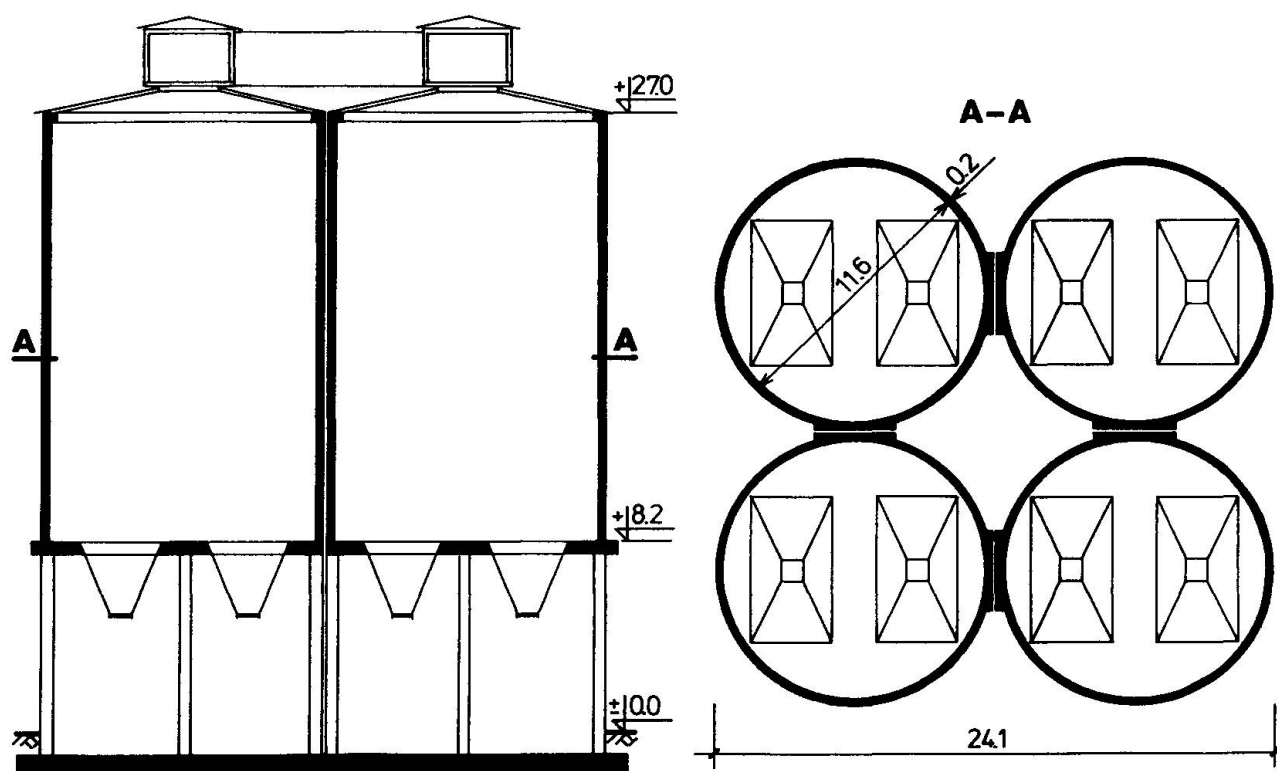
The second example of silos reconstruction refers to quite different case of damage of structure. The three groups of four cylindrical silos each have been exploited continuously for more than 15 years in the cement plant. The silos were necessary to store cement clinker before grinding (Fig. 4).

Fig. 4 Group of silos in cement plant

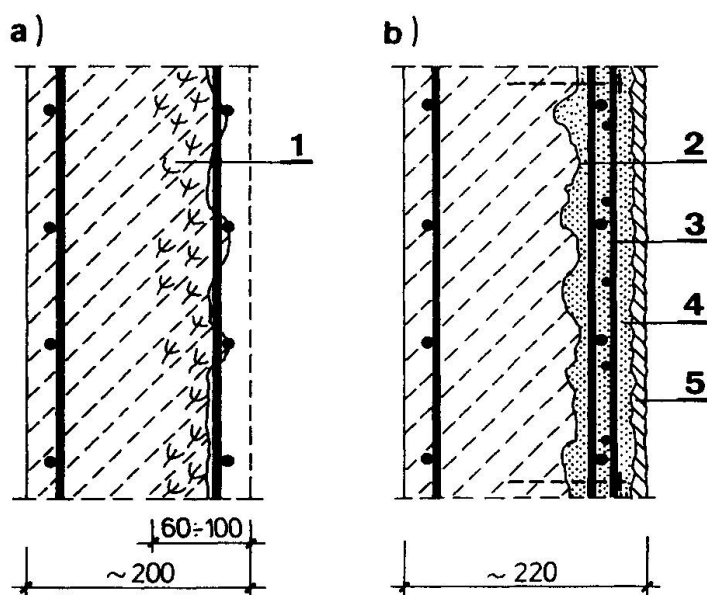
The thermal influences were taken into account by designer and over the common bottom-slab the cells were quite independent. During the proper production process the temperature of clinker at loading should not be more than 70°C . Unfortunately, very often the material of 200°C and sometimes even almost 300°C was loaded into the silos, as a result of irregularity of production. The random thermal actions were not noticed for long time. From outside almost no signals of damage could be observed, particularly in very dusty atmosphere of the cement plant. The local cracks of width up to 0.3mm were not visible without special cleaning of surface.

By accident, during the replacement of steel hoppers in one silo the part of concrete cover from internal surface fell down and uncovered the surface of seriously cracked concrete. The investigations were undertaken and completely destroyed layer of concrete up to the depth of $60 - 100\text{mm}$ from inside was discovered (Fig.5a). In many parts the solids of concrete (like cubes up to 100mm) could be taken away by hand, because, apart from cracking, the bond between concrete and reinforcement was entirely destroyed.

Fig.5 The wall of cement clinker silo:
a) damaged by multiple thermal actions,
b) reconstructed from inside;

- 1 - zone of highly cracked/crushed concrete,
- 2 - cleaned surface of slightly cracked concrete and uncovered reinforcement,
- 3 - additional steel fabrics $\varnothing 8@100/100\text{mm}$,
- 4 - shotcrete with basalt aggregate,
- 5 - anti-abrasive layer with fibers

Due to dry environment inside the steel bars were relatively in good stage, almost without signs of corrosion, but in many parts the bars were bent by mechanical action of sliding down solids of clinker.

The only problem, but very significant was the long time of process of dehydration of concrete connected with destruction due to local overheating of the wall.

The immediate general repair was necessary with replacing part of existing reinforcement and addition of reinforced shotcrete supplementary layer. The shotcrete was placed in three steps, $25 - 30\text{mm}$ each. The final layer of shotcrete was of particular recipe, with anti-abrasive components (basalt aggregate, reinforcing fibers and Sikacrete admixture) - Fig.5b.
