Zeitschrift: IABSE reports = Rapports AIPC = IVBH Berichte
Band: 73/1/73/2 (1995)

Artikel: Structural rehabilitation of a reinforced concrete and a prestressed concrete bridge
Autor: Croci, G. / Santoro, V.M. / Macri, F.
DOI: <https://doi.org/10.5169/seals-55162>

Structural Rehabilitation of a Reinforced Concrete and a Prestressed Concrete Bridge

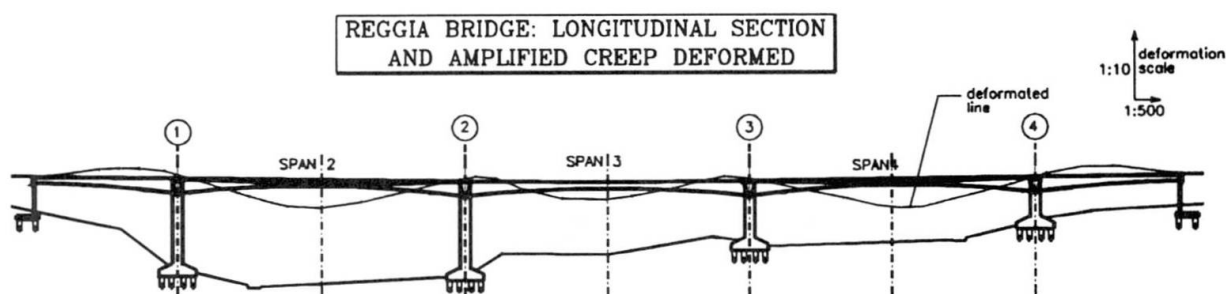
FIGURE 11

The phenomena observed are related to creep processes that cannot easily be predicted at the design stage. On account of the construction method, based on a cantilevered section-by-section procedure that involved building a structure with provisional boundary conditions that differed from the final ones, the creep effects have produced a redistribution of the stress for permanent loads and, in particular, an increase in positive bending moments in the middle of the spans and a reduction near the piers (figure 12). The individual sections of the cantilevers were poured in different stages, with non-homogeneous pouring and weathering conditions, so that they presented different creep functions. Even minor uncertainties in calculating the dead or prestressing loads could also have led to considerable variations in the creep deformations, bearing in mind the effective reciprocal influences between the creep and the steel relaxation of the prestressing cables. Another factor that should be considered is the possible effect of the insertion of provisional hydraulic jacks in the middle of the central span, which may have partially compensated the creep deformations of the third span, jeopardizing the second and fourth spans.
