Artikel: Structural rehabilitation of a reinforced concrete and a prestressed concrete bridge
Autor: Croci, G. / Santoro, V.M. / Macri, F.
DOI: <https://doi.org/10.5169/seals-55162>

Structural Rehabilitation of a Reinforced Concrete and a Prestressed Concrete Bridge

Two examples of works on reinforced and prestressed concrete bridges are described, each involving different aspects of problems faced by the maintenance programs that the Italian Roadway Board has carried out in recent years. The first case involves an old reinforced concrete bridge whose heavily damaged structures required radical repairs and anti-seismic measures. The second case concerns prestressed concrete span cantilever cables to be inserted in the cross section in order to restore safety margins and correct some of the deflections due to creep.

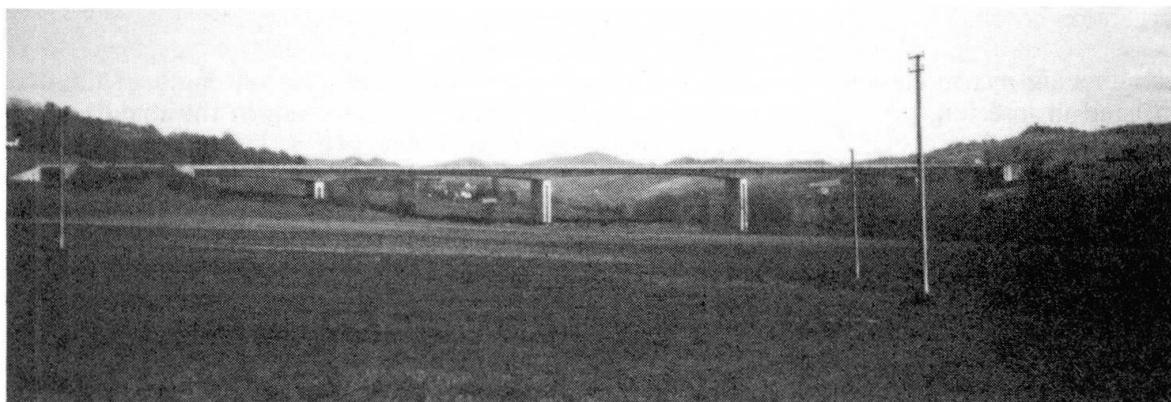
The Reggia viaduct crosses the catch drain of the same name on the E45 Highway 30 km north of Perugia. It was built in the late seventies using the successive segment cantilever method on piers with a maximum height of 15 meters (photo 10). The cantilevers were then connected, so that the end result is a continuous 5-spans beam on 6 supports. The three central spans are 90 meters long and the lateral spans 45 meters. The supports on the central piers are of the fixed hinge type and those on

photo 10 - Reggia Viaduct - General view

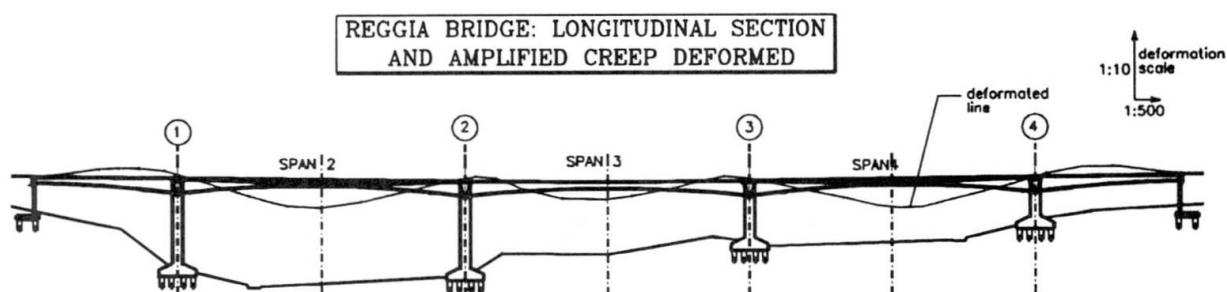
FIGURE 11

The phenomena observed are related to creep processes that cannot easily be predicted at the design stage. On account of the construction method, based on a cantilevered section-by-section procedure that involved building a structure with provisional boundary conditions that differed from the final ones, the creep effects have produced a redistribution of the stress for permanent loads and, in particular, an increase in positive bending moments in the middle of the spans and a reduction near the piers (figure 12). The individual sections of the cantilevers were poured in different stages, with non-homogeneous pouring and weathering conditions, so that they presented different creep functions. Even minor uncertainties in calculating the dead or prestressing loads could also have led to considerable variations in the creep deformations, bearing in mind the effective reciprocal influences between the creep and the steel relaxation of the prestressing cables. Another factor that should be considered is the possible effect of the insertion of provisional hydraulic jacks in the middle of the central span, which may have partially compensated the creep deformations of the third span, jeopardizing the second and fourth spans.
