Damage of SRC building structures by 1995 Hyogo earthquake

Damage of SRC Building Structures by 1995 Hyogo Earthquake

A large number of Steel Reinforced Concrete (SRC) building structures were damaged seriously owing to 1995 Hyogoken-Nanbu Earthquake in Japan. The authors have investigated the damage of buildings and collected the data of 1,307 SRC buildings in and around Kobe city. Thirty-one SRC buildings collapsed by the story failure. All of them were constructed before 1972 and openweb type steels were used in SRC members. In this paper examples of damage of SRC buildings and members, and statistical analysis of damage are described.

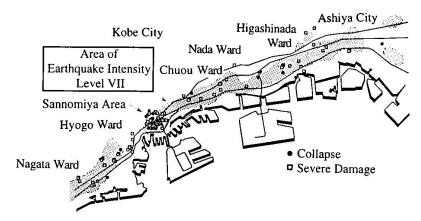
Fig. 1 Distribution of SRC buildings subjected collapse or severe damage.

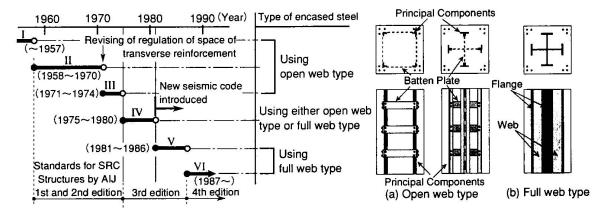
Figure 2 shows the relation of SRC type and construction year of buildings, and the construction years are divided into six periods according to the revising of the standards for structural calculation of SRC structures published by Architectural Institute of Japan [3] (AIJ standard). The term IV (1975-1980) show the period that buildings were constructed with either open web type or full web type.

Fig. 2 Decision of Classification of Years of Completion of Buildings

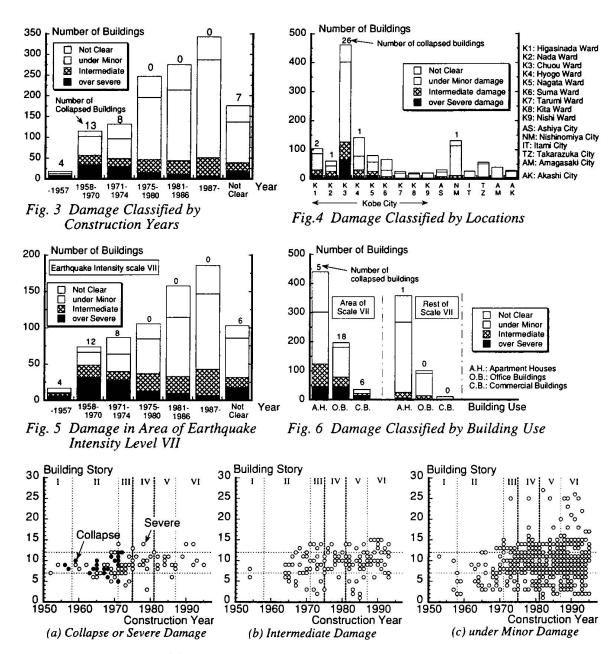
Fig. 7 Damage Classified by Story and Construction Year

Figure 7 shows the distribution of damage classified by building story and construction years. From these figures, it was clear that almost all of the buildings collapsed or sustained severe damage had over seven to twelve stories, and the buildings under six stories tended to be able to avoid severe damage, regardless of construction years of buildings. The buildings over fifteen stories did not sustain severer damage.
