Artikel: Damage of SRC building structures by 1995 Hyogo earthquake
Autor: Sakai, Junichi / Minami, Koichi / Matsui, Chiaki
DOI: <https://doi.org/10.5169/seals-1035>

Damage of SRC Building Structures by 1995 Hyogo Earthquake

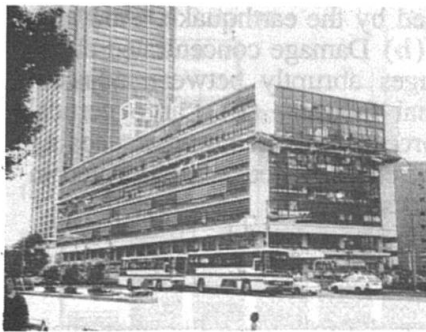
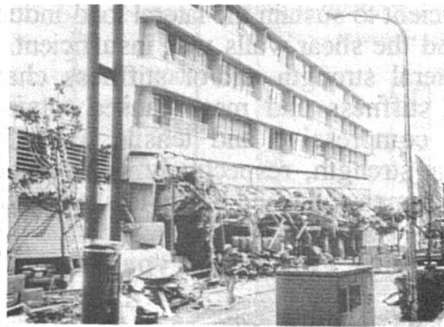
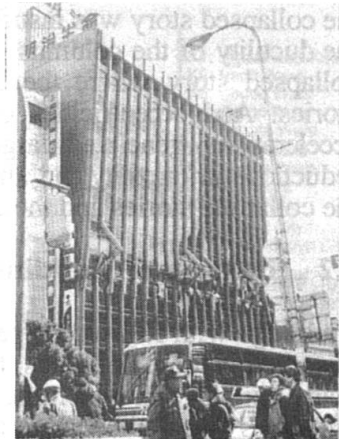
Photo. 1 Collapsed Building with Story Failure at an Upper Floor Level

Thirty-one of SRC buildings collapsed by the story failure. All of them were constructed before 1972 and composed of the open web type SRC. Twenty-seven buildings collapsed by the story failure at an upper floor level (see Photo. 1) and four buildings collapsed at the first story. At the failure story, SRC columns collapsed brittly in shear (see Photo. 2) and concrete in RC shear walls crushed to out of plane. Collapse by the story failure at an upper floor level was characterized of the damage caused by this earthquake. Several factors potentially responsible for these failures can be considered as follows: (a) The design earthquake force distribution over the height used in the old design codes is different from the one used now, and the proportion of design story shear force is smaller at the mid-stories in the old codes. Then the ultimate strength of

the collapsed story was insufficient to sustain the lateral load induced by the earthquake. And also the ductility of the columns and the shear walls was insufficient. (b) Damage concentrated at the collapsed story where the lateral strength and/or stiffness changes abruptly between adjacent stories. And eccentricities of stiffness and mass caused torsional failure. (c) Large vertical accelerations generated large compressive and tensile axial forces in the columns, causing reductions in ductility and shear strength, respectively. (d) Joint of encased steel was located in the collapsed stories and the columns collapsed brittly in shear at this story.

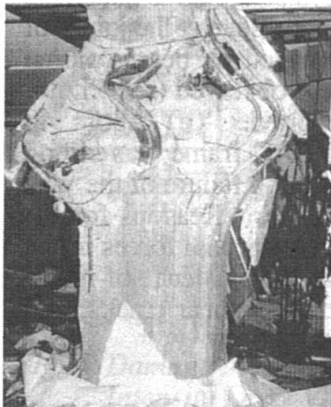
Photo. 2 Collapsed Column in Shear

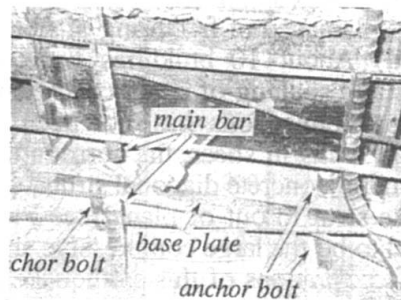
Photo. 3 Fracturing of Anchor Bolt at Column Base (after chipping concrete)

Buildings with full web type SRC did not collapse at all. However the following damages were observed in these buildings: (a) About 40 buildings were damaged at the column base. There were many buildings in which the steel base plate was anchored at the ground floor level using a detail known as "non-embedment type steel base". Severe damage was observed in buildings that used this base plate detail. Concrete crushed at the column base and anchor bolts were pulled out (see Photo. 3). (b) About 10 buildings were damaged of fracturing of encased steel flange plate (see Photo. 4). (c) About 10 buildings were damaged of fracturing of steel splice plate at the joints of columns or beams (see Photo. 5). (d) About 10 buildings were damaged at beam-column connections where diagonal shear cracks and spalling of cover concrete were observed (see Photo. 6), but severe damage at beam-column connections has not been reported. (e) About 40 buildings were damaged of the shear RC walls in shear; the surrounding SRC frame was strong enough to carry the forces delivered from the concrete diagonal struts, so sliding failure of the wall took place with crushing of the concrete strut to out of plane (see Photo. 7). Reasons for the damage from (a) to (d) were considered to be the large compressive and tensile axial forces in the columns generated by the large vertical accelerations of this earthquake and the existence of multi-story shear walls. A large number of columns or beams with flexural cracks, shear cracks, and shear bond cracks were observed, but severe damage has not been reported.

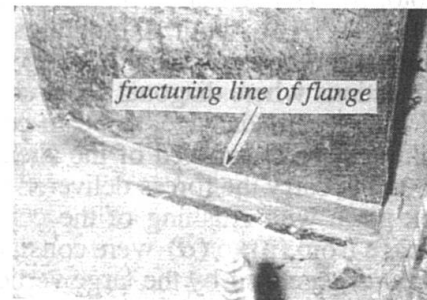
Photo. 4 Fracturing of Column Steel Flange Plate (after chipping concrete)

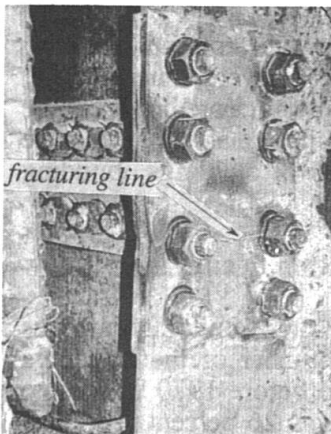
Photo. 5 Fracturing of Splice Plate at Column Joint (after chipping concrete)

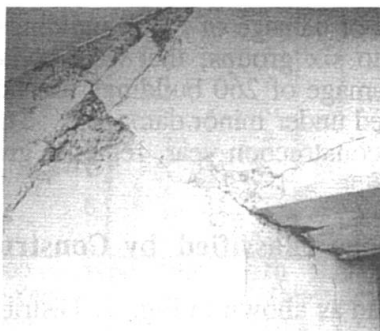
Photo. 6 Damage of Beam-Column Connection

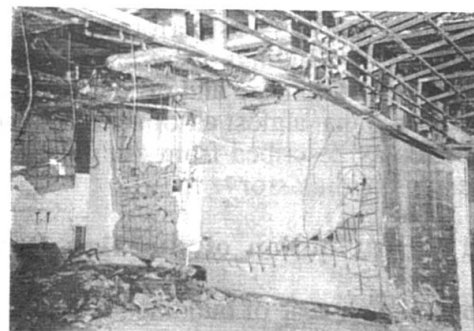
Photo. 7 Damage of RC Shear Wall

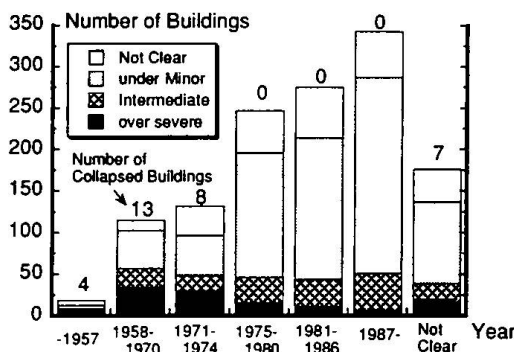
Fig. 3 Damage Classified by Construction Years

Construction year of buildings was divided as shown in Fig. 2. Distribution of building damages classified by construction years is shown in Fig. 3. The ratio of the number of the buildings collapsed or sustained severe damage to the total of buildings constructed before 1970 was up to 30 percent (40/134), and the ratio of buildings constructed before 1974 was 26 percent (70/266). Almost all of them were composed of open web type SRC. On the other hand, with full web type SRC constructed after 1981, only 3 percent of buildings sustained severe damage (18/618), and no such a building collapsed.

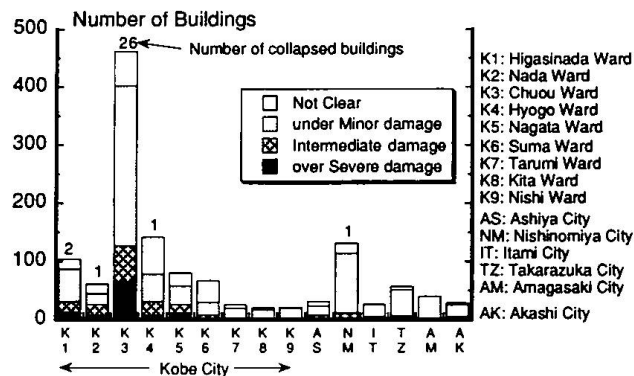
Fig. 4 Damage Classified by Locations

Distribution of building damage classified by locations is shown in Fig. 4. Locations are nine ward of Kobe city, Ashiya city, Nishinomiya city, Itami city, Takarazuka city, Amagasaki city and Akashi city. The number of SRC buildings constructed in chuou ward of Kobe city was 462, and the ratio of this number to all buildings was 35 percent. In this ward, 26 buildings collapsed, 40 buildings were subjected to severe damage, and the ratio of the number of buildings sustained those damage to total buildings was 15 percent.

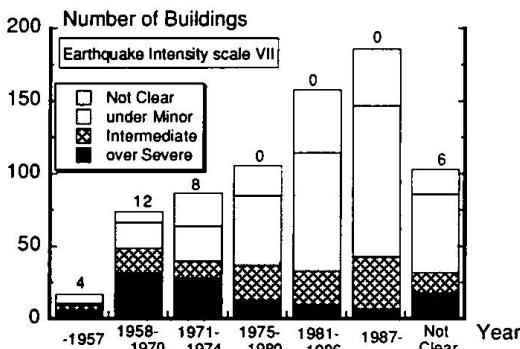
Fig. 5 Damage in Area of Earthquake Intensity Level VII

An earthquake intensity scale is defined eight grade scales by Japanese Meteorological Agency. The intensity scale VII is the most intense grade, where the maximum acceleration of ground motion is over 400 gal. The area of earthquake intensity scale VII (area VII) spread widely in and around Kobe city. The area VII was defined on the map by Geographical Survey Institute of Japan, and M. Murakami presumed the address of the area from this map [4]. The ratio of the number of buildings constructed in the area VII to the total of buildings was 56 percent (731 buildings). Figure 5 shows the distribution of the building damage classified by construction years in the area VII. The buildings constructed before 1974 in the area VII tended to be subjected severer damage, and about half of the buildings constructed from 1958 to 1970 collapsed or sustained severe damage (32/74). On the other hand, only 5 percent of buildings constructed after 1981 sustained severe damage (17/344).

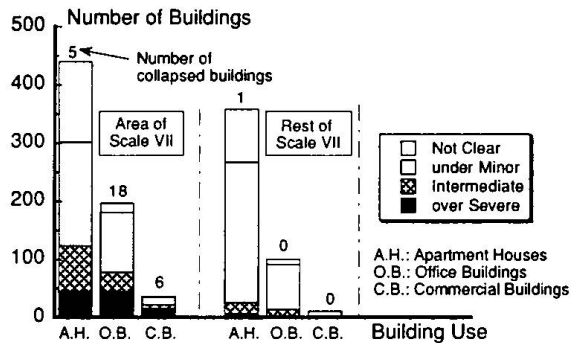
Fig. 6 Damage Classified by Building Use

Buildings were divided by building use as apartment houses, office buildings, commercial buildings and the others (see Fig. 6). The ratio of the number of apartment houses, office buildings and commercial buildings to the total of buildings were 61 percent (802 buildings), 23 percent (298) and 4 percent (49), respectively. The number of collapsed buildings were 5, 19 and 7 for apartment houses, office buildings and commercial buildings, respectively. The ratio of the number of commercial buildings collapsed or sustained severe damage to the total of buildings constructed in the area VII was up to 43 percent (16/37). The ratio for office buildings and for apartment houses was 23 percent (45/197) and 16 percent (45/441), respectively.

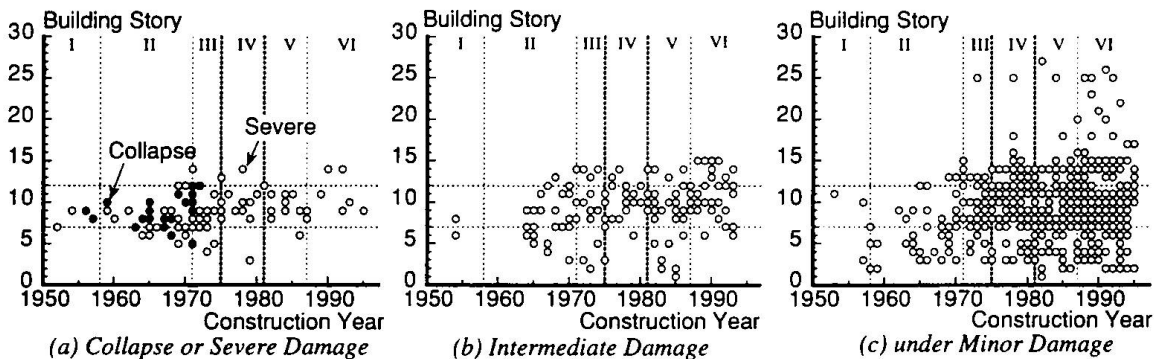
Fig. 7 Damage Classified by Story and Construction Year

Figure 7 shows the distribution of damage classified by building story and construction years. From these figures, it was clear that almost all of the buildings collapsed or sustained severe damage had over seven to twelve stories, and the buildings under six stories tended to be able to avoid severe damage, regardless of construction years of buildings. The buildings over fifteen stories did not sustain severer damage.
