Zeitschrift: IABSE reports = Rapports AIPC = IVBH Berichte
Band: 999 (1997)
Rubrik: Diagnosis, maintenance, retrofitting, repair

Collapse and Rehabilitation of Composite Trussed Structures

Major Repairs to Frank Lloyd Wright's Largest House: Wingspread, Racine, WI, USA

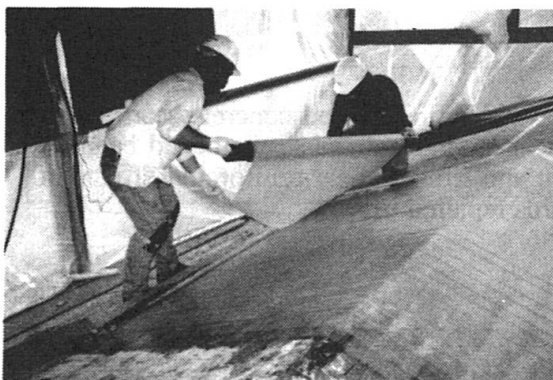
After extensive computer modeling using Finite Element Analysis, it was decided to create a shell structure out of the lower roof by coating the bare wood sheathing with 13 layers (12 mm total thickness) of quad-axial carbon fiber fabric set in a 50%-50% matrix of epoxy resin which was bonded to the wood. Prior to the first layer of carbon fiber installation the wood was thoroughly cleaned and large diameter screws were installed through the sheathing into the rafters at 15 cm on centers in oversized holes flooded with epoxy. Thus the carbon fiber was bonded to the wood sheathing which was in turn acting compositely with the rafters. Each layer of carbon was offset approximately 7-8 cm from the layer below to provide a scarf joint at every lap of fabric. Vacuum bagging was not practical for this on site installation so air bubbles were forced out using toothed rollers. The entire operation was conducted inside an environmentally controlled temporary timber framed structure built over the top of the roof. Upon completion, the composite membrane was post cured at 60° C for 24 hours.

Fig. 1 Installation of Carbon Fiber Fabric

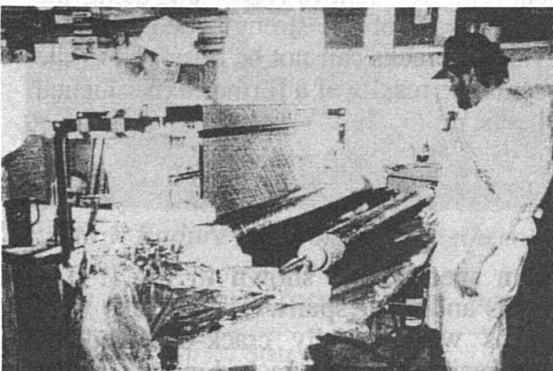
Fig. 2 Impregnating Fabric with Epoxy
