Zeitschrift: IABSE reports = Rapports AIPC = IVBH Berichte
Band: 999 (1997)
Rubrik: Diagnosis, maintenance, retrofitting, repair

Collapse and Rehabilitation of Composite Trussed Structures

Use of Aluminium Alloys in Retrofitting Ancient Suspension Bridges

Major Repairs to Frank Lloyd Wright's Largest House: Wingspread, Racine, WI, USA

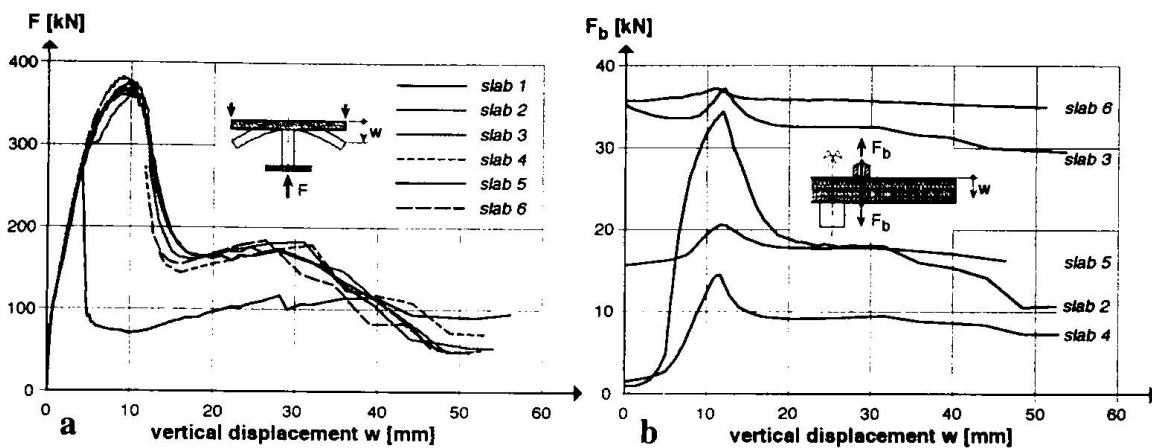
The test results are presented with the load-displacement curve (Fig. 1a) and the mean force in the bolts versus the vertical displacement of the slab (Fig. 1b). It follows that the punching load is increased from 280 kN up to 380 kN or 37% due to the strengthening. The vertical displacement at maximum load is significantly increased by the strengthening as it has more than doubled. It is observed that slab 1 is characterized by a punching cone inclined at an angle of approximately 30° . For all strengthened slabs, the punching cone is formed between the column diameter and the perimeter defined by the bolts. The inclination of the punching cone is approximately 70° (Fig. 2). This means that all the strengthened slabs exhibit a punching failure which is characterized by a punching crack that did not cross the strengthening bolts.

Fig. 1: Load-displacement curves and mean force in the bolts versus vertical displacement

The post-peak descending branch of the load-displacement curve is characterized by a strong reduction of the load carrying capacity with increasing displacement characterizing punching failure (Fig. 1a). After peak, the first drop of the load carrying capacity is about 200 kN for all the slabs (strengthened or not) which indicates that this decrease is due to a similar failure mechanism, that is, the concrete failure.

Injection modifies the slab mode of resistance so that it resists globally resulting in reduction of the stress level in the bolts (compare slab 2 and 4 in Fig. 1b). The injection also improves the serviceability of the slab and provides a protection against corrosion of the bolts.

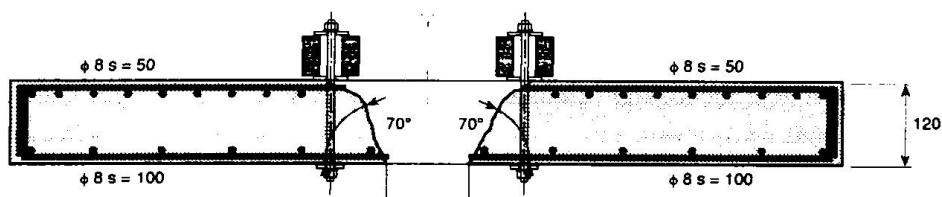
The punching load for the slab without strengthening bolts is predicted with the analytical model developed by Men  trety [2] which leads to $V_{pun}=250$ kN. The punching load of the strengthened slabs with a punching crack inclination of 70° is influenced by the punching and the flexural strength (as proposed by Men  trety [3]) resulting in $V_{fail}=364$ kN.

Fig. 2 : Sketch of the punching crack in the strengthened slab

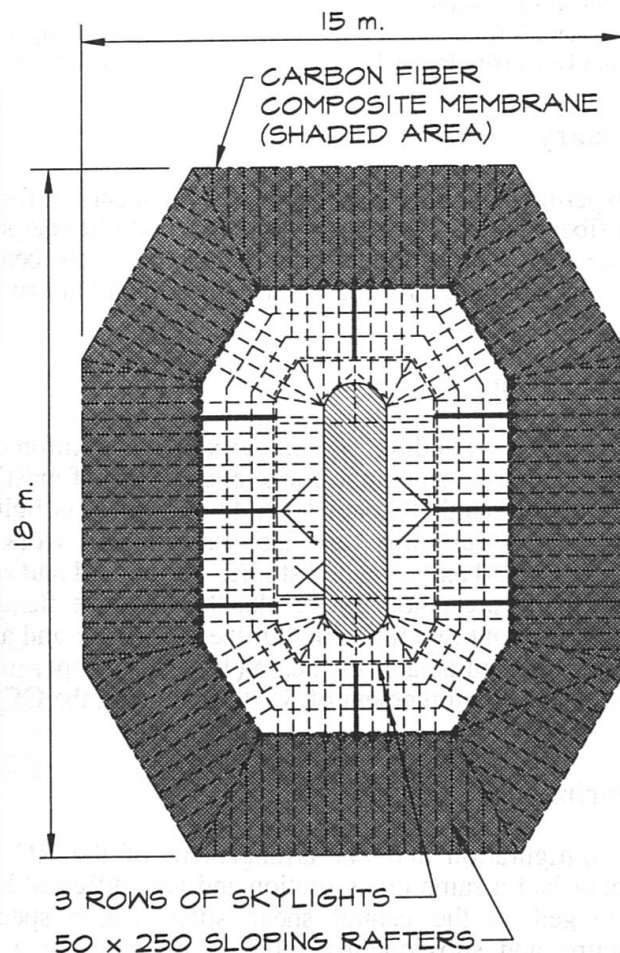
Fig. 3 Roof Framing Plan

Over the years small cracks had appeared in the plaster and wood ceiling of the Great Hall as well as the East Wing. The heavy snows during the winter of 1993-94 however caused a major displacement near the skylight rings in the Great Hall with cracks larger than 40 mm opening. In addition the exterior walls of the East Wing were noticed to be considerably out of plumb due to thrust at the top of the wood stud wall caused by load from the gable roof rafters. Clearly immediate action was necessary to stabilize and repair this structure, now used as a conference center for the Johnson Foundation.
