Zeitschrift: IABSE reports = Rapports AIPC = IVBH Berichte
Band: 77 (1998)

Artikel: Repairing and extending the lifespan of chimney under severe conditions
Autor: Ajdukiewicz, Andrzej B. / Hulimka, Jacek S. / Kliszciewicz, Alina T.
DOI: <https://doi.org/10.5169/seals-58201>

Repairing and Extending the Lifespan of Chimney under Severe Conditions

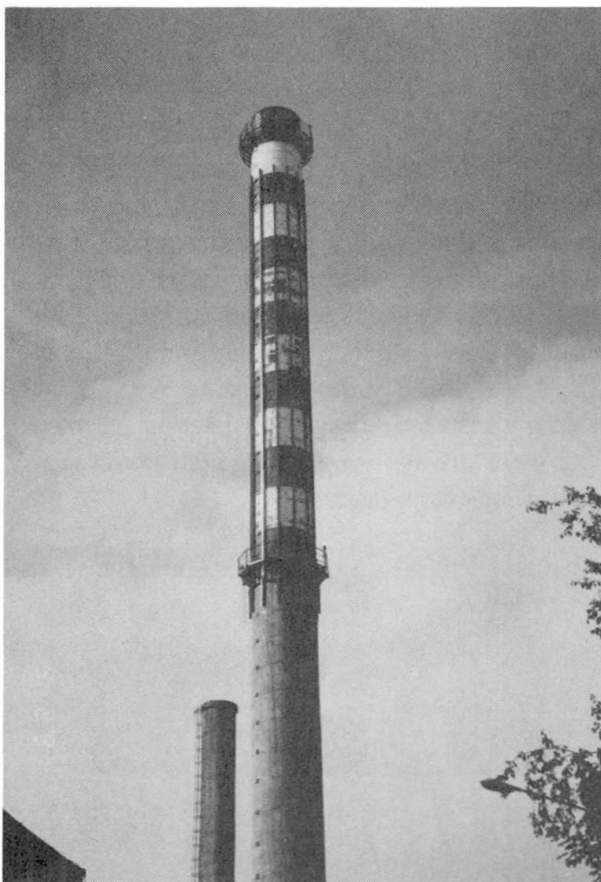
Five years later, much worse situation was observed during inspection. The vertical cracks in the lower part exceeded in some places 20 mm, and the length of cracks was 15 m or more. It was the result of thermal influences due to destruction of internal lining and insulation layer, as well as external action of severe atmospheric influences on cracked concrete surfaces.

Fig.1: Overall-view of strengthened chimney

The strengthening of the chimney up to the level of 35 m (in form of R.C. shell, 0.12 m thick), new lining at the bottom part, and extension of hoops up the top of chimney were introduced. Such a kind of strengthening was possible because the foundation slab was relatively strong and supported by 39 piles 12.0 m long. The additional mass of concrete in the lower part of structure was advantageous for the improvement of dynamic response of the structure.

Finally, the steel external structure consisting of 12 columns and system of crossing tie-bars was designed. The vertical columns were fixed in the reinforced concrete shell of the lower part, made from the strong concrete. It created the kind of braid which was matched exactly to the real shape of structure. To ensure the possibility of simple and safe work, without heavy cranes, the elements of columns were divided into segments about 4.0 m long. All the assembly connections were bolted. High strength friction grip bolts were used in joints. The base of the braid was provided in form of strong ring with twelve arms anchored in the lower concrete part. Before fixing the anchors the layer of epoxy mortar was used to adjust the rigid ring to the existing concrete set-off. It was the only "wet" work during assembly. After preparation of steel members and trial assembly in the workshop, all the strengthening structure was erected in about six weeks with few breaks according to weather conditions. Another four weeks took the finishing of the surfaces of concrete and final painting. In this particular case the method of strengthening was assessed as over two times cheaper than the new external concrete shell.
