**Zeitschrift:** IABSE reports = Rapports AIPC = IVBH Berichte  
**Band:** 77 (1998)

**Artikel:** Repairing and extending the lifespan of chimney under severe conditions  
**Autor:** Ajdukiewicz, Andrzej B. / Hulimka, Jacek S. / Kliszczewicz, Alina T.  
**DOI:** <https://doi.org/10.5169/seals-58201>

## Repairing and Extending the Lifespan of Chimney under Severe Conditions

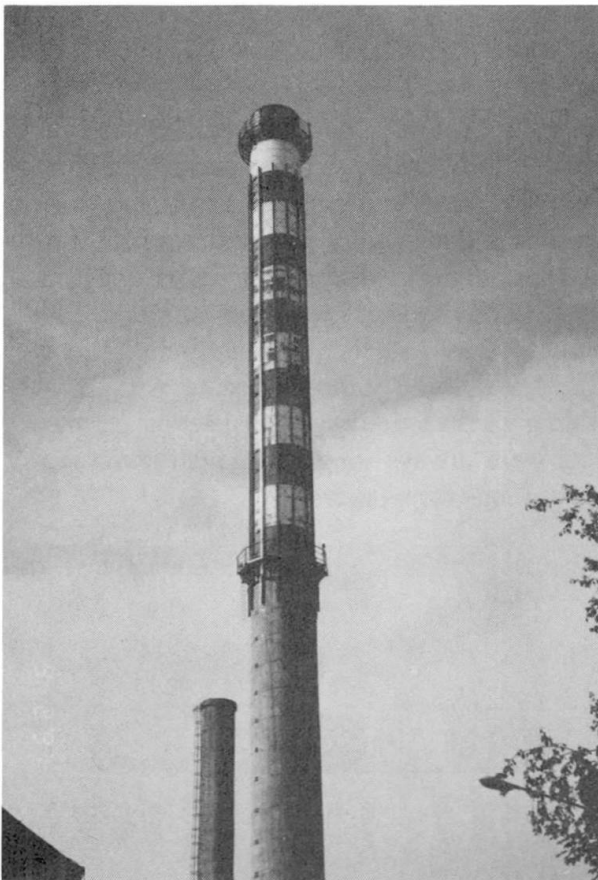
*Fig.1: Overall-view of strengthened chimney*

Finally, the steel external structure consisting of 12 columns and system of crossing tie-bars was designed. The vertical columns were fixed in the reinforced concrete shell of the lower part, made from the strong concrete. It created the kind of braid which was matched exactly to the real shape of structure. To ensure the possibility of simple and safe work, without heavy cranes, the elements of columns were divided into segments about 4.0 m long. All the assembly connections were bolted. High strength friction grip bolts were used in joints. The base of the braid was provided in form of strong ring with twelve arms anchored in the lower concrete part. Before fixing the anchors the layer of epoxy mortar was used to adjust the rigid ring to the existing concrete set-off. It was the only "wet" work during assembly. After preparation of steel members and trial assembly in the workshop, all the strengthening structure was erected in about six weeks with few breaks according to weather conditions. Another four weeks took the finishing of the surfaces of concrete and final painting. In this particular case the method of strengthening was assessed as over two times cheaper than the new external concrete shell.
