Zeitschrift: IABSE reports = Rapports AIPC = IVBH Berichte

Band: 77 (1998)

Repairing and Extending the Lifespan of Chimney under Severe Conditions

The main chimney of the one and only heat-generating plant located on the island at the seaside was erected with initial faults of concrete shell. During the period of over 20 years the structure has been examined several times. As a result of specific localisation the chimney was exposed to severe conditions of wind, moisture, and salt attack. First time, after several years of use the emergency repair works were necessary, and in the next few years other serious repairs have been applied. Finally, the problem of radical strengthening appeared in 1997, as the existing plant must work for the next five years, at least. Description of diagnosis, recent repair methods, and final strengthening are presented in the report.

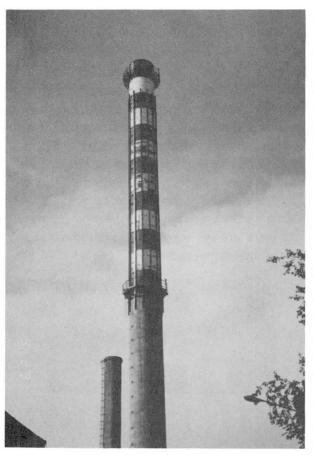
Fig. 1: Overall-view of strengthened chimney

Finally, the steel external structure consisting of 12 columns and system of crossing tie-bars was designed. The vertical columns were fixed in the reinforced concrete shell of the lower part, made from the strong concrete. It created the kind of braid which was matched exactly to the real shape of structure. To ensure the possibility of simple and safe work, without heavy cranes, the elements of columns were divided into segments about 4.0 m long. All the assembly connections were bolted. High strength friction grip bolts were used in joints. The base of the braid was provided in form of strong ring with twelve arms anchored in the lower concrete part. Before fixing the anchors the layer of epoxy mortar was used to adjust the rigid ring to the existing concrete set-off. It was the only "wet" work during assembly. After preparation of steel members and trial assembly in the workshop, all the strengthening structure was erected in about six weeks with few breaks according to weather conditions. Another four weeks took the finishing of the surfaces of concrete and final painting. In this particular case the method of strengthening was assessed as over two times cheaper than the new external concrete shell.
