## Repairing and Extending the Lifespan of Chimney under Severe Conditions

### Summary

The main chimney of the one and only heat-generating plant located on the island at the seaside was erected with initial faults of concrete shell. During the period of over 20 years the structure has been examined several times. As a result of specific localisation the chimney was exposed to severe conditions of wind, moisture, and salt attack. First time, after several years of use the emergency repair works were necessary, and in the next few years other serious repairs have been applied. Finally, the problem of radical strengthening appeared in 1997, as the existing plant must work for the next five years, at least. Description of diagnosis, recent repair methods, and final strengthening are presented in the report.

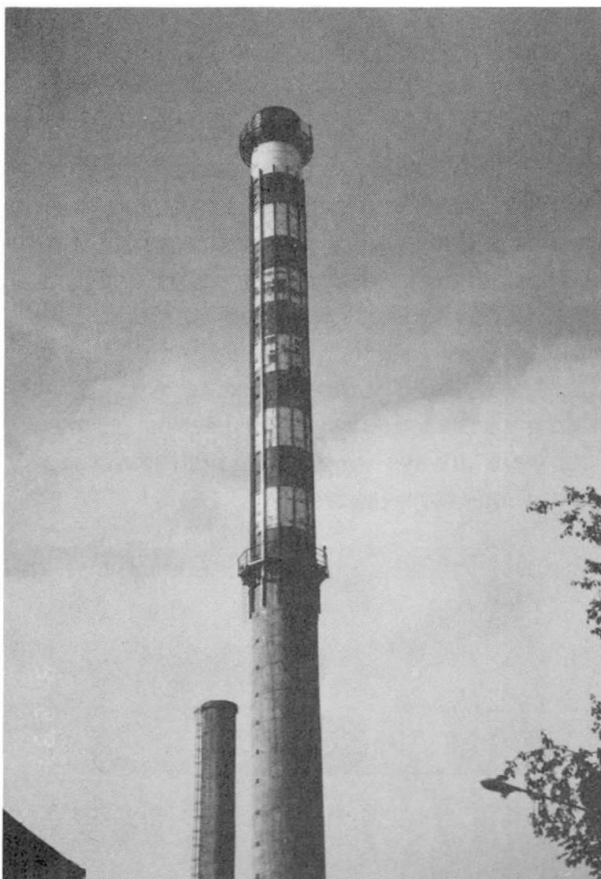
*Fig.1: Overall-view of strengthened chimney*

Finally, the steel external structure consisting of 12 columns and system of crossing tie-bars was designed. The vertical columns were fixed in the reinforced concrete shell of the lower part, made from the strong concrete. It created the kind of braid which was matched exactly to the real shape of structure. To ensure the possibility of simple and safe work, without heavy cranes, the elements of columns were divided into segments about 4.0 m long. All the assembly connections were bolted. High strength friction grip bolts were used in joints. The base of the braid was provided in form of strong ring with twelve arms anchored in the lower concrete part. Before fixing the anchors the layer of epoxy mortar was used to adjust the rigid ring to the existing concrete set-off. It was the only "wet" work during assembly. After preparation of steel members and trial assembly in the workshop, all the strengthening structure was erected in about six weeks with few breaks according to weather conditions. Another four weeks took the finishing of the surfaces of concrete and final painting. In this particular case the method of strengthening was assessed as over two times cheaper than the new external concrete shell.
