**Zeitschrift:** IABSE reports = Rapports AIPC = IVBH Berichte  
**Band:** 77 (1998)

**Artikel:** Repairing and extending the lifespan of chimney under severe conditions  
**Autor:** Ajdukiewicz, Andrzej B. / Hulimka, Jacek S. / Kliszczewicz, Alina T.  
**DOI:** <https://doi.org/10.5169/seals-58201>

## Repairing and Extending the Lifespan of Chimney under Severe Conditions

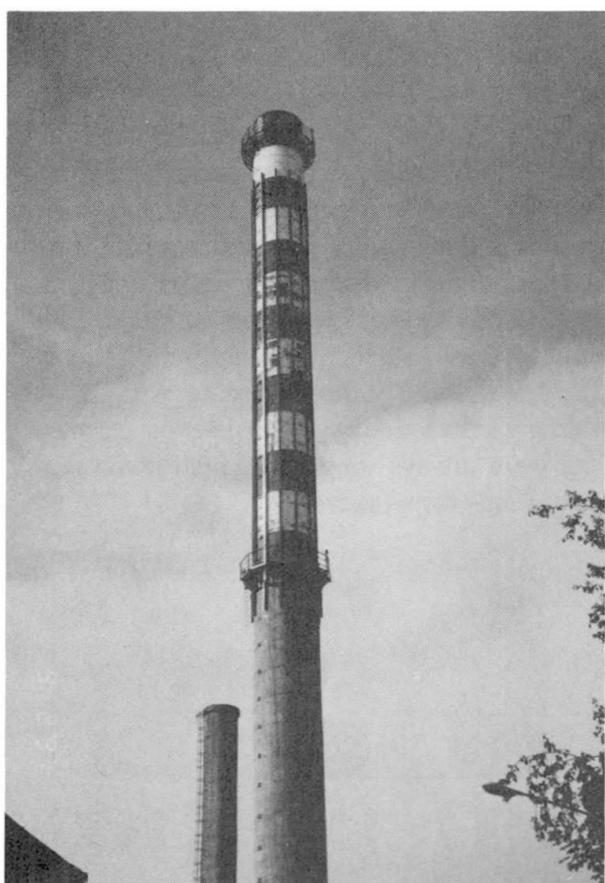
Fig.1: Overall-view of strengthened chimney

Finally, the steel external structure consisting of 12 columns and system of crossing tie-bars was designed. The vertical columns were fixed in the reinforced concrete shell of the lower part, made from the strong concrete. It created the kind of braid which was matched exactly to the real shape of structure. To ensure the possibility of simple and safe work, without heavy cranes, the elements of columns were divided into segments about 4.0 m long. All the assembly connections were bolted. High strength friction grip bolts were used in joints. The base of the braid was provided in form of strong ring with twelve arms anchored in the lower concrete part. Before fixing the anchors the layer of epoxy mortar was used to adjust the rigid ring to the existing concrete set-off. It was the only "wet" work during assembly. After preparation of steel members and trial assembly in the workshop, all the strengthening structure was erected in about six weeks with few breaks according to weather conditions. Another four weeks took the finishing of the surfaces of concrete and final painting. In this particular case the method of strengthening was assessed as over two times cheaper than the new external concrete shell.
