Structural Rehabilitation of an Industrial Steel Building

Nicolae TARANU, Petru STRATEANU and Dorina ISOPESCU

Department of Civil Engineering
Technical University of Iasi, Romania

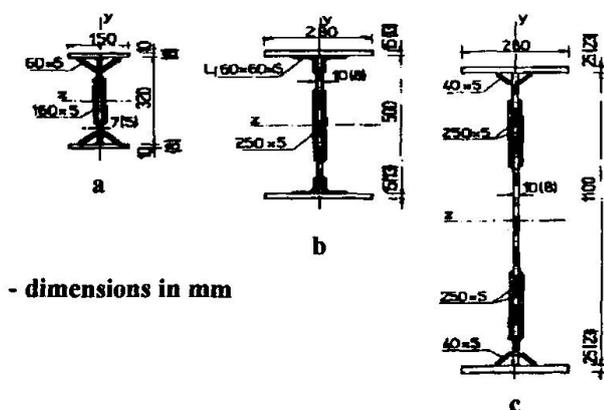
The structural steel members were exploited in a very aggressive environment (involving the use of sulfuric acid, chlorine hydride and hot water) between 1967 and 1980 and in a less corrosive atmosphere until 1992. All structural steel members have been severely affected by the corrosion process. Depending on the type of the element, the stress level and the local corrosive factors, extensive damages of the protective coatings, from 7% to 100% have been identified and corrosion penetrations up to 1.5 mm have been determined.

The verification procedures for ultimate limit states and for serviceability limit states have been applied according to the Romanian Standard STAS 10108/0, and to the Code P-100-92, for design of structures in seismic zones. To assess the corrosion effect on the loadbearing capacity of the structural steel members the initial geometric characteristics (A_0 =the noncorroded initial area and W_0 =the noncorroded initial section modulus) have been compared with the same properties after exploitation in corrosive atmosphere (A_c =the corroded cross-sectional area and W_c =the section modulus of the corroded structural members). The numerical values of the deterioration ratios have been calculated for all main structural members as follows: purlins, $W_c/W_0 = 0.785$; crane girders, $W_c/W_0 = 0.912$; columns, $W_c/W_0 = 0.789$ and $A_c/A_0 = 0.820$; frame girders, $W_c/W_0 = 0.823$ at midspan, and $W_c/W_0 = 0.901$ on columns.

Fig.2 Strengthening solutions of bent elements:
a-purlins; b&c-tapered frame girders

To restore the initial loadbearing capacity of the steel members, the strengthening solutions presented in figs.2 and 3, have been proposed. The strengthening pieces illustrated by dashed areas have been attached to the weakened members after careful cleaning of the corroded elements. The dimensions given in the parenthesis correspond to the corroded areas. After consolidation the ratios between the strengthened sections characteristics (W_1, A_1) and the initial ones (W_0, A_0) have been calculated: purlins, $W_1/W_0 = 1.03$; columns, $W_1/W_0 = 1.04$ and $A_1/A_0 = 1.02$; frame girders, $W_1/W_0 = 1.08$ at midspan, and $W_1/W_0 = 1.02$ on columns.

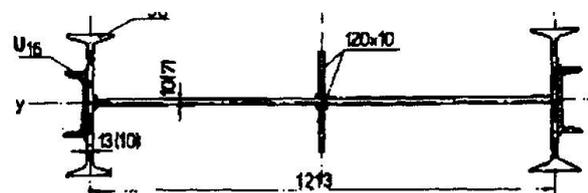
Fig.3 Cross-section strengthening of the main steel columns
