**Artikel:** Structural rehabilitation of an industrial steel building

## Structural Rehabilitation of an Industrial Steel Building

Nicolae TARANU, Petru STRATEANU and Dorina ISOPESCU

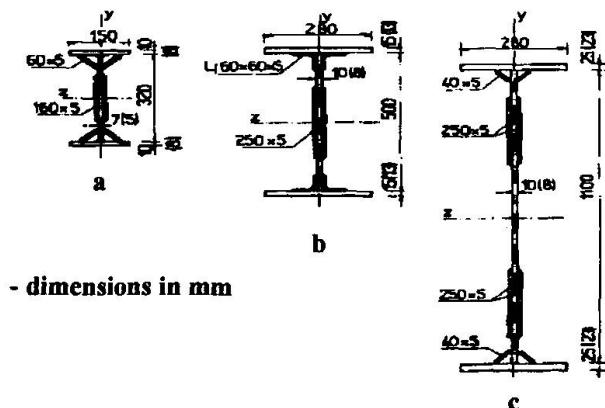
Fig.2 Strengthening solutions of bent elements:  
a-purlins; b&c-tapered frame girders

To restore the initial loadbearing capacity of the steel members, the strengthening solutions presented in figs.2 and 3, have been proposed. The strengthening pieces illustrated by dashed areas have been attached to the weakened members after careful cleaning of the corroded elements. The dimensions given in the parenthesis correspond to the corroded areas. After consolidation the ratios between the strengthened sections characteristics ( $W_1$ ,  $A_1$ ) and the initial ones ( $W_o$ ,  $A_o$ ) have been calculated: purlins,  $W_1/W_o = 1.03$ ; columns,  $W_1/W_o = 1.04$  and  $A_1/A_o = 1.02$ ; frame girders,  $W_1/W_o = 1.08$  at midspan, and  $W_1/W_o = 1.02$  on columns.

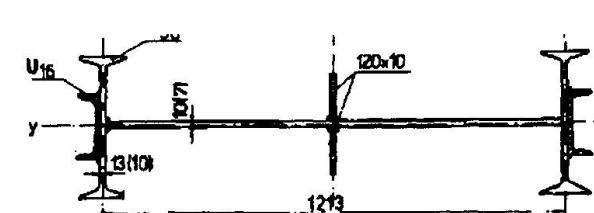
Fig.3 Cross-section strengthening of the main steel columns
