Repairs of coal processing buildings under continuing production

Zeitschrift: **IABSE reports = Rapports AIPC = IVBH Berichte**

Repairs of Coal Processing Buildings under Continuing Production

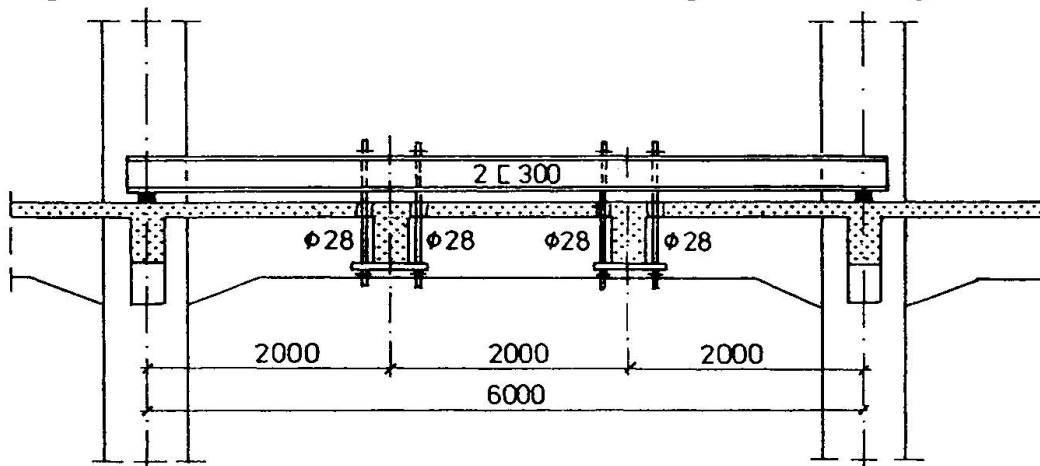
Authors suggested to unload the floor with stay ropes and horizontal steel beams. Fig.1 presents the idea of unloading. The feature of this solution was that instead of main beams the secondary beams or floor slab were underslung to traverse beam. This enabled the possibility of free access to parts being repaired. After unloading, the corroded weak concrete was removed without removing reinforcement steel and surface was cleaned using wet sand blasting.

Fig.1 The method of suspending of secondary beams and unloading the stay ropes

After boarding was made, the removed part of concrete was filled with fast-setting cement. When concrete achieved required strength the boarding and unloading steel construction were dismantled and openings made for strings of suspensions were sealed. The next stage included repairing of damaged floor and sealing of construction to eliminate the leakage. Due to necessity to continue the production and short break of wet processes (48 hours in week) application of standard solutions of watertight insulation could not be taken into account.
