**Artikel:** Repairs of coal processing buildings under continuing production  
**Autor:** Starosolski, Wlodzimierz / Pajak, Zbigniew / Kubica, Jan  
**DOI:** <https://doi.org/10.5169/seals-58263>

## Repairs of Coal Processing Buildings under Continuing Production

In the paper the technology of repair of corrosion damaged, reinforced concrete floor of level +6.00 m in coal processing building. Repair of the floor was carried out under continuing production; no breaks in production occurred. The range and degree of corrosion damage, the methods of reinforcement of load-bearing structure and sealing of tile floor were described.

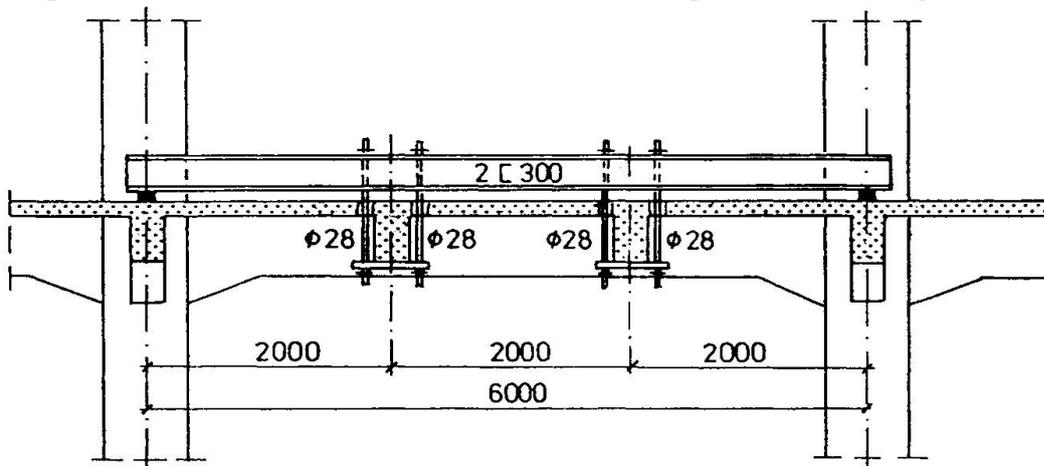
Fig.1 The method of suspending of secondary beams and unloading the stay ropes

Authors suggested to unload the floor with stay ropes and horizontal steel beams. Fig.1 presents the idea of unloading. The feature of this solution was that instead of main beams the secondary beams or floor slab were underslung to traverse beam. This enabled the possibility of free access to parts being repaired. After unloading, the corroded weak concrete was removed without removing reinforcement steel and surface was cleaned using wet sand blasting.

After boarding was made, the removed part of concrete was filled with fast-setting cement. When concrete achieved required strength the boarding and unloading steel construction were dismantled and openings made for strings of suspensions were sealed. The next stage included repairing of damaged floor and sealing of construction to eliminate the leakage. Due to necessity to continue the production and short break of wet processes (48 hours in week) application of standard solutions of watertight insulation could not be taken into account.
