Artikel: Repairs of coal processing buildings under continuing production
Autor: Starosolski, Wlodzimierz / Pajak, Zbigniew / Kubica, Jan
DOI: <https://doi.org/10.5169/seals-58263>

Repairs of Coal Processing Buildings under Continuing Production

In the paper the technology of repair of corrosion damaged, reinforced concrete floor of level +6.00 m in coal processing building. Repair of the floor was carried out under continuing production; no breaks in production occurred. The range and degree of corrosion damage, the methods of reinforcement of load-bearing structure and sealing of tile floor were described.

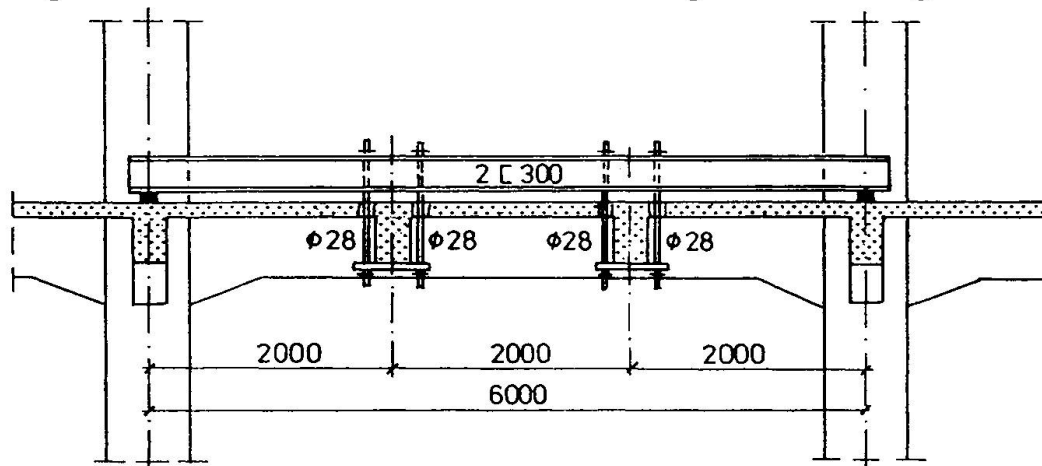
Authors suggested to unload the floor with stay ropes and horizontal steel beams. Fig.1 presents the idea of unloading. The feature of this solution was that instead of main beams the secondary beams or floor slab were underslung to traverse beam. This enabled the possibility of free access to parts being repaired. After unloading, the corroded weak concrete was removed without removing reinforcement steel and surface was cleaned using wet sand blasting.

Fig.1 The method of suspending of secondary beams and unloading the stay ropes

After boarding was made, the removed part of concrete was filled with fast-setting cement. When concrete achieved required strength the boarding and unloading steel construction were dismantled and openings made for strings of suspensions were sealed. The next stage included repairing of damaged floor and sealing of construction to eliminate the leakage. Due to necessity to continue the production and short break of wet processes (48 hours in week) application of standard solutions of watertight insulation could not be taken into account.
