Artikel: Repairs of coal processing buildings under continuing production
Autor: Starosolski, Włodzimierz / Pajak, Zbigniew / Kubica, Jan
DOI: <https://doi.org/10.5169/seals-58263>

Repairs of Coal Processing Buildings under Continuing Production

In the paper the technology of repair of corrosion damaged, reinforced concrete floor of level +6.00 m in coal processing building. Repair of the floor was carried out under continuing production; no breaks in production occurred. The range and degree of corrosion damage, the methods of reinforcement of load-bearing structure and sealing of tile floor were described.

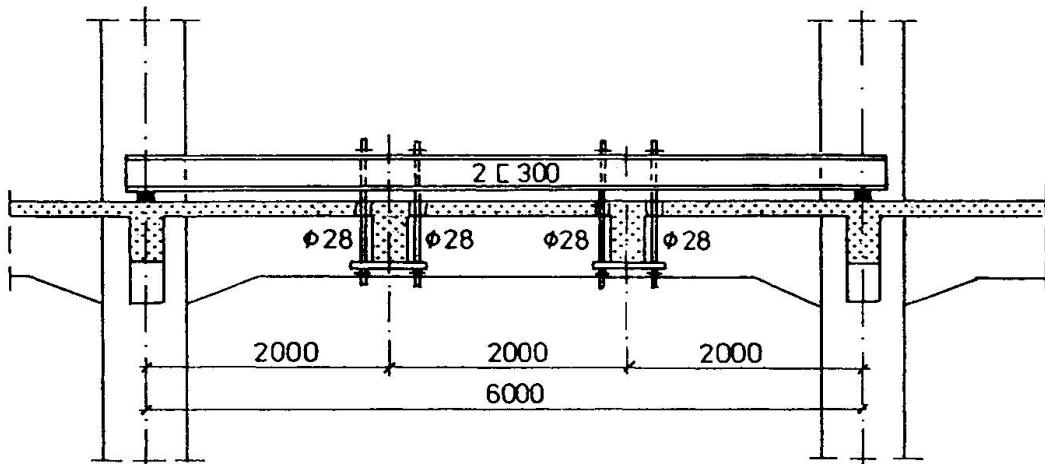
Authors suggested to unload the floor with stay ropes and horizontal steel beams. Fig.1 presents the idea of unloading. The feature of this solution was that instead of main beams the secondary beams or floor slab were underslung to traverse beam. This enabled the possibility of free access to parts being repaired. After unloading, the corroded weak concrete was removed without removing reinforcement steel and surface was cleaned using wet sand blasting.

Fig.1 The method of suspending of secondary beams and unloading the stay ropes

After boarding was made, the removed part of concrete was filled with fast-setting cement. When concrete achieved required strength the boarding and unloading steel construction were dismantled and openings made for strings of suspensions were sealed. The next stage included repairing of damaged floor and sealing of construction to eliminate the leakage. Due to necessity to continue the production and short break of wet processes (48 hours in week) application of standard solutions of watertight insulation could not be taken into account.
