War and Earthquake Damage in Dubrovnik: Preventive and Remedial Measures

Giorgio CROCI

Alessandro BONCI

Summary

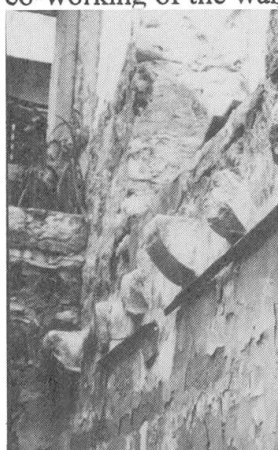
Fig. 1

The main walls of the buildings of Dubrovnik and Ston are usually made of sack masonry, with the timber floors and roofs supported by stone cantilevers inserted in the walls (Fig. 1); this structural solution, because of the lack of connection to the walls, does not help develop the co-operation among the walls themselves, which would allow them to resist the horizontal forces more effectively.

In Dubrovnik the signs of shell impacts are still visible on the fronts of the houses: direct hits struck about 70 % of the 824 buildings of the inner city. Further damage was produced by the fires following to the explosions (Fig. 1): the roofs of 5 buildings were affected by fire and in 9 buildings the roofs and floors were completely destroyed.

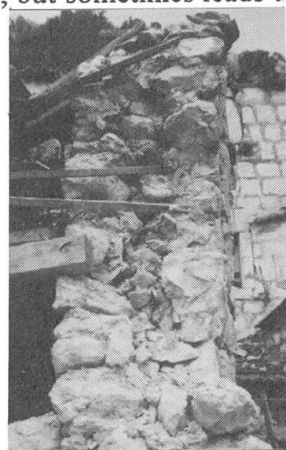
Fig. 2

Intrinsic weakness of the sack masonry (weak bond, decay of the mortar): which explains the detachment of blocks in the external skin and the collapse of entire sections of wall. (Fig. 2).

The materials: the intrinsic weakness of the sack masonry construction requires, both as a preventive and a remedial measure, the injection of the walls, or, in the case of very loose material, which was very common, the use of grout percolated in from the top; cracks, depending on their width, could be filled with grout or repaired with the technique of "unpicking and sewing". (toothing out and bonding)

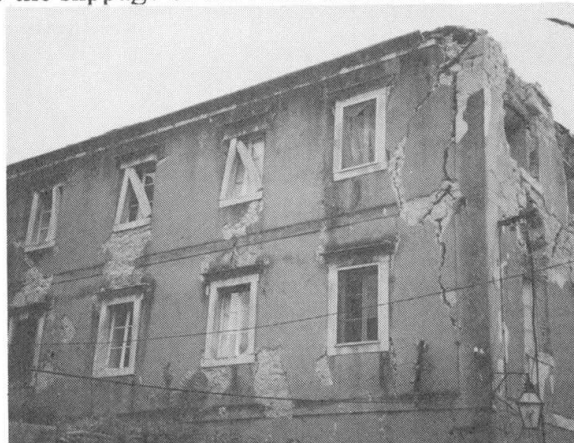
Fig. 3

Structural weakness of the walls: in the façades which were almost parallel to the seismic action (left façade in Fig. 3) cracks under the windows, due to the insufficient stiffness of the floor bands (reduced thickness of the zone under the windows, the lack of horizontal ties), were frequently noted; the façades almost perpendicular to the seismic action were often detached due to the inadequate connections to the lateral walls (left façade in Fig. 3).
