Artikel: War and earthquake damage in Dubrovnik: preventive and remedial measures
Autor: Croci, Giorgio / Bonci, Alessandro
DOI: <https://doi.org/10.5169/seals-58279>

War and Earthquake Damage in Dubrovnik: Preventive and Remedial Measures

In the historic towns of Dubrovnik and Ston, building dating back up to the 14th century, suffered major damage during the recent war and were then subsequently struck by a strong earthquake in September 1996; Because of the exceptional value of the sites, UNESCO organised several missions which involved Prof. G. Croci. This paper summarises the studies carried out after a detailed survey which sought to examine the structural behaviour of the buildings and the relationship between local construction techniques and the actual damage. With this as a basis, various guidelines for preventive and remedial measures have been proposed with specific reference to the local building methods and typologies.

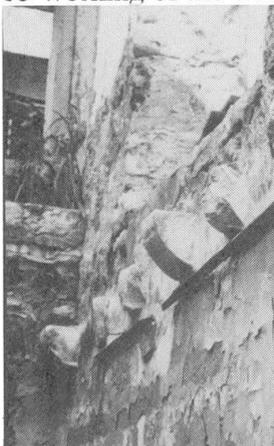
Fig. 1

The main walls of the buildings of Dubrovnik and Ston are usually made of sack masonry, with the timber floors and roofs supported by stone cantilevers inserted in the walls (Fig. 1); this structural solution, because of the lack of connection to the walls, does not help develop the co-operation among the walls themselves, which would allow them to resist the horizontal forces more effectively.

In Dubrovnik the signs of shell impacts are still visible on the fronts of the houses: direct hits struck about 70 % of the 824 buildings of the inner city. Further damage was produced by the fires following to the explosions (Fig. 1): the roofs of 5 buildings were affected by fire and in 9 buildings the roofs and floors were completely destroyed. The damage caused by the earthquake of September 5th 1996 (peak ground acceleration of 0.6 g, epicentre 10 km SE from Ston) can be traced, however, to other causes. These are:

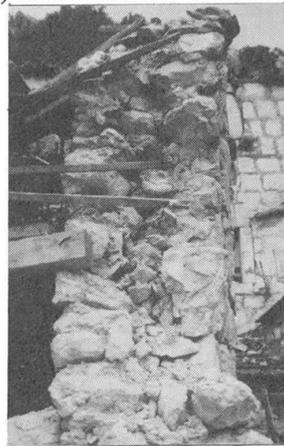
Fig. 2

Intrinsic weakness of the sack masonry (weak bond, decay of the mortar): which explains the detachment of blocks in the external skin and the collapse of entire sections of wall. (Fig. 2).

The materials: the intrinsic weakness of the sack masonry construction requires, both as a preventive and a remedial measure, the injection of the walls, or, in the case of very loose material, which was very common, the use of grout percolated in from the top; cracks, depending on their width, could be filled with grout or repaired with the technique of "unpicking and sewing". (toothing out and bonding)

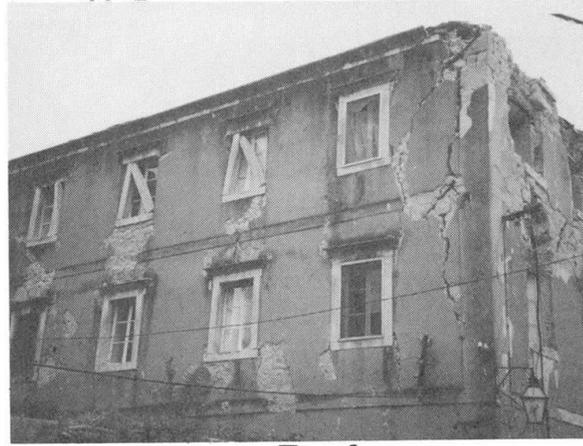
Fig. 3

Structural weakness of the walls: in the façades which were almost parallel to the seismic action (left façade in Fig. 3) cracks under the windows, due to the insufficient stiffness of the floor bands (reduced thickness of the zone under the windows, the lack of horizontal ties), were frequently noted; the façades almost perpendicular to the seismic action were often detached due to the inadequate connections to the lateral walls (left façade in Fig. 3).
