Zeitschrift: IABSE reports = Rapports AIPC = IVBH Berichte
Band: 77 (1998)

War and Earthquake Damage in Dubrovnik: Preventive and Remedial Measures

In the historic towns of Dubrovnik and Ston, building dating back up to the 14th century, suffered major damage during the recent war and were then subsequently struck by a strong earthquake in September 1996; Because of the exceptional value of the sites, UNESCO organised several missions which involved Prof. G. Croci. This paper summarises the studies carried out after a detailed survey which sought to examine the structural behaviour of the buildings and the relationship between local construction techniques and the actual damage. With this as a basis, various guidelines for preventive and remedial measures have been proposed with specific reference to the local building methods and typologies.

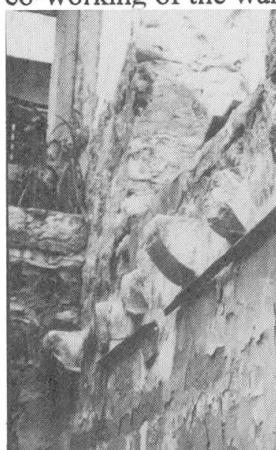
Fig. 1

The main walls of the buildings of Dubrovnik and Ston are usually made of sack masonry, with the timber floors and roofs supported by stone cantilevers inserted in the walls (Fig. 1); this structural solution, because of the lack of connection to the walls, does not help develop the co-operation among the walls themselves, which would allow them to resist the horizontal forces more effectively.

In Dubrovnik the signs of shell impacts are still visible on the fronts of the houses: direct hits struck about 70 % of the 824 buildings of the inner city. Further damage was produced by the fires following to the explosions (Fig. 1): the roofs of 5 buildings were affected by fire and in 9 buildings the roofs and floors were completely destroyed.

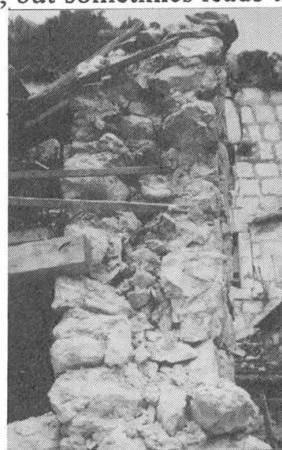
Fig. 2

Intrinsic weakness of the sack masonry (weak bond, decay of the mortar): which explains the detachment of blocks in the external skin and the collapse of entire sections of wall. (Fig. 2).

The materials: the intrinsic weakness of the sack masonry construction requires, both as a preventive and a remedial measure, the injection of the walls, or, in the case of very loose material, which was very common, the use of grout percolated in from the top; cracks, depending on their width, could be filled with grout or repaired with the technique of "unpicking and sewing". (toothing out and bonding)

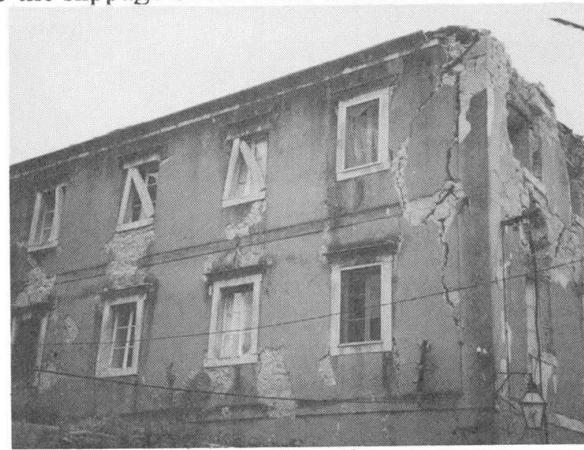
Fig. 3

Structural weakness of the walls: in the façades which were almost parallel to the seismic action (left façade in Fig. 3) cracks under the windows, due to the insufficient stiffness of the floor bands (reduced thickness of the zone under the windows, the lack of horizontal ties), were frequently noted; the façades almost perpendicular to the seismic action were often detached due to the inadequate connections to the lateral walls (left façade in Fig. 3).
