Artikel: Repair and rehabilitation: three case studies in Bucharest

Repair and Rehabilitation - Three Case Studies in Bucharest

Strengthening solutions of three buildings in Bucharest are presented. Two buildings are part of the Technical University of Civil Engineering and the third is a warehouse for high value equipment. They have been affected by three major earthquakes: in 1977, 1986 and 1990. The strengthening solutions were adopted after an accurate analysis on seismic structural performances. The three buildings have different static and spatial shape. The structural models are spatial, with uni- and bidimensional finite elements. The structural analysis was performed in elastic range with a common programme.

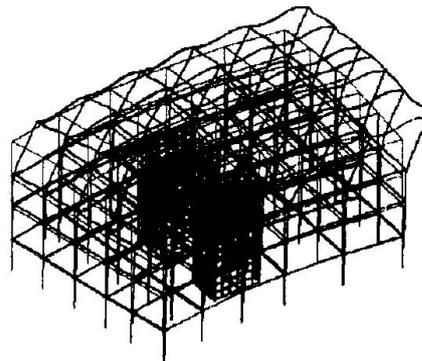
The magnitude of the interstory drifts are of ca. 3.5 times larger than those required by the Code. The most stressed columns are: for Section A those in the corners of the buildings; for section B those of the outside bay. The structure has no redundant reserves and requires strengthening

Proposed solution for the rehabilitation is the same for both sections aiming to reduce the interstory deflection to that accepted by the Code. The solution consist of newly-added structural reinforced concrete walls interacting with existing frames. The displacements and the moments were greatly reduced in the existing structure. The maximum interstory drift is 0.0073 and is almost as with that required by the Code (0.0070). The sum of maximum displacements of the two sections is less than the size of the expansion/contraction joint. Fig. 2 presents the deformed shape of the strengthened Section B.
