Artikel: Repair and rehabilitation: three case studies in Bucharest
Autor: Bucur, Carmen / Chivu, Neculai / Ardelea, Aurel
DOI: <https://doi.org/10.5169/seals-58286>

Repair and Rehabilitation - Three Case Studies in Bucharest

Strengthening solutions of three buildings in Bucharest are presented. Two buildings are part of the Technical University of Civil Engineering and the third is a warehouse for high value equipment. They have been affected by three major earthquakes: in 1977, 1986 and 1990. The strengthening solutions were adopted after an accurate analysis on seismic structural performances. The three buildings have different static and spatial shape. The structural models are spatial, with uni- and bidimensional finite elements. The structural analysis was performed in elastic range with a common programme.

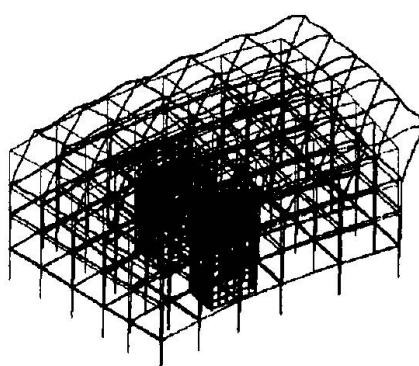
The magnitude of the interstory drifts are of ca. 3.5 times larger than those required by the Code. The most stressed columns are: for Section A those in the corners of the buildings; for section B those of the outside bay. The structure has no redundant reserves and requires strengthening.

Proposed solution for the rehabilitation is the same for both sections aiming to reduce the interstory deflection to that accepted by the Code. The solution consists of newly-added structural reinforced concrete walls interacting with existing frames. The displacements and the moments were greatly reduced in the existing structure. The maximum interstory drift is 0.0073 and is almost as with that required by the Code (0.0070). The sum of maximum displacements of the two sections is less than the size of the expansion/contraction joint. Fig. 2 presents the deformed shape of the strengthened Section B.
