**Artikel:** Repair and rehabilitation: three case studies in Bucharest  
**Autor:** Bucur, Carmen / Chivu, Neculai / Ardelea, Aurel  
**DOI:** <https://doi.org/10.5169/seals-58286>

## Repair and Rehabilitation - Three Case Studies in Bucharest

Strengthening solutions of three buildings in Bucharest are presented. Two buildings are part of the Technical University of Civil Engineering and the third is a warehouse for high value equipment. They have been affected by three major earthquakes: in 1977, 1986 and 1990. The strengthening solutions were adopted after an accurate analysis on seismic structural performances. The three buildings have different static and spatial shape. The structural models are spatial, with uni- and bidimensional finite elements. The structural analysis was performed in elastic range with a common programme.

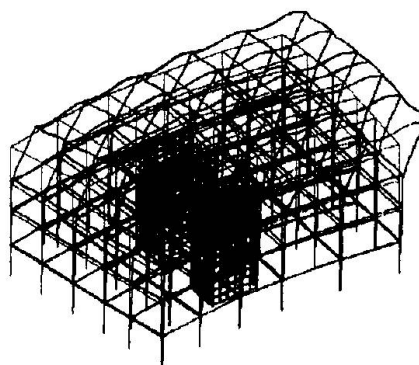
The magnitude of the interstory drifts are of ca. 3.5 times larger than those required by the Code. The most stressed columns are: for Section A those in the corners of the buildings; for section B those of the outside bay. The structure has no redundant reserves and requires strengthening

*Proposed solution* for the rehabilitation is the same for both sections aiming to reduce the interstory deflection to that accepted by the Code. The solution consist of newly-added structural reinforced concrete walls interacting with existing frames. The displacements and the moments were greatly reduced in the existing structure. The maximum interstory drift is 0.0073 and is almost as with that required by the Code (0.0070). The sum of maximum displacements of the two sections is less than the size of the expansion/contraction joint. Fig. 2 presents the deformed shape of the strengthened Section B.
