**Zeitschrift:** IABSE reports = Rapports AIPC = IVBH Berichte  
**Band:** 78 (1998)  
**Rubrik:** Session 6: Maintenance and repair

### **Maintenance and repair**

## Session 6 - MAINTENANCE AND REPAIR

### Keynote address

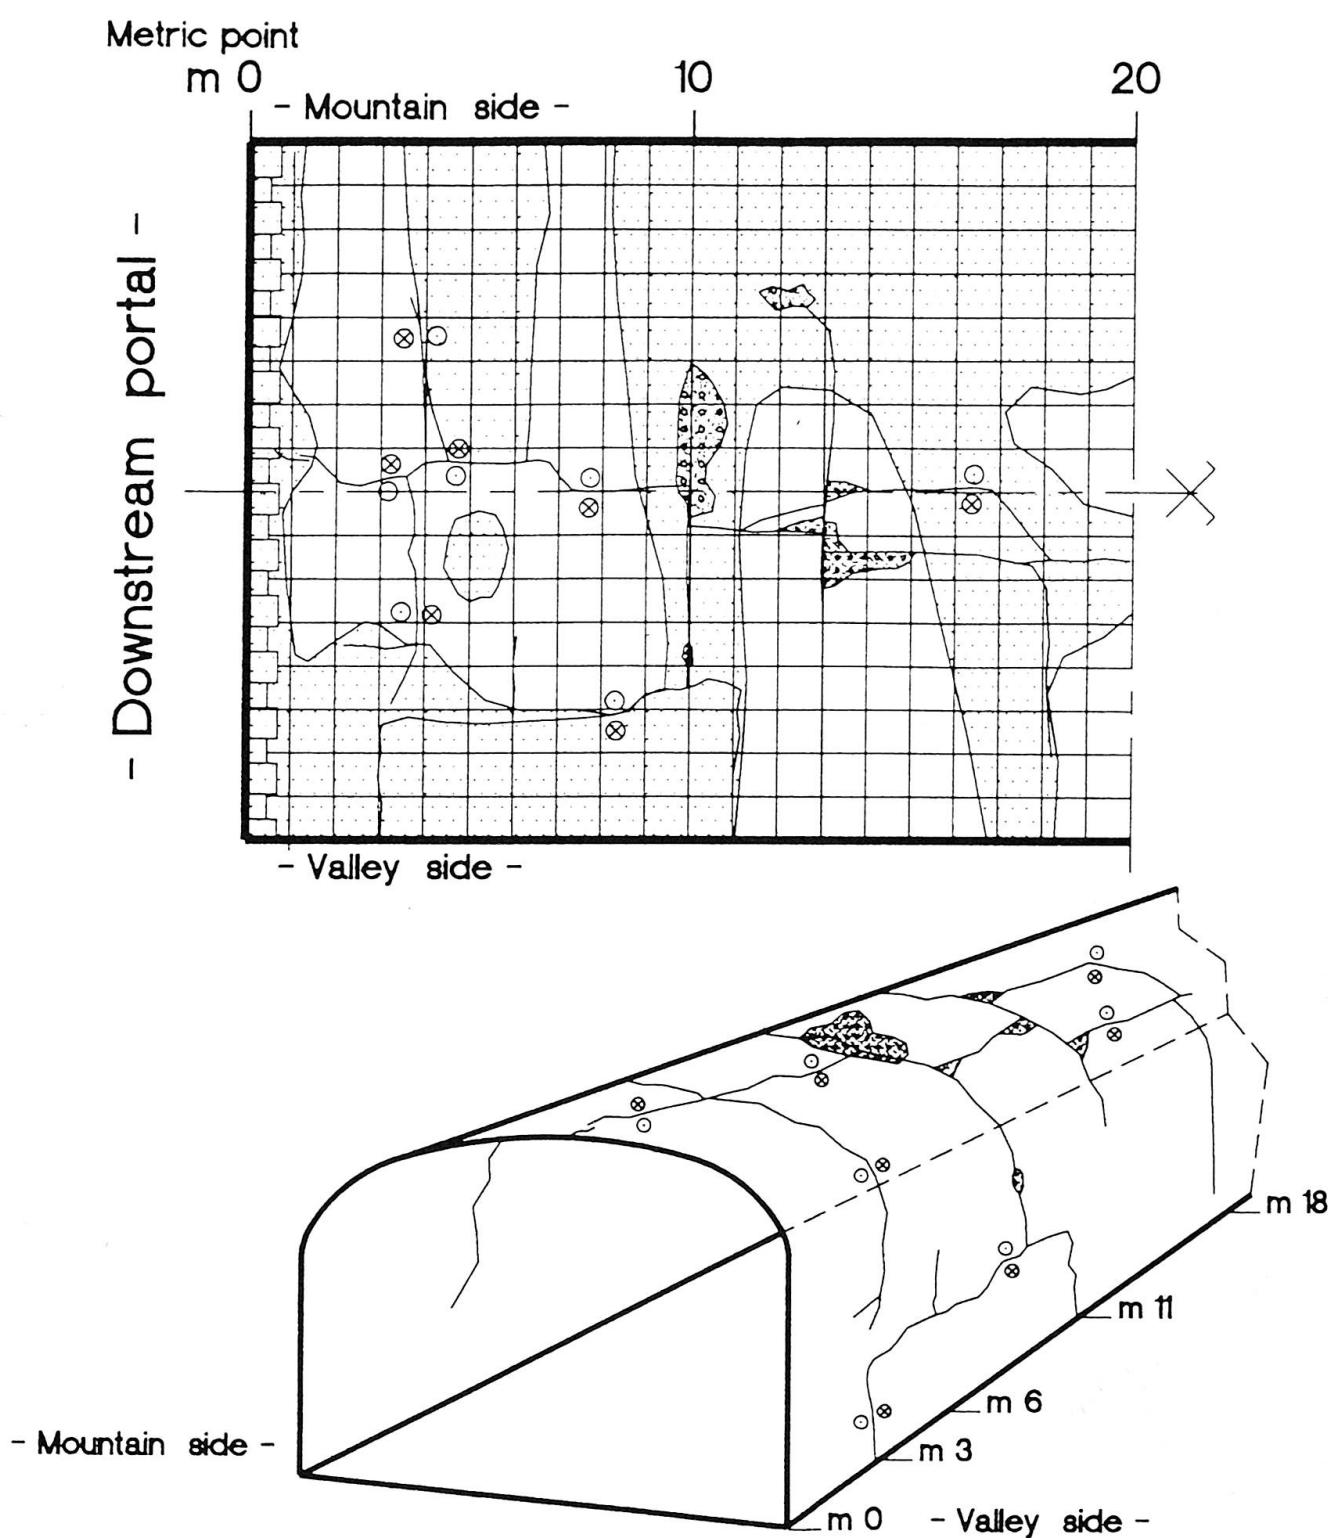
Fig. 1 Representation of cracking affecting a concrete tunnel portal

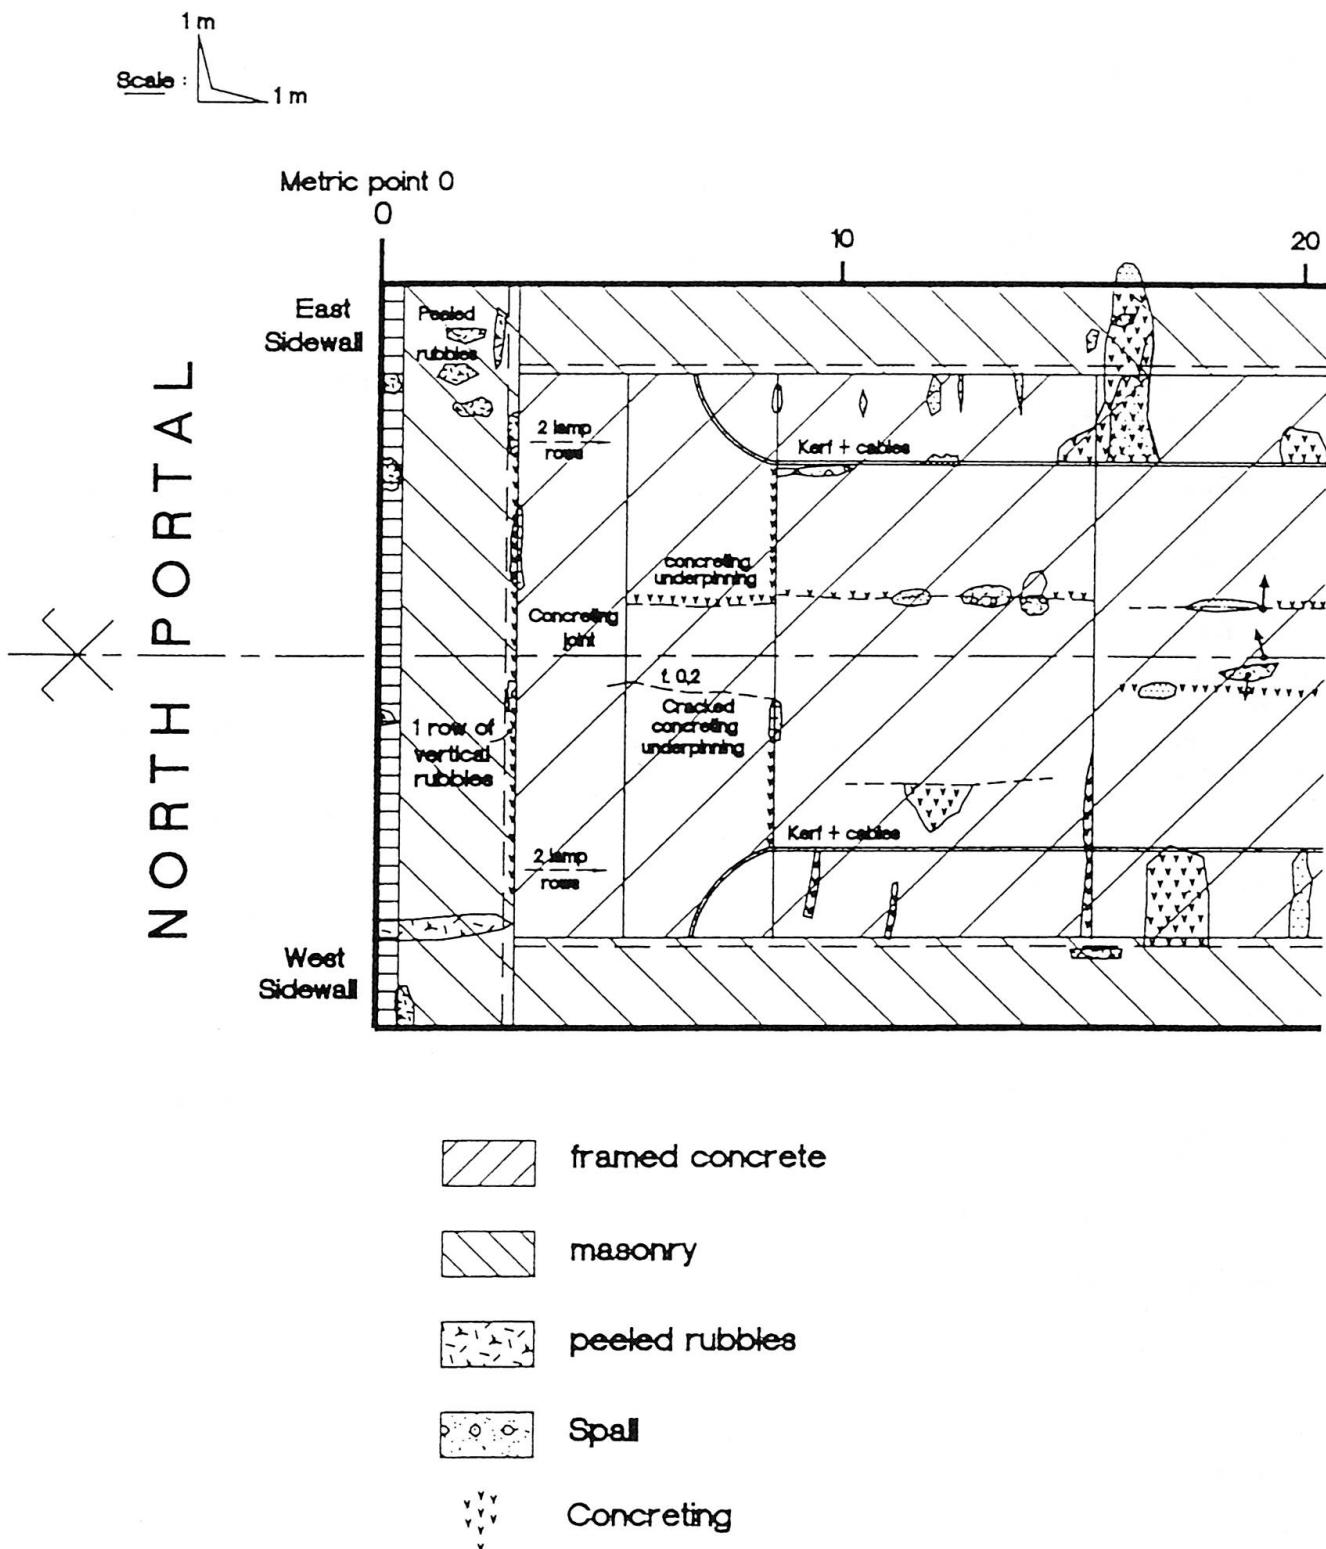
Fig. 2 Excerpt from the intrados survey of SISTERON tunnel, France

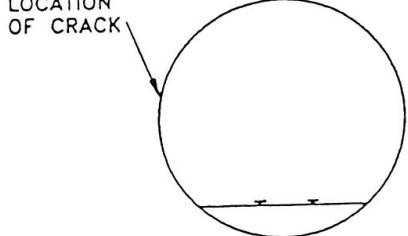
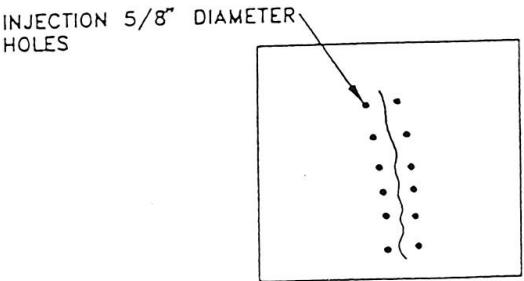
Fig. 4 Example of measures against water leakage in tunnel

Classification		Cross-section of tunnel (Add geological information if available) GLACIAL TILL	
Classification	WATER STOPPAGE		
Method	CRACK INJECTION		
Outline of tunnel			
Type	SUBWAY		
Tunnelling method	TBM		
Length of service	10 YEARS		
Lining materials	(Primary) STEEL RIBS/ WOODEN LAGGING (Secondary) CAST-IN-PLACE CONCRETE		
Degree of leakage	DRIP		
Location of leakage	SIDEWALLS		
Presence of frost	NO		
Special conditions in the choice of method

Evaluation of method (workability, cost, etc.) METHOD IS TIME CONSUMING AND EXPENSIVE			
Post-repair Inspection Observations CRACKS HAVE MINOR LEAKS AFTER 10 YEARS

- LIMITATION OF CLEARANCE - SMALL TOOLS ONLY NEEDED			
Description of trouble caused by water leakage PREVENTION OF DETERIORATION OF ELECTRICAL EQUIPMENT			
Materials used CHEMICAL GROUT			
Outline of method INJECTION HOLES ARE DRILLED AT 30° ANGLE TO THE CRACK. HOLES ARE DRILLED ON BOTH SIDES OF THE CRACK AND THEN ARE INJECTED WITH A CHEMICAL GROUT THAT EXPANDS AND SEALS CRACK WHEN IT COMES INTO CONTACT WITH WATER.			
Schema of method

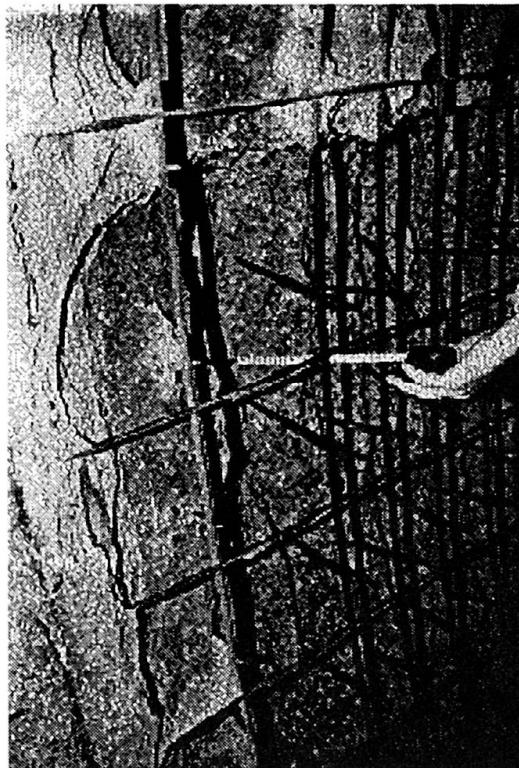
Fig. 7 Channel tunnel, after the fire of 18 November 1996.  
After curing of the concrete surface spalling, the reinforcement is maintained.

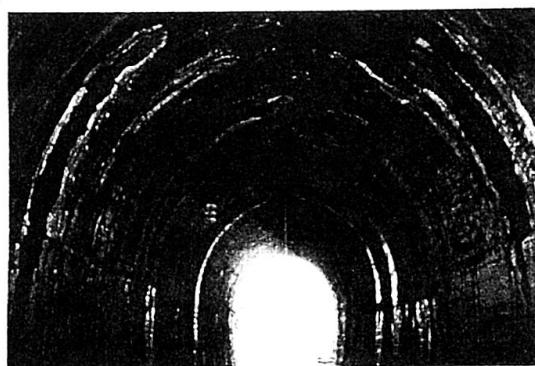
**Figure 3. The surface before repair**

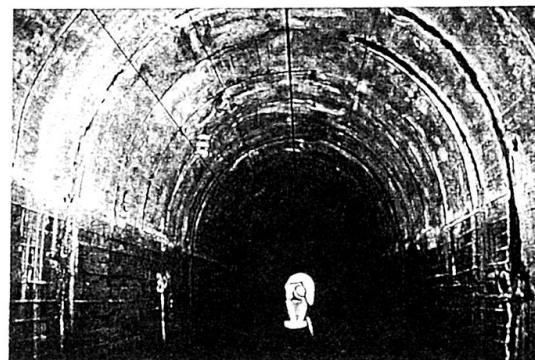
**Figure 4. The surface after repair**

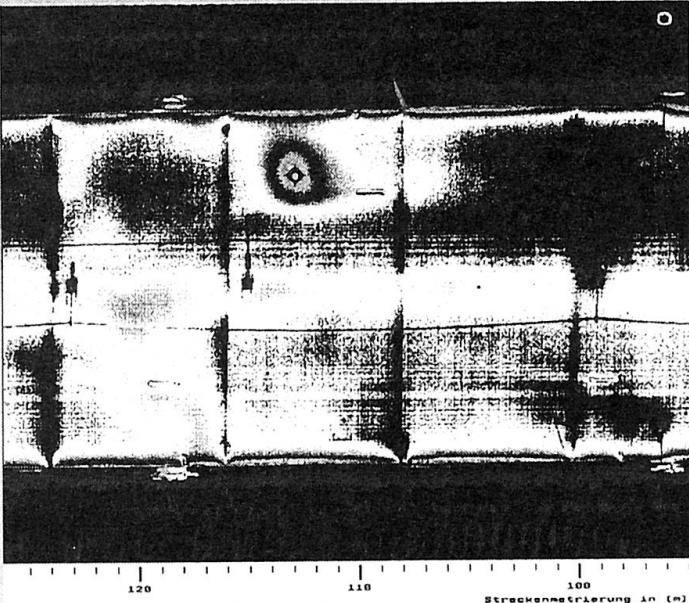
Thermography shows a striking thermal anomaly on the left side wall. Water has intruded into the concrete of the lining.

Drilling: at the depth of 70 cm a strong jet of water exits from the drillhole.

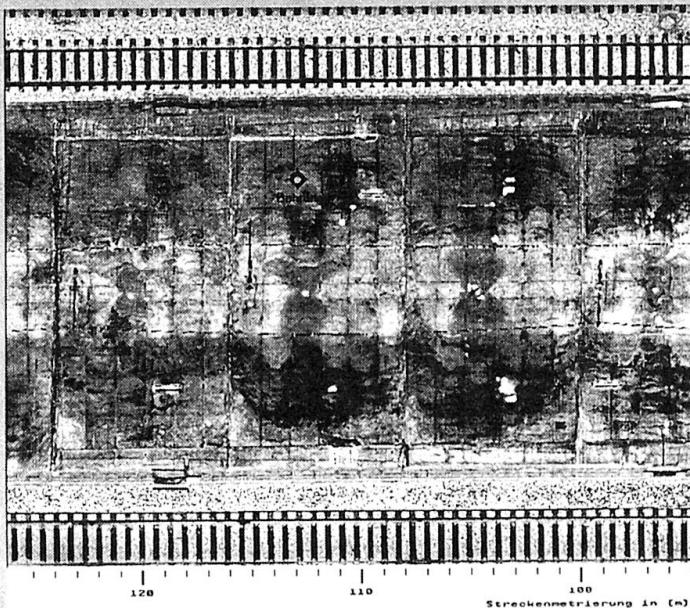
The visual image shows no traces of water on the lining surface.

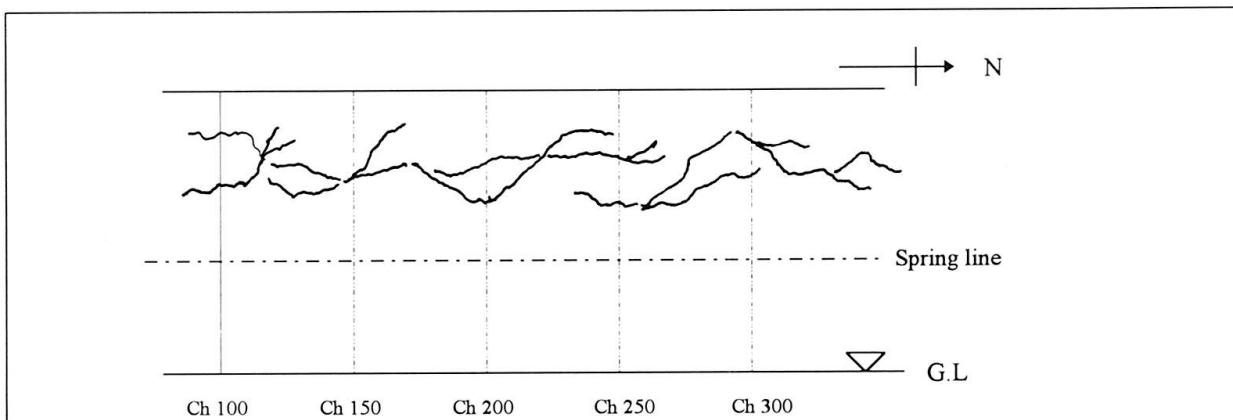
The appearance of cracks in the tunnel lining of both the tunnels was generally of concern to most motorists using the tunnels. However, from the detailed investigation carried out during the assessment programme it was noted that the pattern of cracks was typical of map cracks as shown in Fig. 3. The dry crack pattern was typical for both tunnels and core samples obtained from cracked concrete generally gave details of depth of cracks. Fig. 4 shows typical crack depths as seen in six 50mm core samples obtained from the tunnel linings. A detailed crack mapping exercise was carried out to locate the extent and severity of the cracks according to established chainages along the total length of the tunnels. The cracks were further divided into two main types; dry and wet cracks. Almost seventy percent of the 8500 metres length of cracks measured for both the tunnels fell under the dry crack category. Most of these cracks were contaminated with dirt particles. The remaining cracks were typically wet owing to their depth and location which was close to faults in rocks. The thickness of the tunnel lining varied between almost 850mm at the base

**Fig.3 Typical map cracks observed in linings of north bound tunnel**

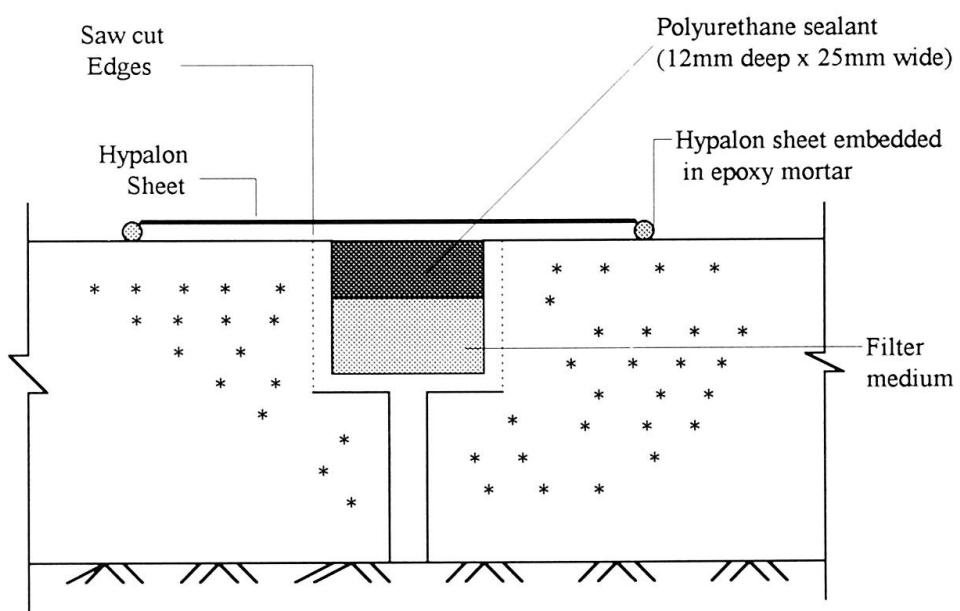
**Fig.5 Section through expansion joint**

The main defect observed in faulty expansion joints was loose and hardened sealant which had debonded from the existing groove. Some of the joints were affected by seepage of water from behind the tunnel lining. The defective sealant was completely removed to ensure the affected expansion joint was free from loose and debonded material. A chase measuring 25mm wide and 50mm deep was cut along the length of the faulty expansion joint using a diamond saw. The joint was cleaned with a high pressure water jet to prepare the surface for remedial treatment. A filter medium was then installed along the length of the expansion joint to convey trapped water into an adjoining uPVC pipe which was connected to the existing drain. The surface of the expansion joint was then sealed with a 12mm thick polyurethane sealant to prevent seepage of water from the filter membrane. As a protection to the exposed sealant, a hypalon sheet was installed along the length of the joint as shown in Fig. 5.

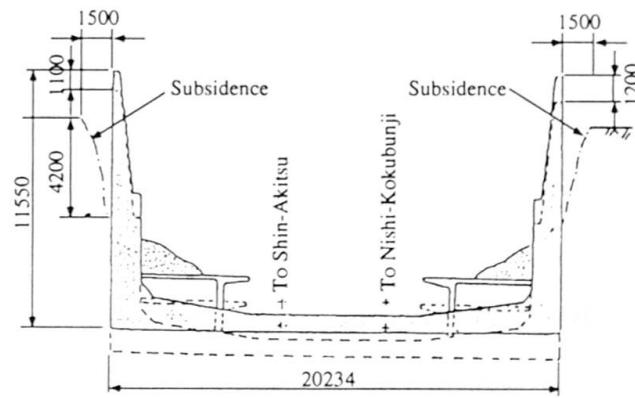
*Fig. 1 Conditions of Damage*

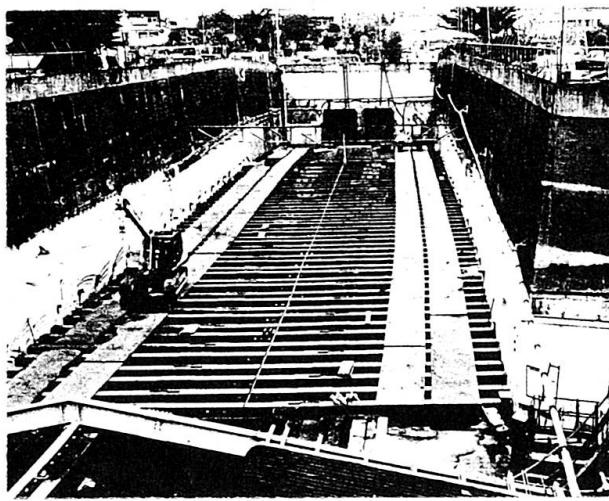
Photo3 Temporary supports

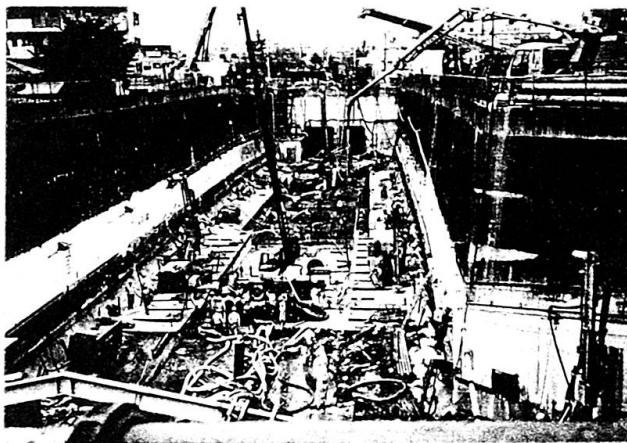
Photo 4 Restoration Work

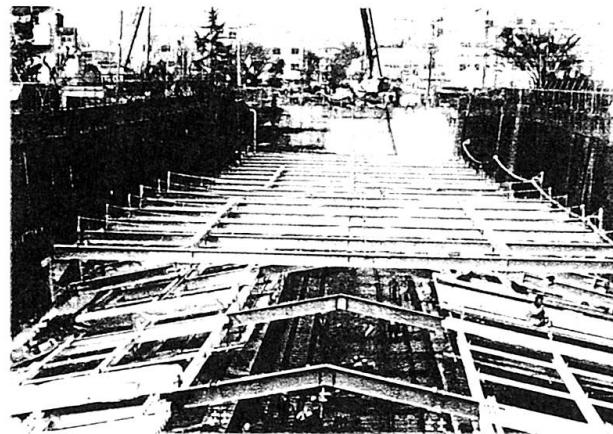
Photo 5 Installation of Struts
