Zeitschrift: IABSE reports = Rapports AIPC = IVBH Berichte
Band: 78 (1998)

SESSION 6

Maintenance and repair

Session 6 - MAINTENANCE AND REPAIR

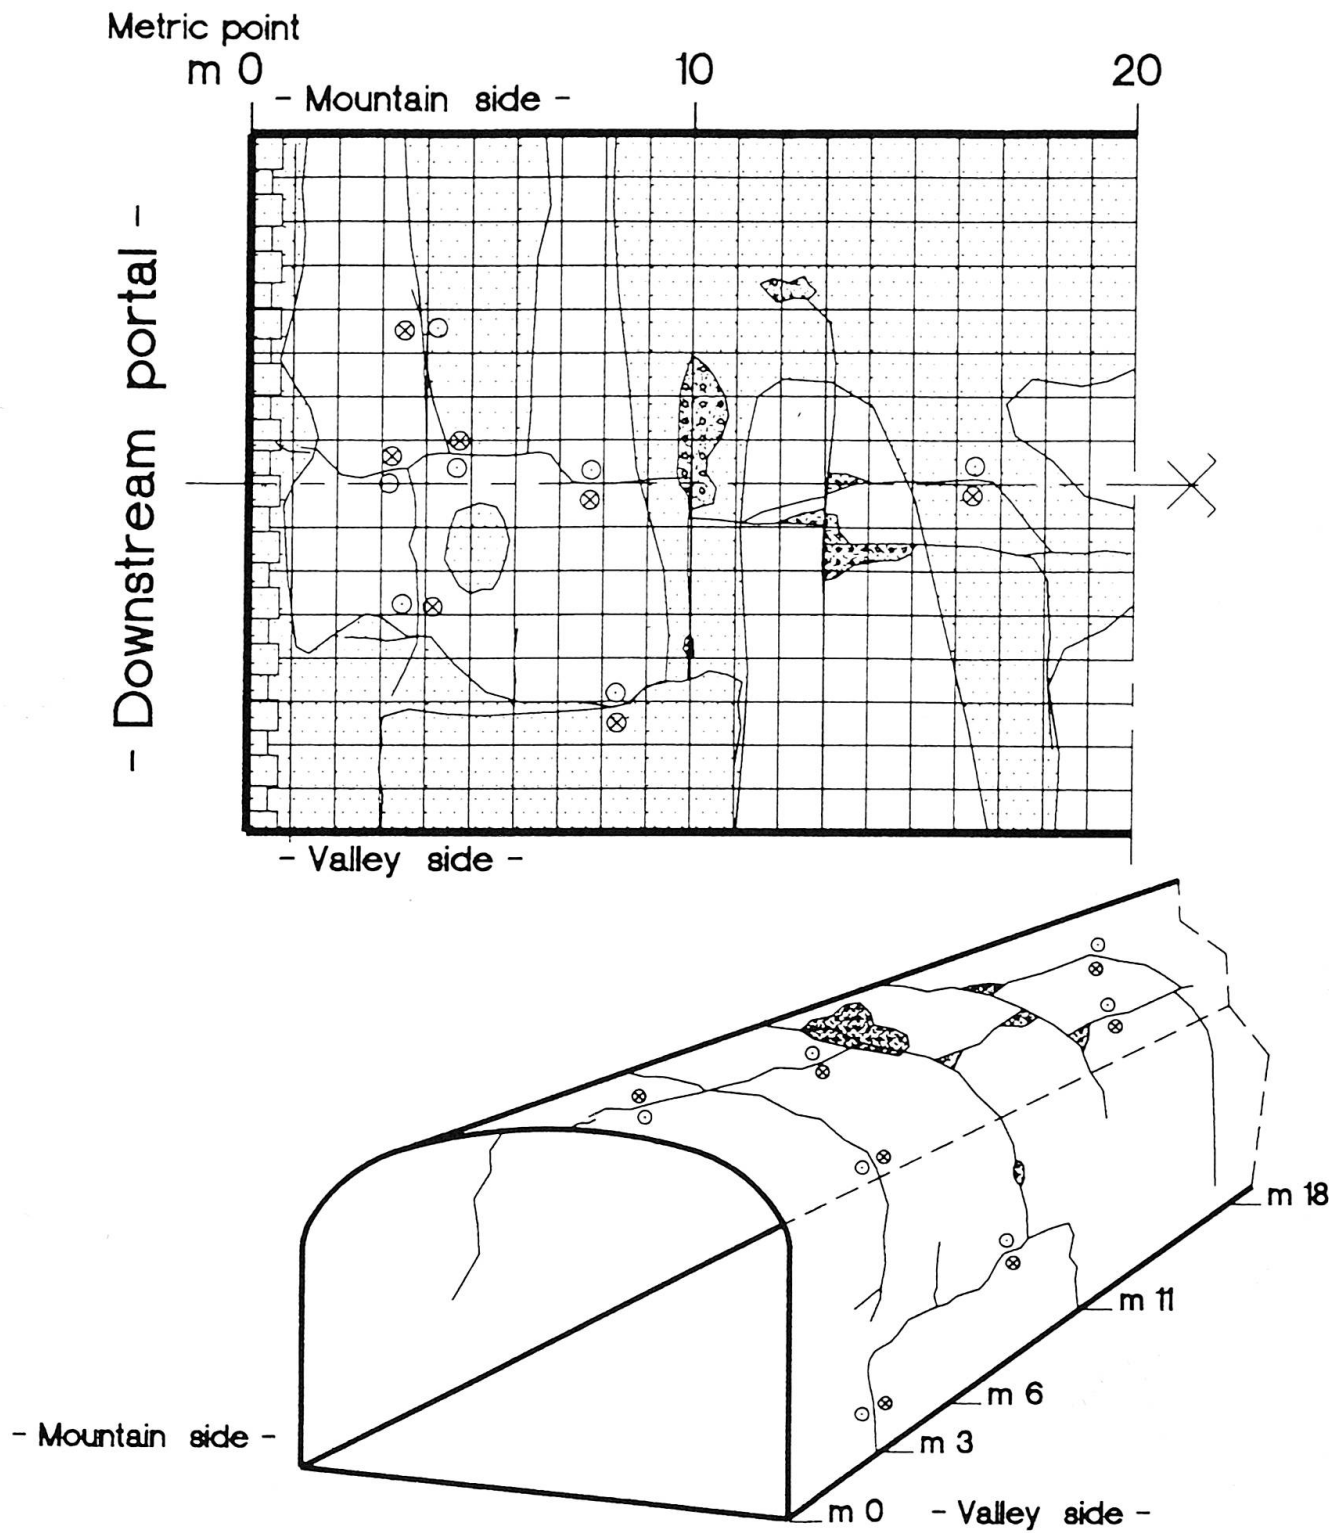
Fig. 1 Representation of cracking affecting a concrete tunnel portal

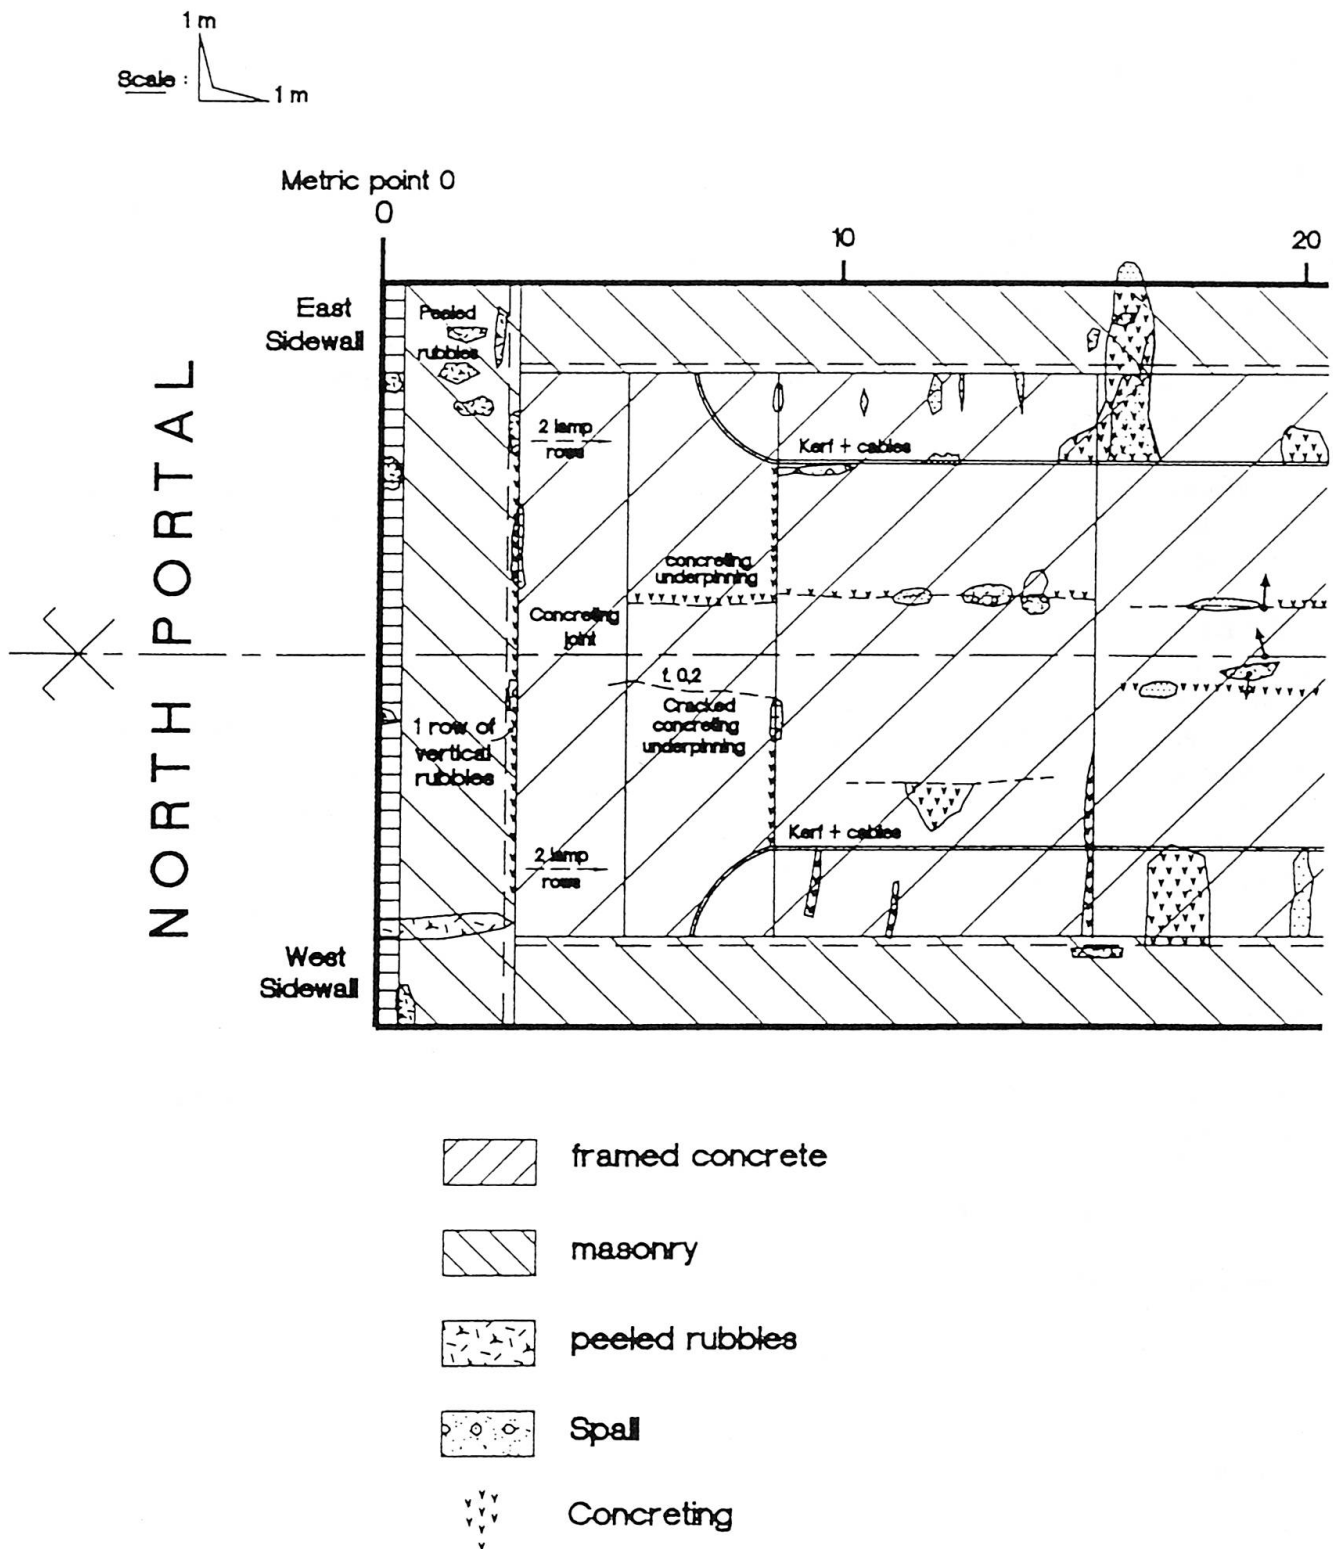
Fig. 2 Excerpt from the intrados survey of SISTERON tunnel, France

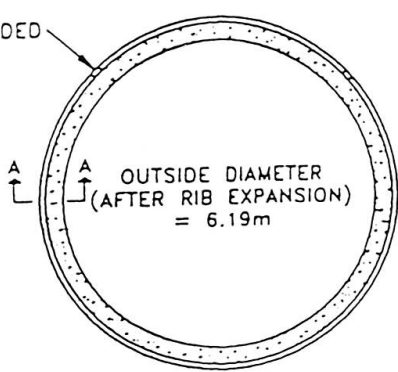
Classification		COUNTRY	CANADA
Classification	WATER STOPPAGE		
Method	CRACK INJECTION		
Outline of tunnel			
Type	SUBWAY		
Tunnelling method	TBM		
Length of service	10 YEARS		
Lining materials	(Primary) STEEL RIBS/ WOODEN LAGGING		
	(Secondary) CAST-IN-PLACE CONCRETE		
Degree of leakage	DRIP		
Location of leakage	SIDEWALLS		
Presence of frost	NO		
Cross-section of tunnel (Add geological information if available) GLACIAL TILL			
<div>EXPANDED JOINT</div> <div>

Fig. 4 Example of measures against water leakage in tunnel

- LIMITATION OF CLEARANCE			
- SMALL TOOLS ONLY NEEDED			
Description of trouble caused by water leakage			
PREVENTION OF DETERIORATION OF ELECTRICAL EQUIPMENT			
Materials used			
CHEMICAL GROUT			
Outline of method			
INJECTION HOLES ARE DRILLED AT 30° ANGLE TO THE CRACK. HOLES ARE DRILLED ON BOTH SIDES OF THE CRACK AND THEN ARE INJECTED WITH A CHEMICAL GROUT THAT EXPANDS AND SEALS CRACK WHEN IT COMES INTO CONTACT WITH WATER.			
Schema of method			
<div><div>LOCATION OF CRACK</div><div>

</div></div>			
Evaluation of method (workability, cost, etc.)			
METHOD IS TIME CONSUMING AND EXPENSIVE			
Post-repair Inspection Observations			
CRACKS HAVE MINOR LEAKS AFTER 10 YEARS

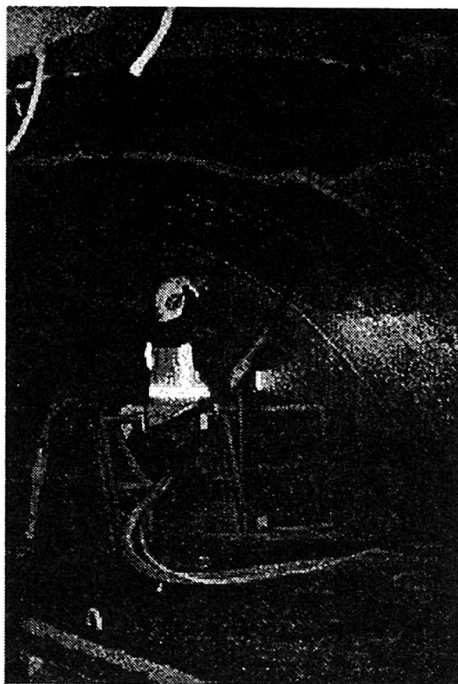
A recent, impressive example is the fire of a lorry-transporting train in the Channel tunnel. The lining was partly damaged or destroyed on a length of 500 m. The repair work consisted of curing the damaged concrete, using a pneumatic hammer and pressure water jets; the reinforcement was kept; it was re-covered with sprayed concrete. The temperature was presumed to exceed 1000°C.

*Fig. 6 Channel tunnel, after the fire of 18 November 1996
Repair of lining with sprayed concrete*

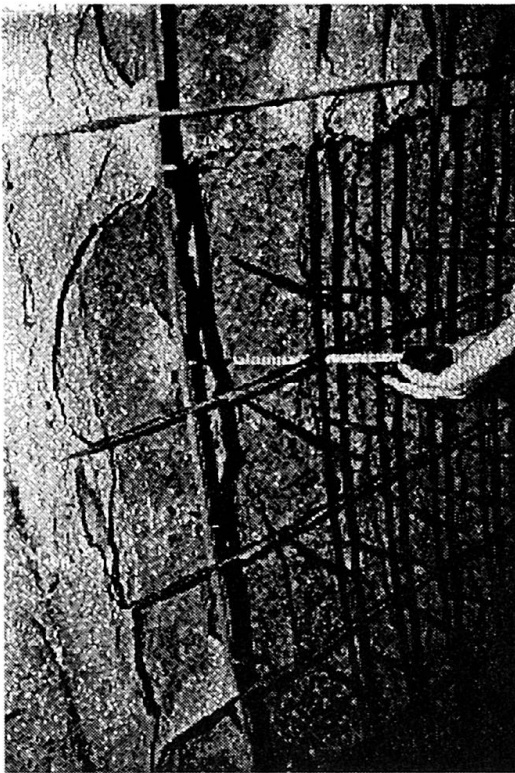
Fig.7 Channel tunnel, after the fire of 18 November 1996.

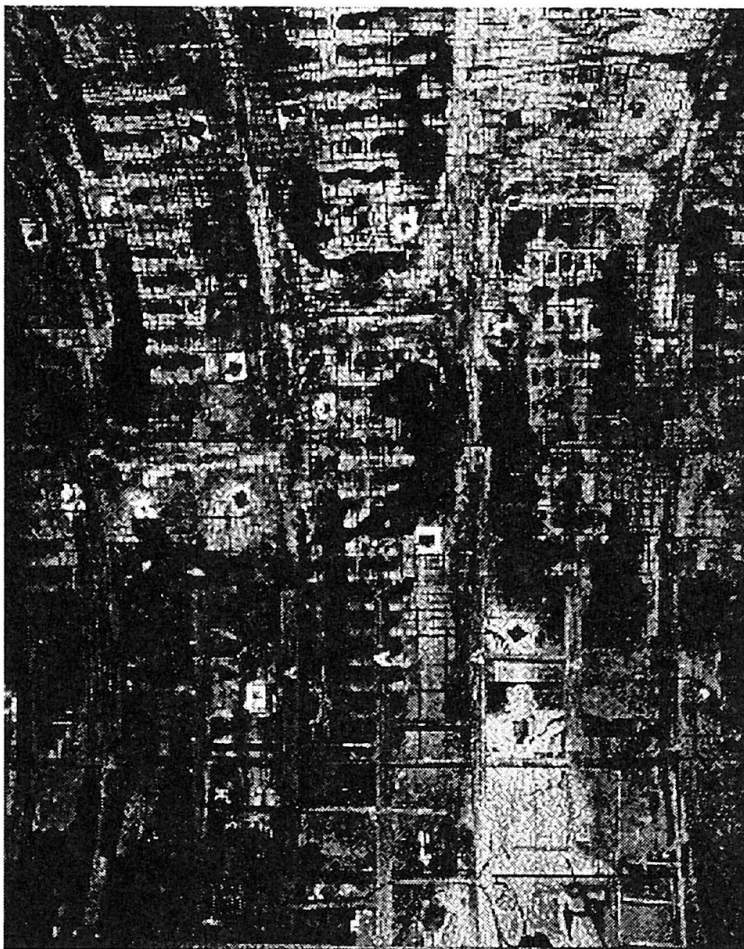
*Fig. 9 Channel tunnel, after the fire of 18 November 1996
Rings 19797 to 800, south side. Middle of Zone 3, the most damaged.
The ribs are being removed, after reinforcing with systematic bolting.*

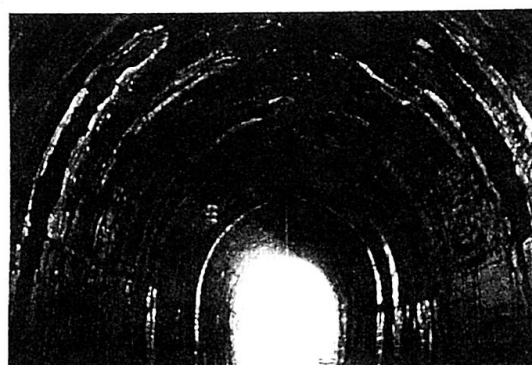
Figure 3. The surface before repair

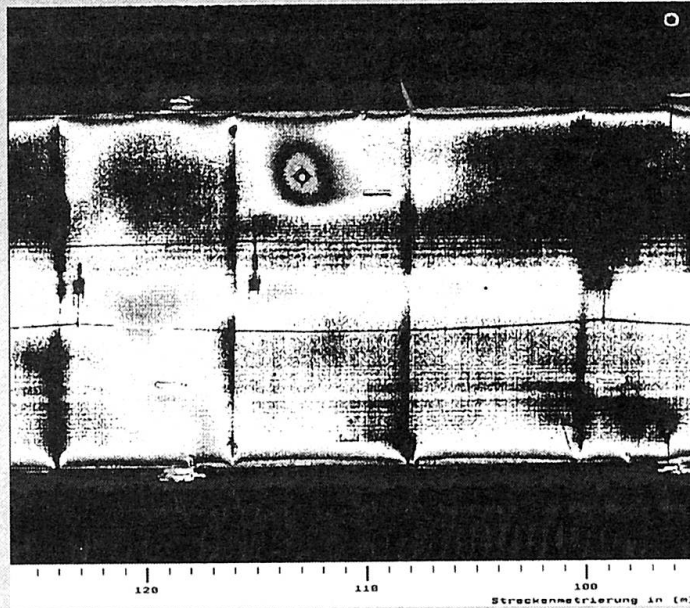
Thermography shows a striking thermal anomaly on the left side wall. Water has intruded into the concrete of the lining.

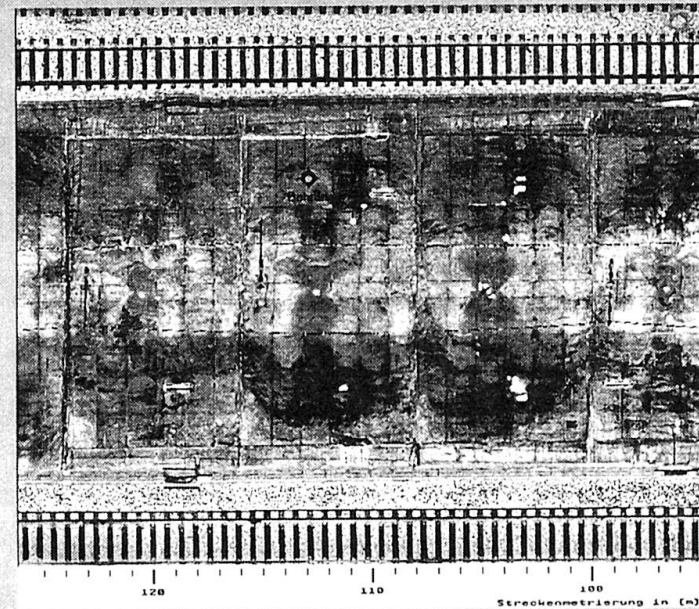
The visual image shows no traces of water on the lining surface.

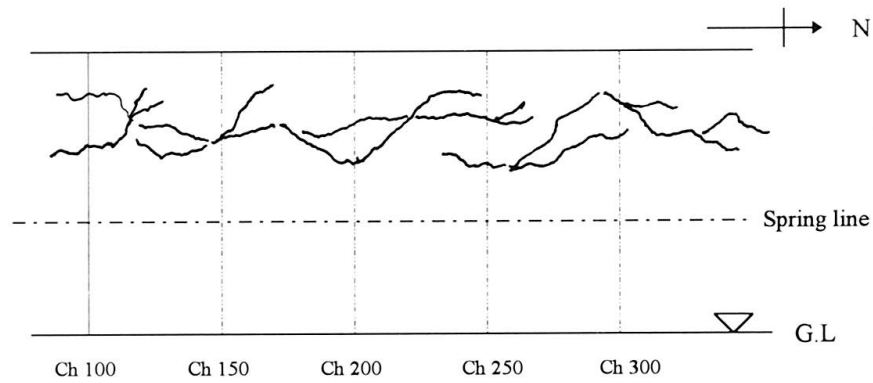
The appearance of cracks in the tunnel lining of both the tunnels was generally of concern to most motorists using the tunnels. However, from the detailed investigation carried out during the assessment programme it was noted that the pattern of cracks was typical of map cracks as shown in Fig. 3. The dry crack pattern was typical for both tunnels and core samples obtained from cracked concrete generally gave details of depth of cracks. Fig. 4 shows typical crack depths as seen in six 50mm core samples obtained from the tunnel linings. A detailed crack mapping exercise was carried out to locate the extent and severity of the cracks according to established chainages along the total length of the tunnels. The cracks were further divided into two main types; dry and wet cracks. Almost seventy percent of the 8500 metres length of cracks measured for both the tunnels fell under the dry crack category. Most of these cracks were contaminated with dirt particles. The remaining cracks were typically wet owing to their depth and location which was close to faults in rocks. The thickness of the tunnel lining varied between almost 850mm at the base

Fig.3 Typical map cracks observed in linings of north bound tunnel

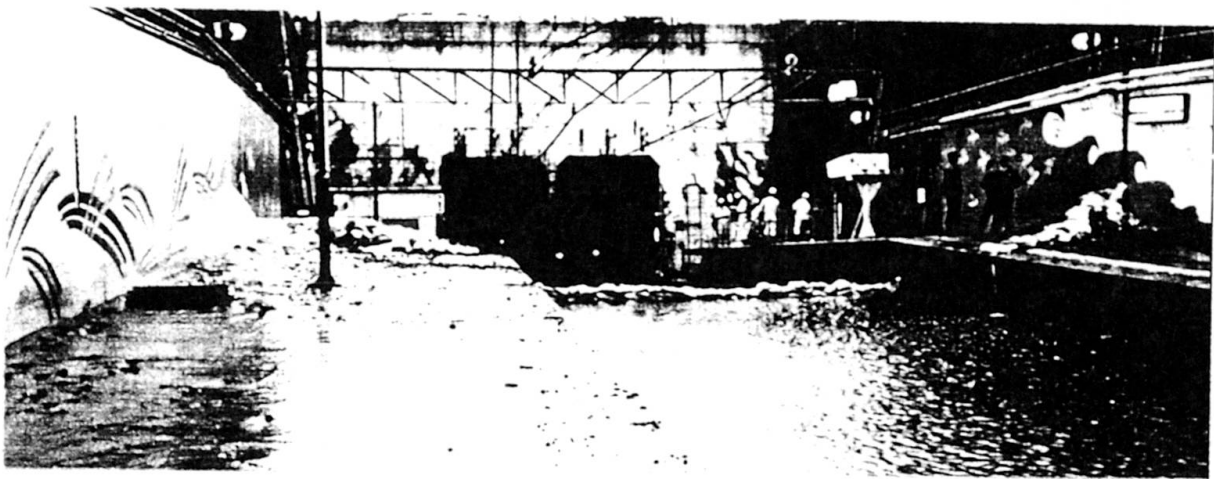
Photo 1 Conditions of Damage

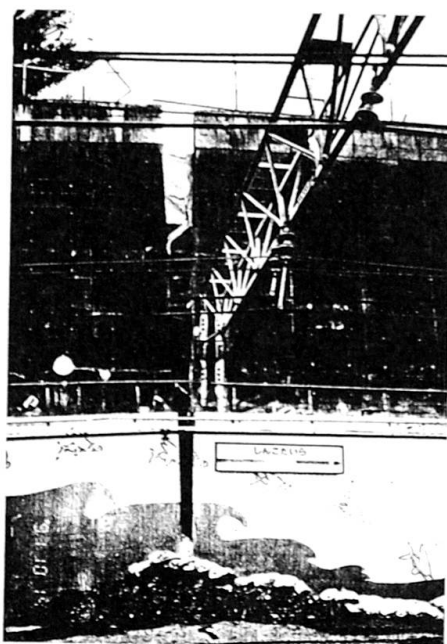
Photo 2 Conditions of Damage
