**Zeitschrift:** IABSE reports = Rapports AIPC = IVBH Berichte

**Band:** 78 (1998)

# Maintenance and repair

# Session 6 - MAINTENANCE AND REPAIR Keynote address

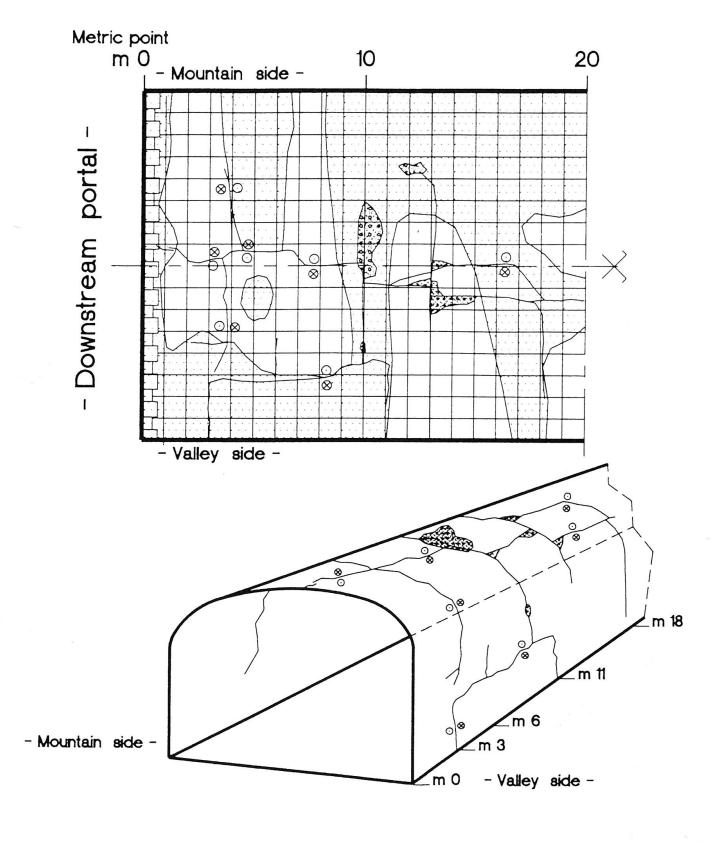
Fig. 1 Representation of cracking affecting a concrete tunnel portal

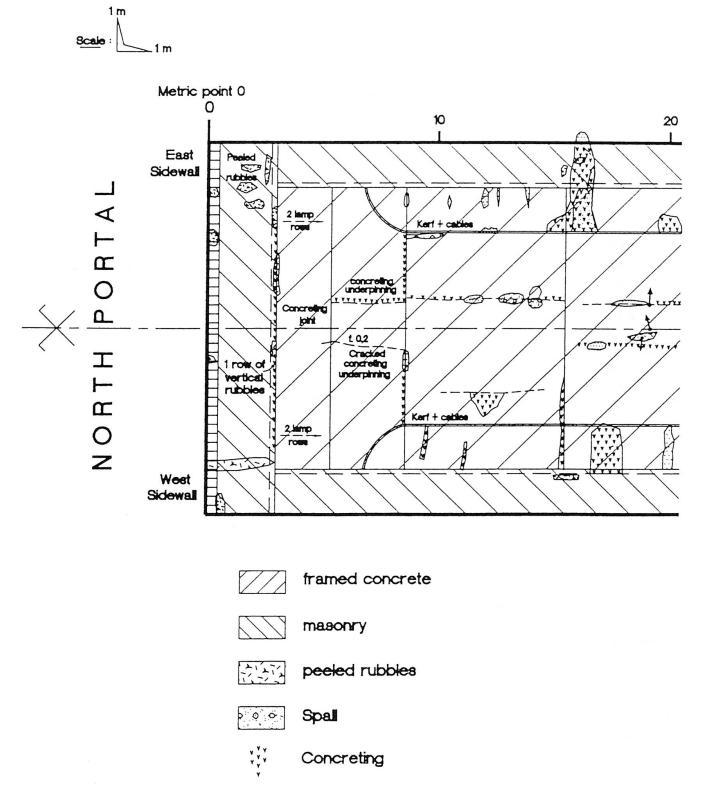
Fig. 2 Excerpt from the intrados survey of SISTERON tunnel, France

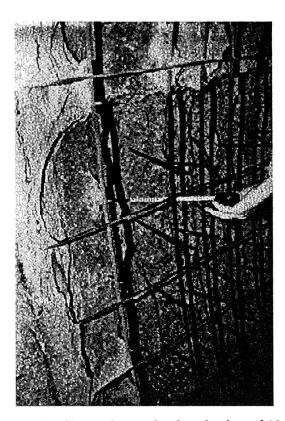
Fig. 7 Channel tunnel, after the fire of 18 November 1996.

After curing of the concrete surface spalling, the reinforcement is maintained.

A recent, impressive example is the fire of a lorry-transporting train in the Channel tunnel. The lining was partly damaged or destroyed on a length of 500 m. The repair work consisted of curing the damaged concrete, using a pneumatic hammer and pressure water jets; the reinforcement was kept; it was re-covered with sprayed concrete. The temperature was presumed to exceed 1000°C.

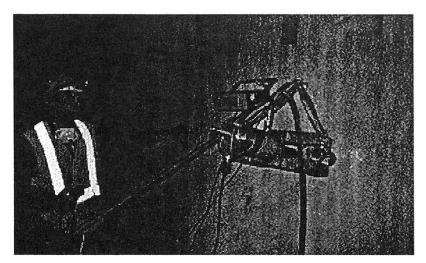
Fig. 8 After sprayed concreting, tearing tests on pins to test the equipment securing conditions

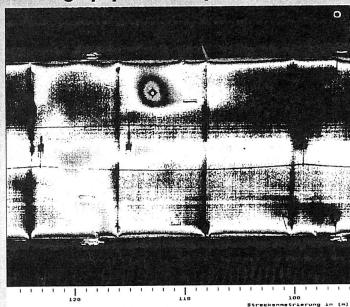
Thermography shows a striking thermal anomaly on the left side wall. Water has intruded into the concrete of the lining.

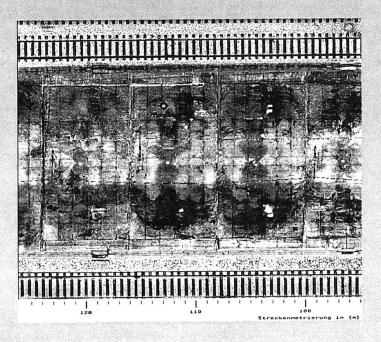
The visual image shows no traces of water on the lining surface.

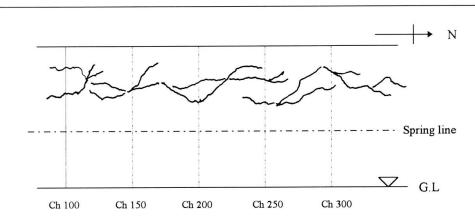
A detailed visual inspection carried out on the cracked concrete did not reveal signs of rust or corrosion of rebars. Localised break-outs were carried out to confirm the absence of rebar corrosion. Leaching of cement through wet cracks was evident in cracks located above the spring line of the tunnel. A detailed crack mapping exercise was carried out to document the extent and pattern of cracks in the lining. This was done by dividing the entire length of the tunnel into chainages and marking individual cracks according to their chainage. The total length of cracks measured for both the tunnels was close to 8500 metres. Most of these cracks were between 0.3mm to 3mm wide.

Fig.3 Typical map cracks observed in linings of north bound tunnel

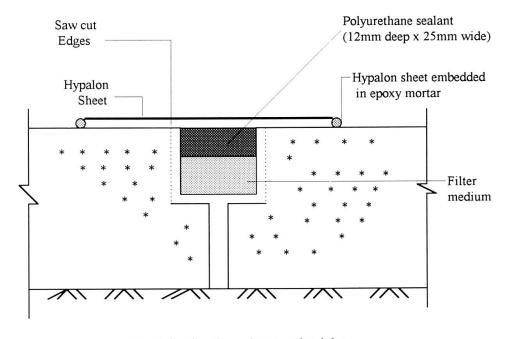
Fig.5 Section through expansion joint

The main defect observed in faulty expansion joints was loose and hardened sealant which had debonded from the existing groove. Some of the joints were affected by seepage of water from behind the tunnel lining. The defective sealant was completely removed to ensure the affected expansion joint was free from loose and debonded material. A chase measuring 25mm wide and 50mm deep was cut along the length of the faulty expansion joint using a diamond saw. The joint was cleaned with a high pressure water jet to prepare the surface for remedial treatment. A filter medium was then installed along the length of the expansion joint to convey trapped water into an adjoining uPVC pipe which was connected to the existing drain. The surface of the expansion joint was then sealed with a 12mm thick polyurethane sealant to prevent seepage of water from the filter membrane. As a protection to the exposed sealant, a hypalon sheet was installed along the length of the joint as shown in Fig. 5.

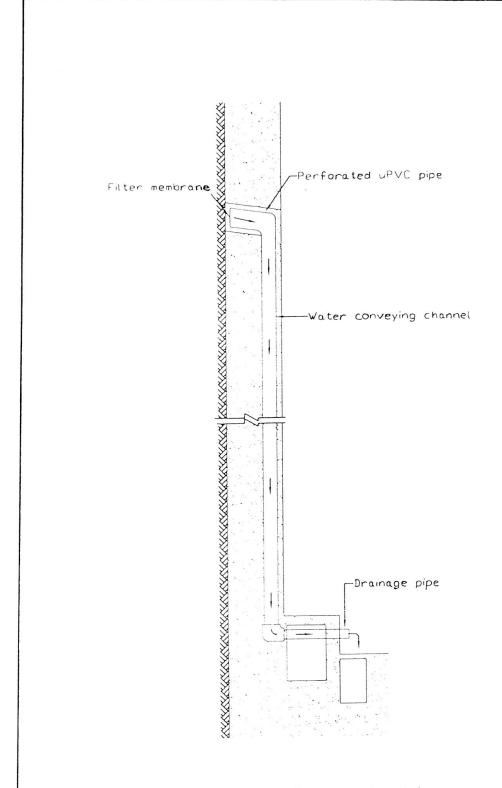
Fig. 6 Section through expansion joint showing drainage system

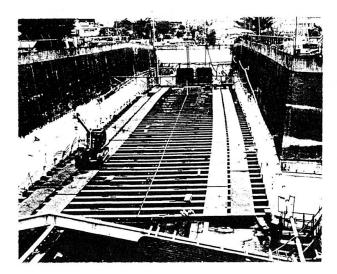
Photo3 Temporary supports
