Zeitschrift: IABSE reports = Rapports AIPC = IVBH Berichte
Band: 78 (1998)

Rubrik: Session 6: Maintenance and repair

Maintenance and repair

Session 6 - MAINTENANCE AND REPAIR

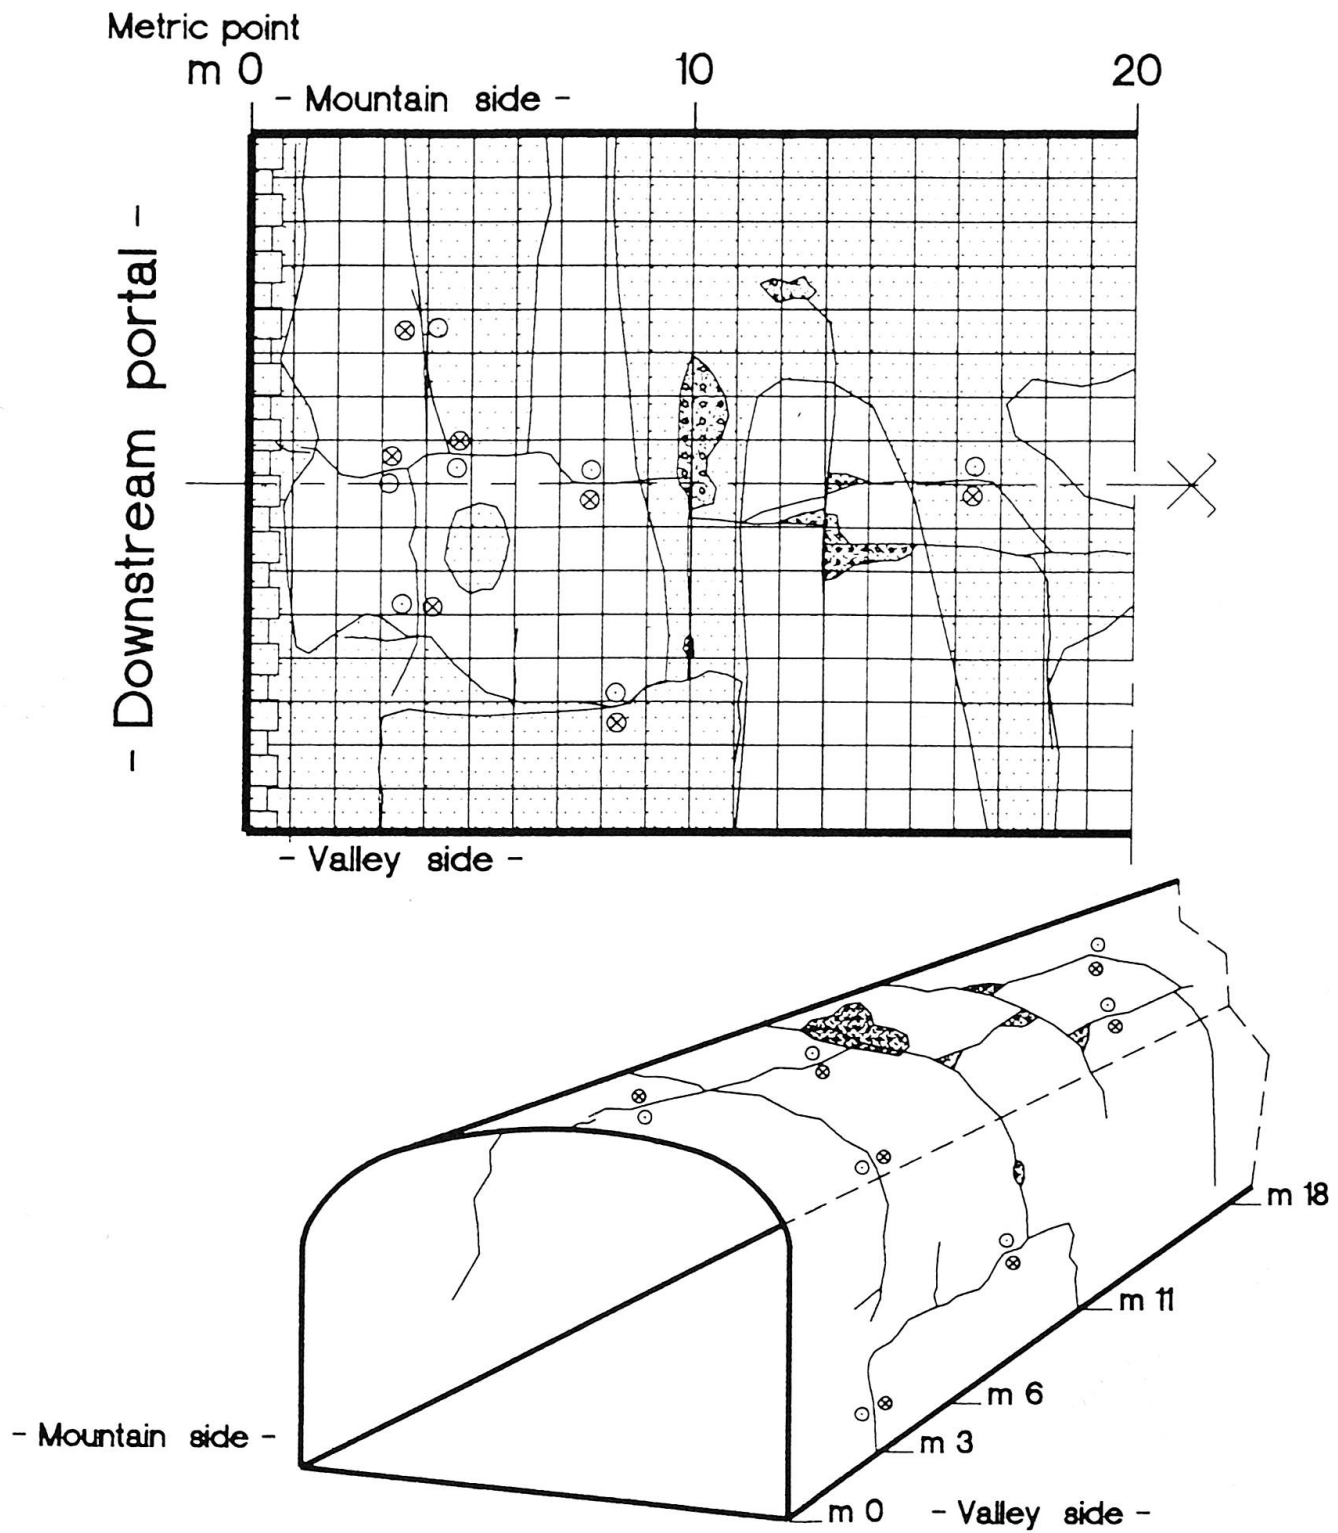
Fig. 1 Representation of cracking affecting a concrete tunnel portal

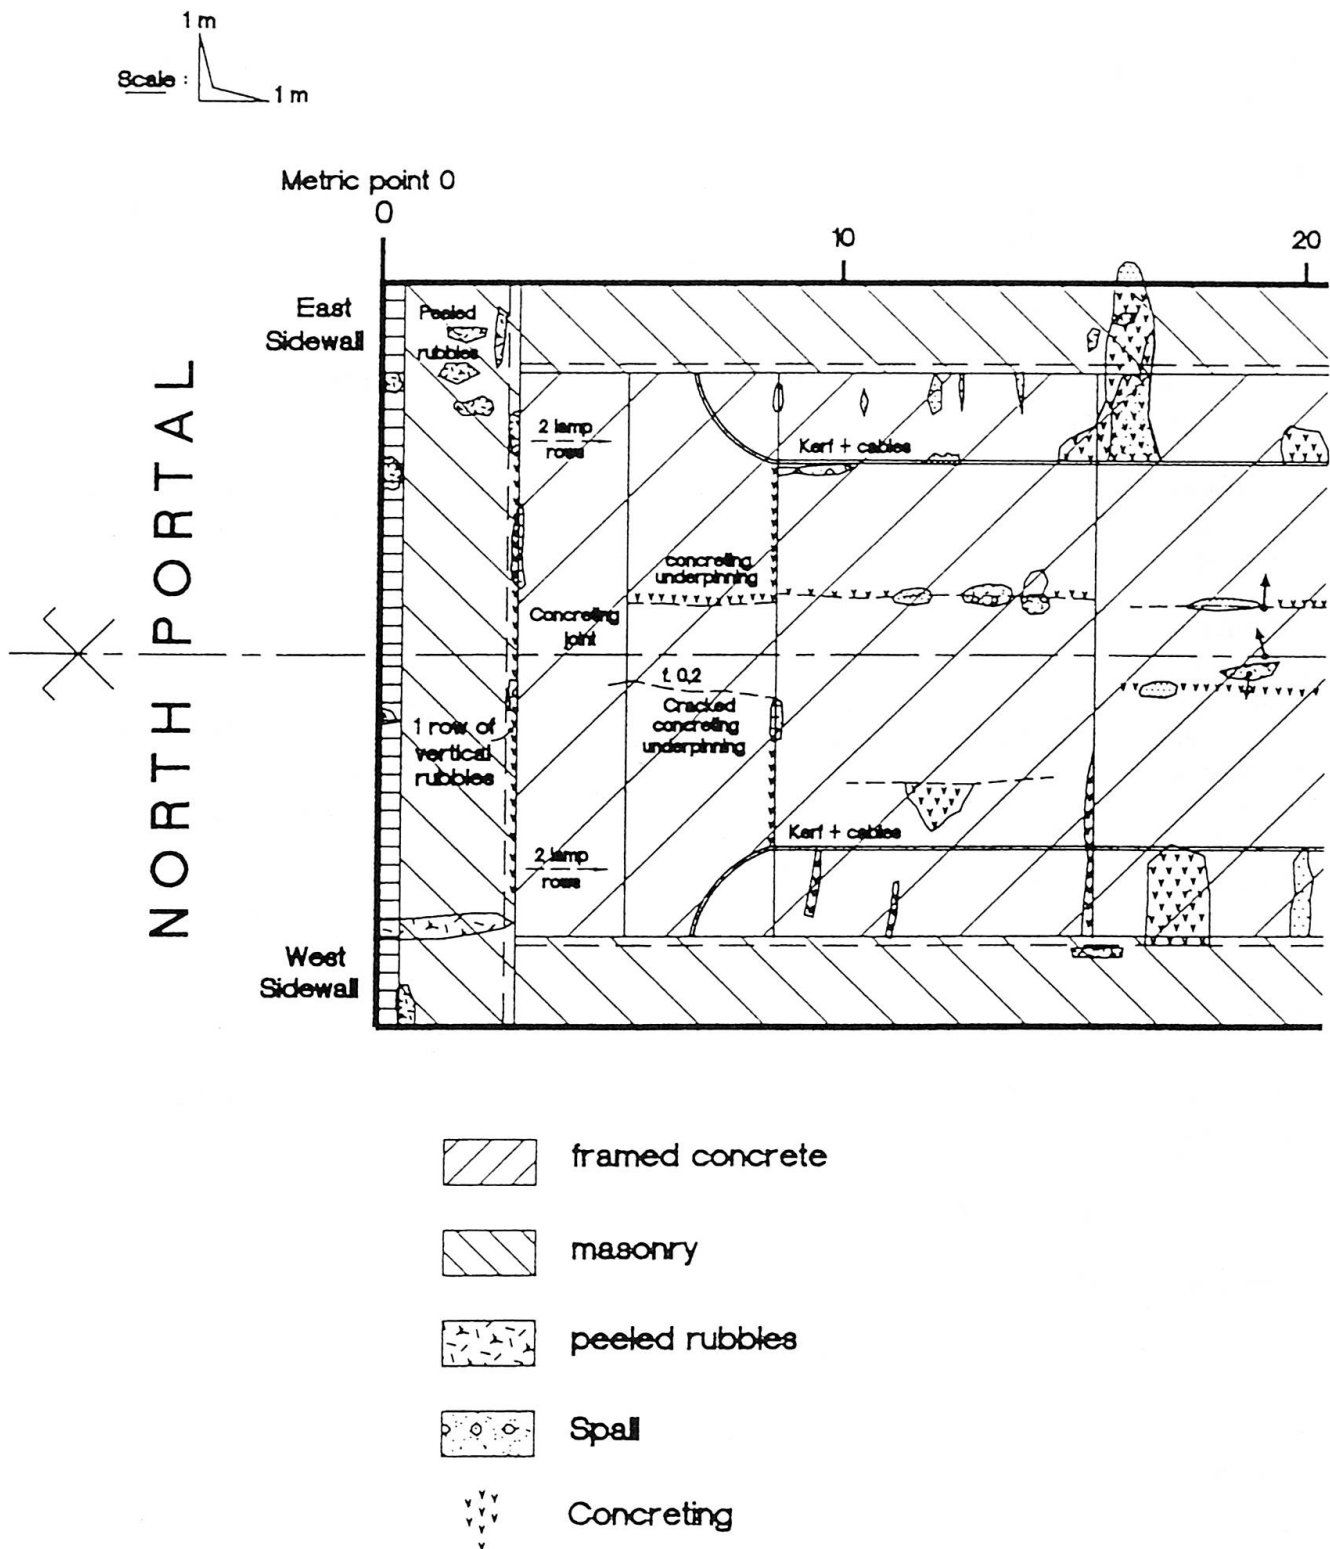
Fig. 2 Excerpt from the intrados survey of SISTERON tunnel, France

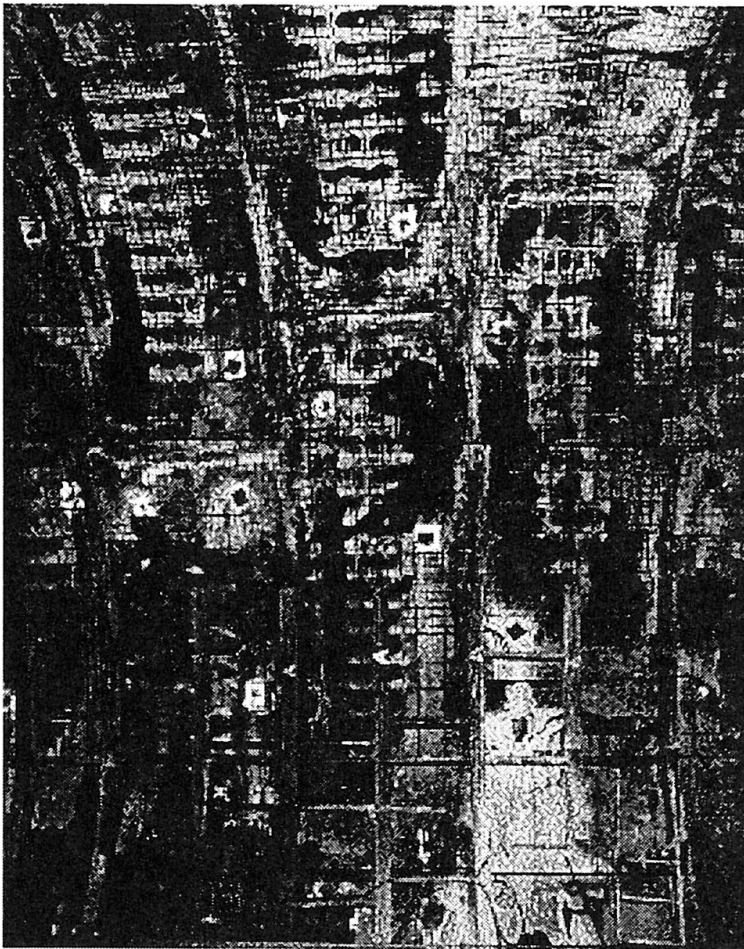
*Fig. 9 Channel tunnel, after the fire of 18 November 1996
Rings 19797 to 800, south side. Middle of Zone 3, the most damaged.
The ribs are being removed, after reinforcing with systematic bolting.*

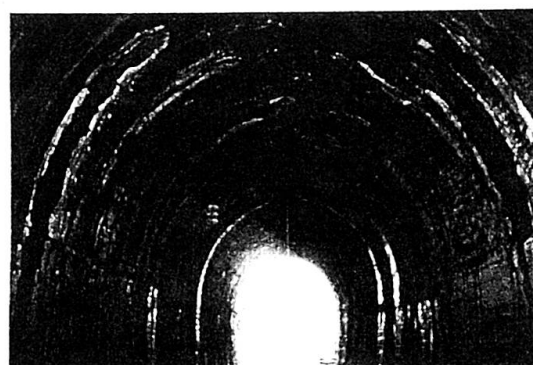
Figure 3. The surface before repair

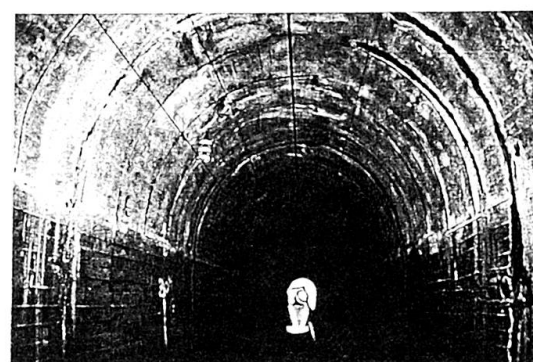
Figure 4. The surface after repair

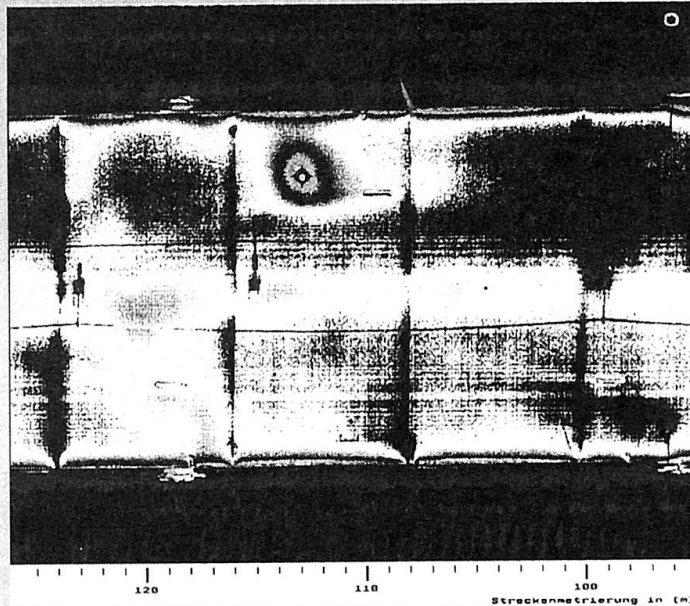
Thermography shows a striking thermal anomaly on the left side wall. Water has intruded into the concrete of the lining.

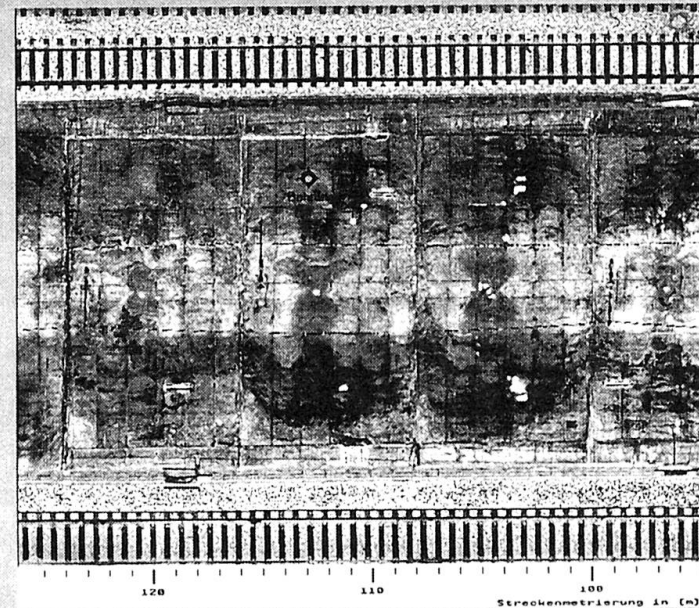
The visual image shows no traces of water on the lining surface.
