Artikel: Repair of the Linfjord tunnel, Denmark
Autor: Vejlby Thomsen, J. / Hededal, Poul
DOI: <https://doi.org/10.5169/seals-59067>

Repair of the Limfjord Tunnel, Denmark

J. Vejlby Thomsen

Poul Hededal

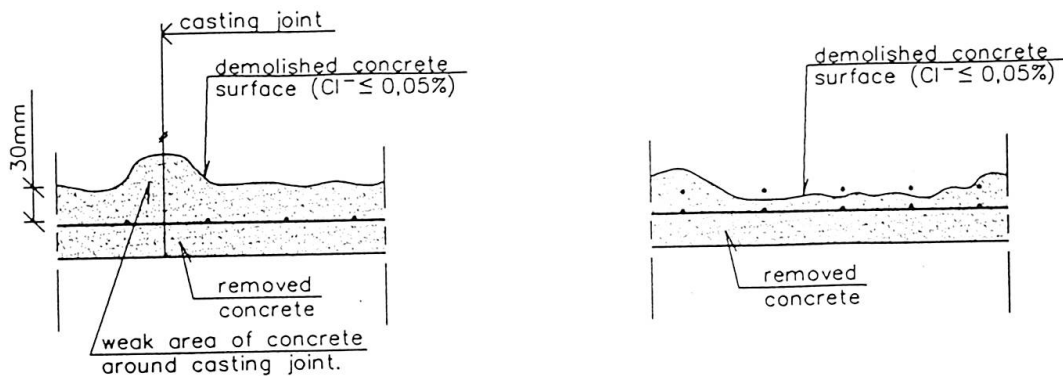
Generally concrete is removed until the amount of chlorides in the concrete is less than 0.05% by weight of concrete, however, never deeper than 30 mm behind the deepest layer of reinforcement unless weak areas of concrete facilitate deeper demolition.

Two typical demolition profile is schematically shown below.
